## Site Photos

# Site Photos

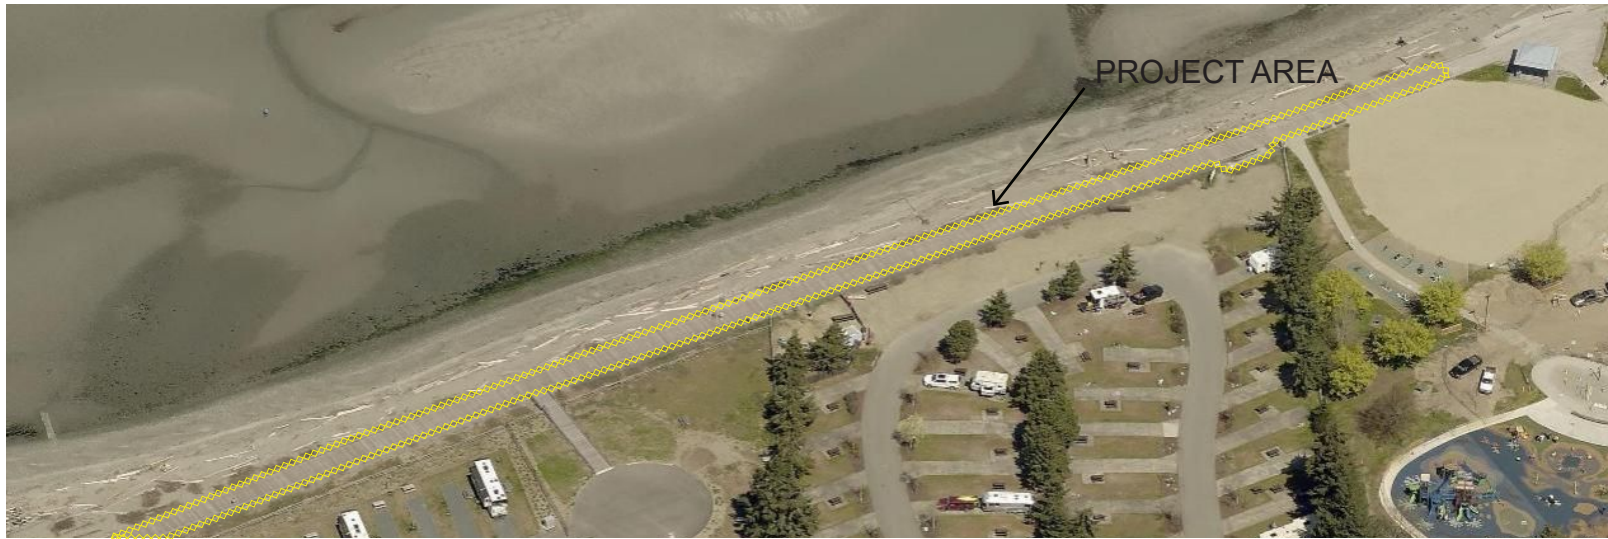
Oblique Aerial Photo - north view of the east end of the project area.

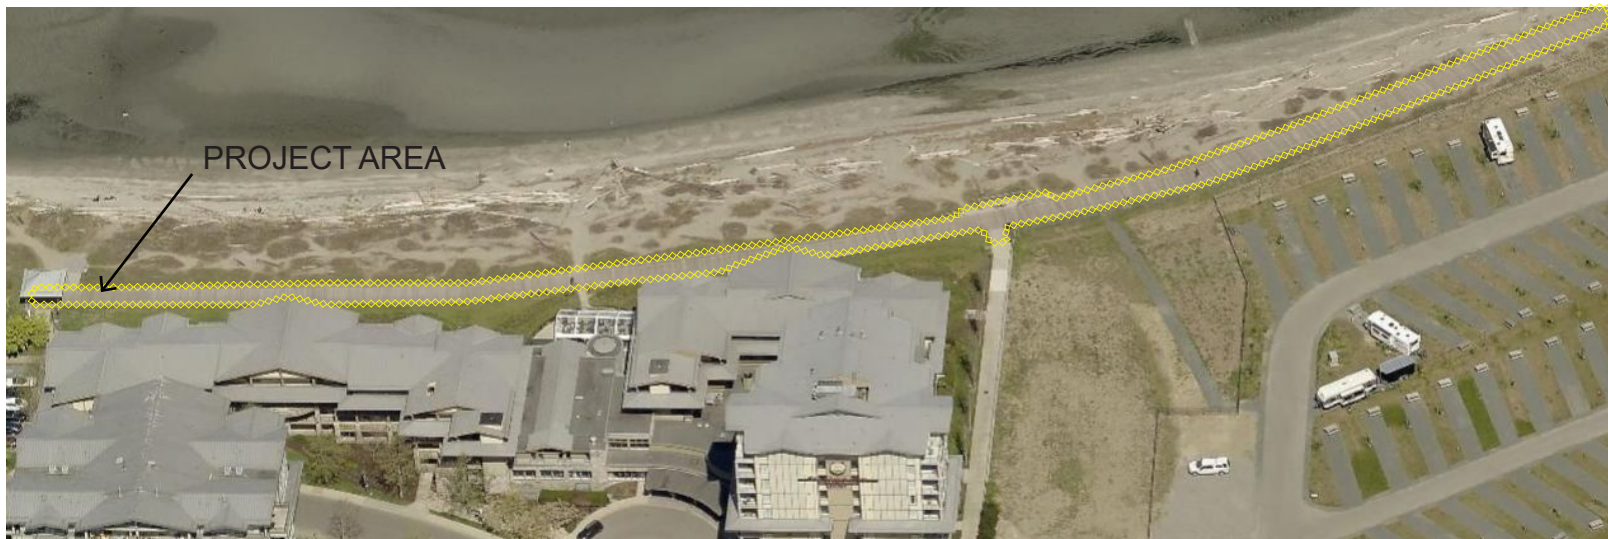
Oblique Aerial Photo - north view of the west end of the project area.

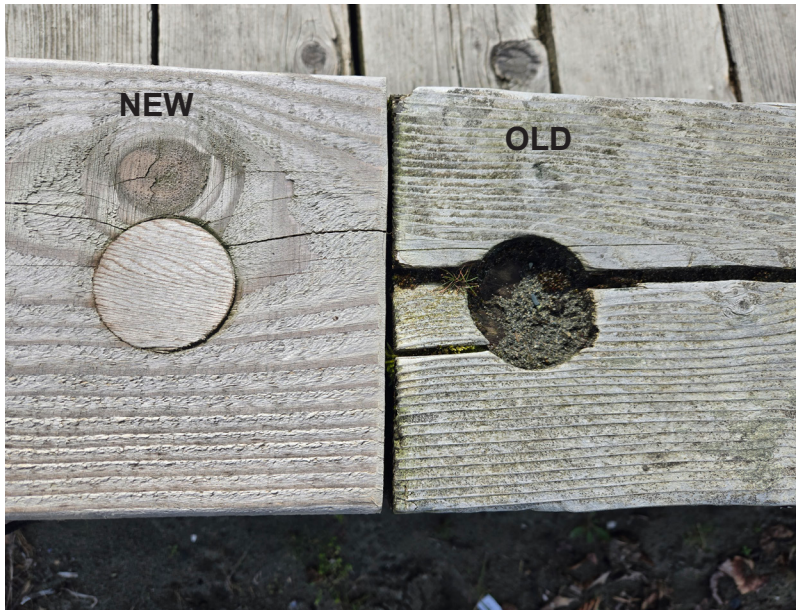
Example of new bull rail section and bolt caps beside an old bull rail without a cap that needs replacement.

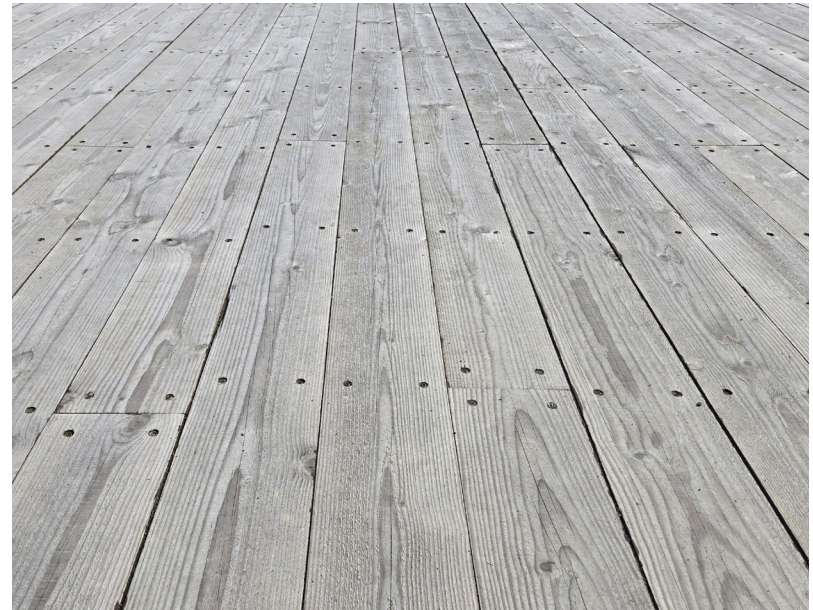
Looking north across the decking replaced in 2024. Note the acceptable gap width between boards. 1/8 inch is desirable.

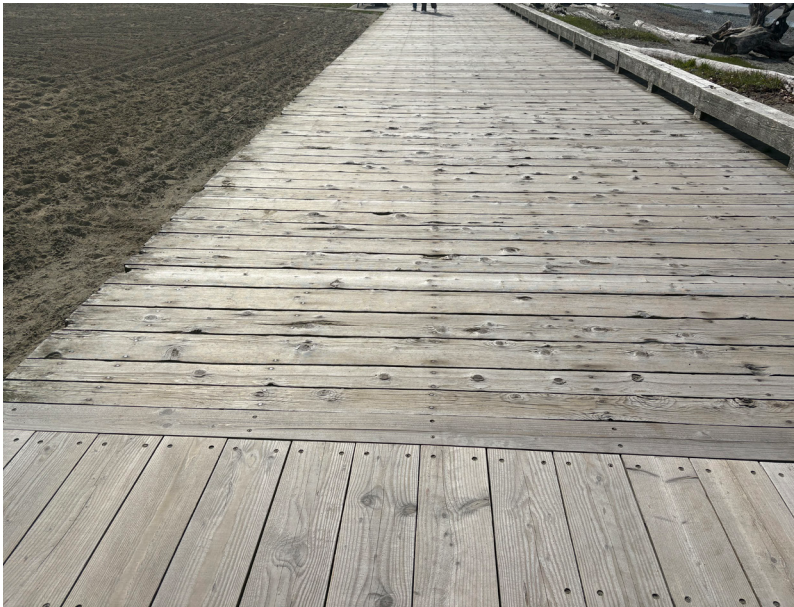
Looking west at the transition between the old boardwalk and new boardwalk section replaced in 2024

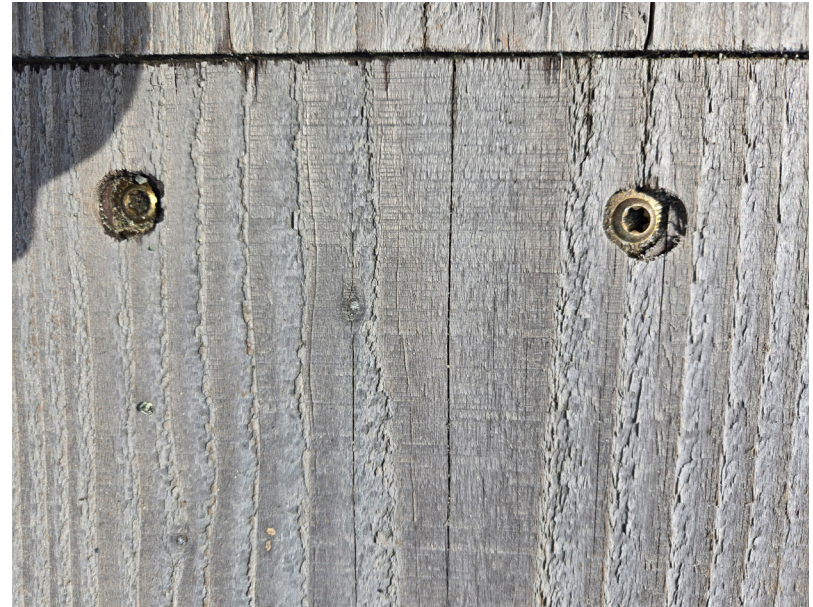
Example of the new decking with GRK screws

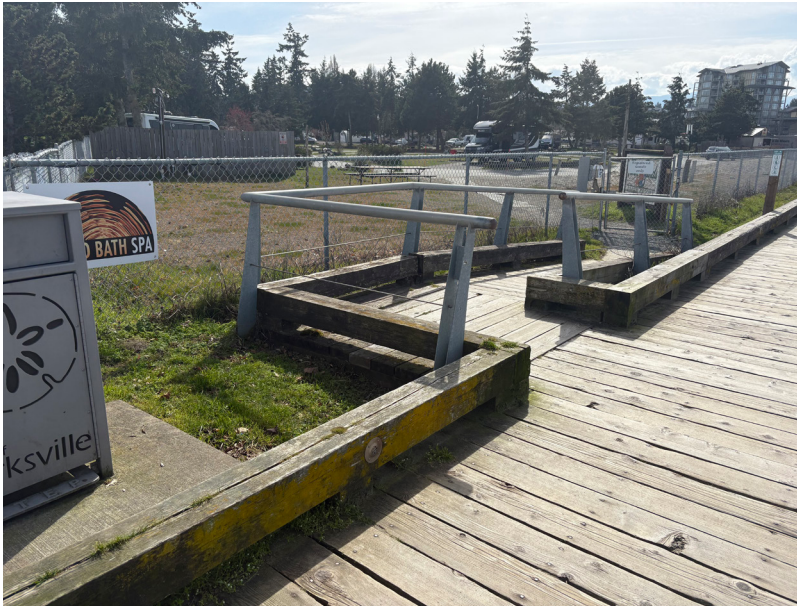
Looking west at the access ramp to Park Sands property. Ramp is included in the scope of work.

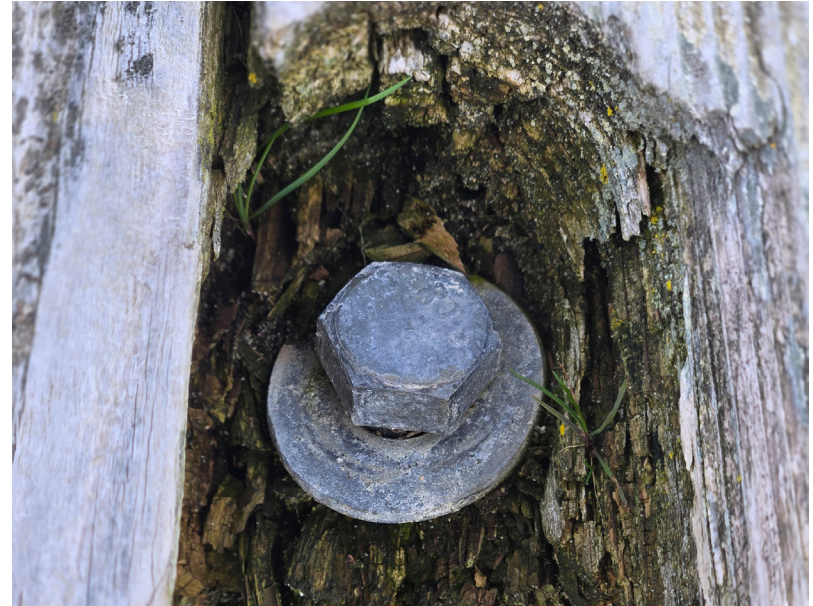
Exposed old lag bolt on bull rail that requires replacement.

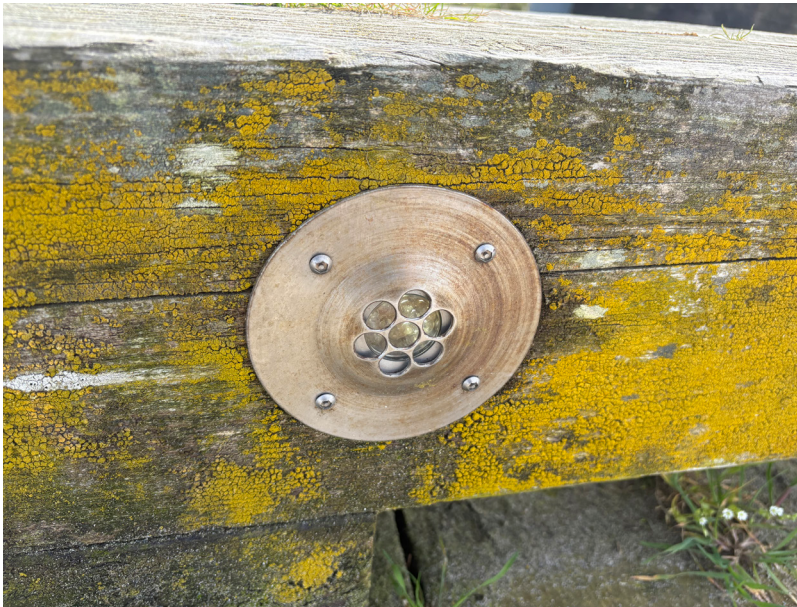
Existing pathway lighting that needs replacement to provide more light. Fixtures are spaced at approximately 30 ft on one side of the boardwalk.

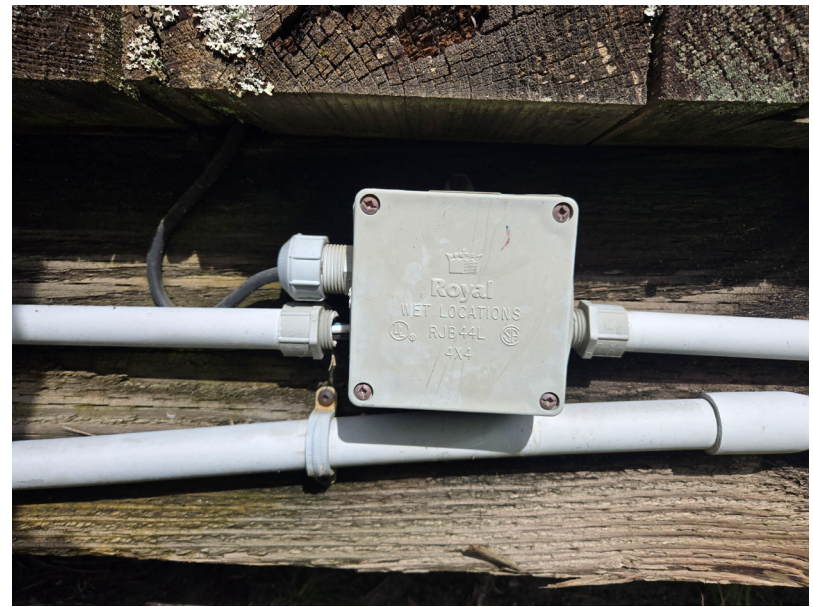
Electrical conduit and junction box behind light fixture on the south face of the boardwalk.

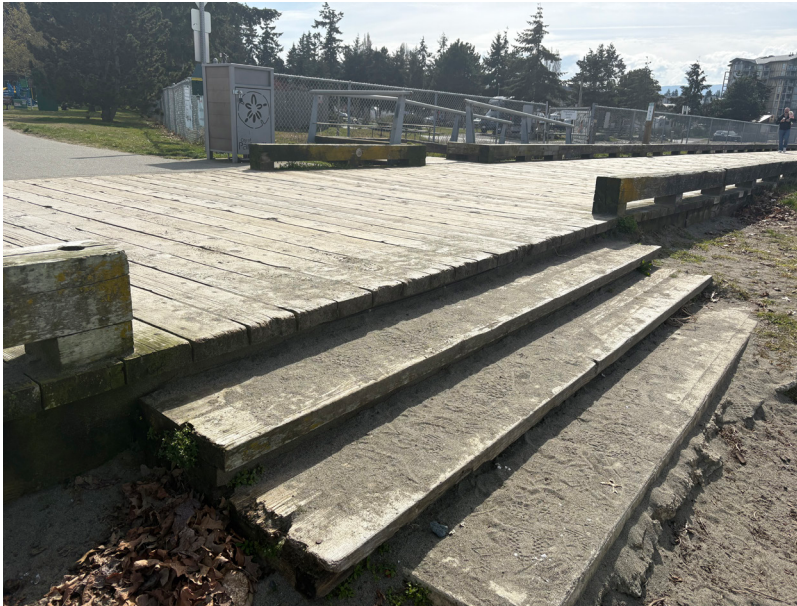
Small set of stairs leading to the beach. Stairs are included in the scope of work.

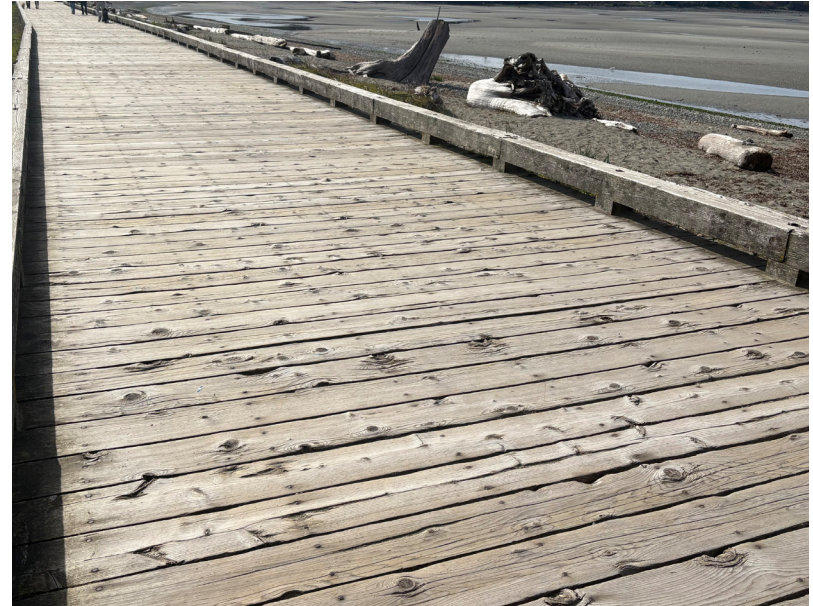
Looking east at the edge of the beach facing boardwalk.

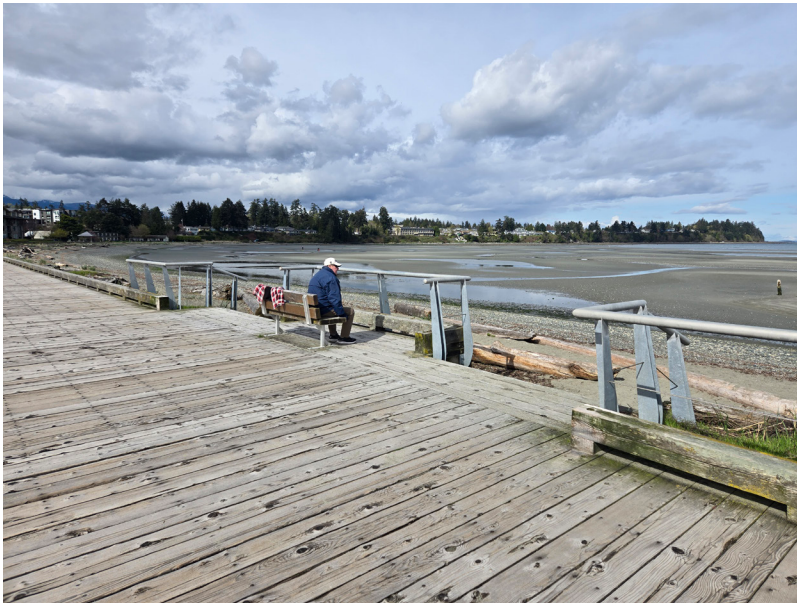
East seating area with two sets of stairs included in the scope of work.

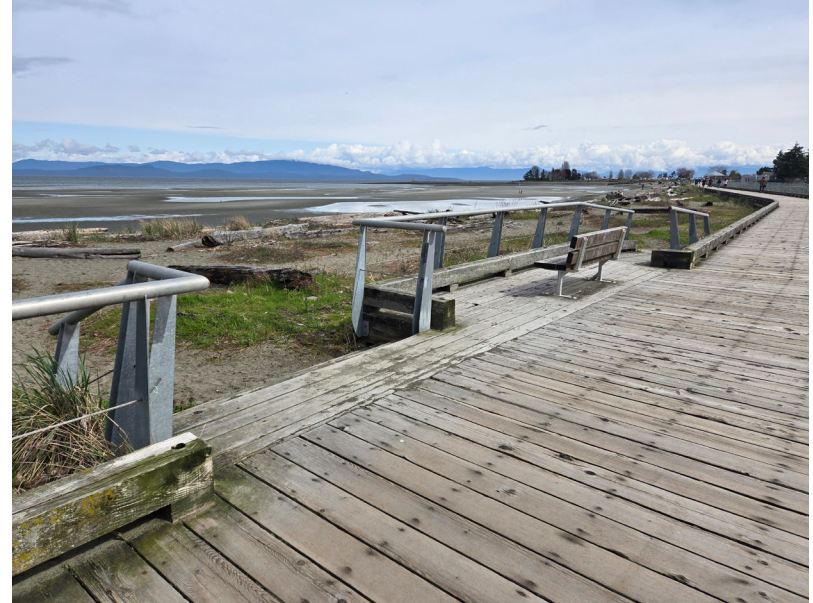
West sitting area with one set of stairs and a ramp included in the scope of work.

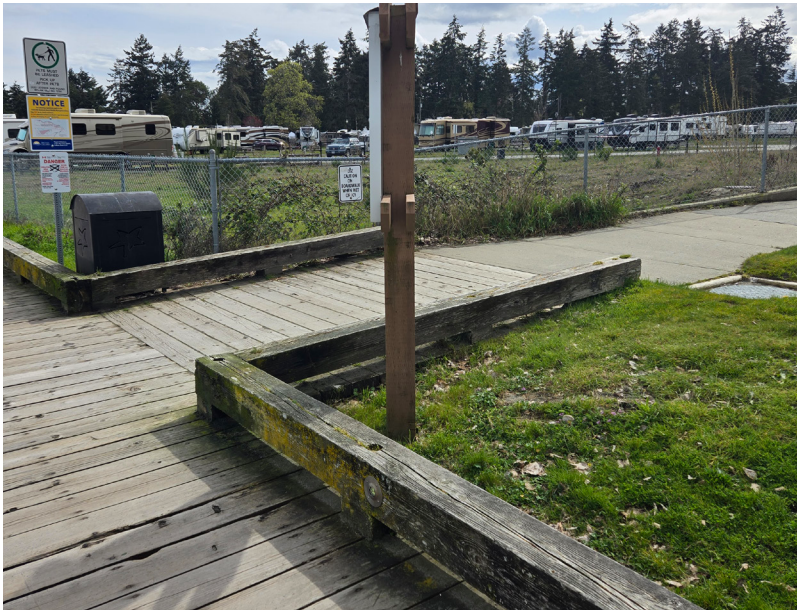
Small perpendicular section connecting to pathway on the east side of the Beachclub included in the scope of work.

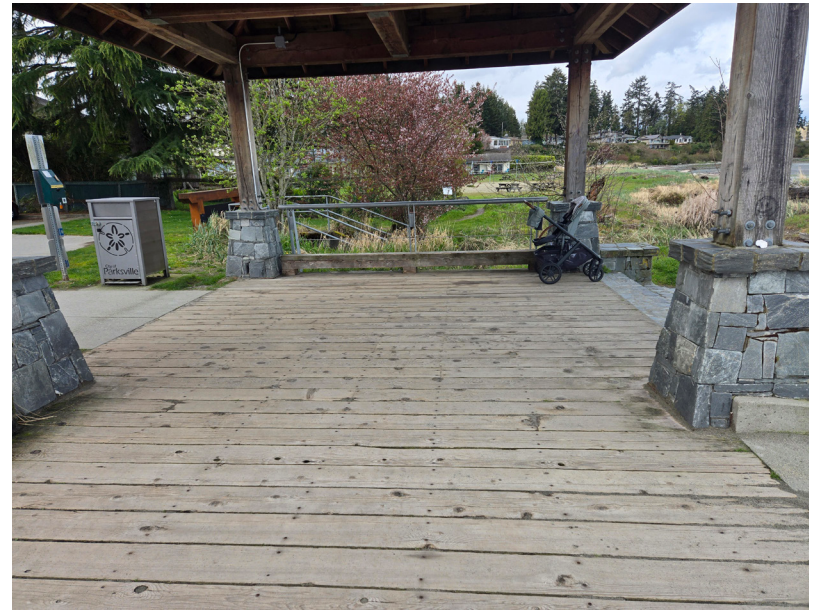
Boardwalk under the west gazebo included in the scope of work.

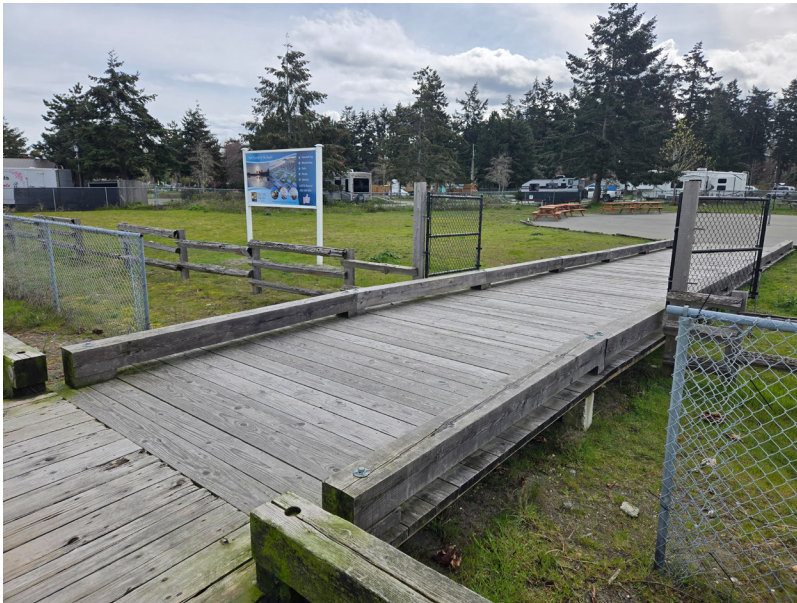
Connecting Ramp to Pacific Palm **NOT** included in the scope of work.

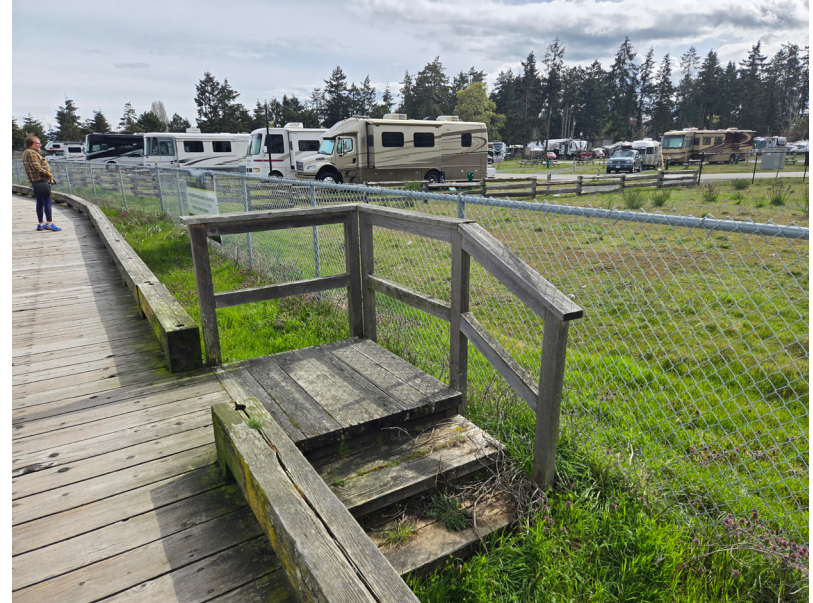
Small access stairs to be removed and **not replaced**.
