Assessment of Groundwater at Risk of Containing Pathogens (GARP), Railway Well Field, Parksville, BC *City of Parksville, Parksville, BC*

22532310-002-R-Rev0

27 September 2023

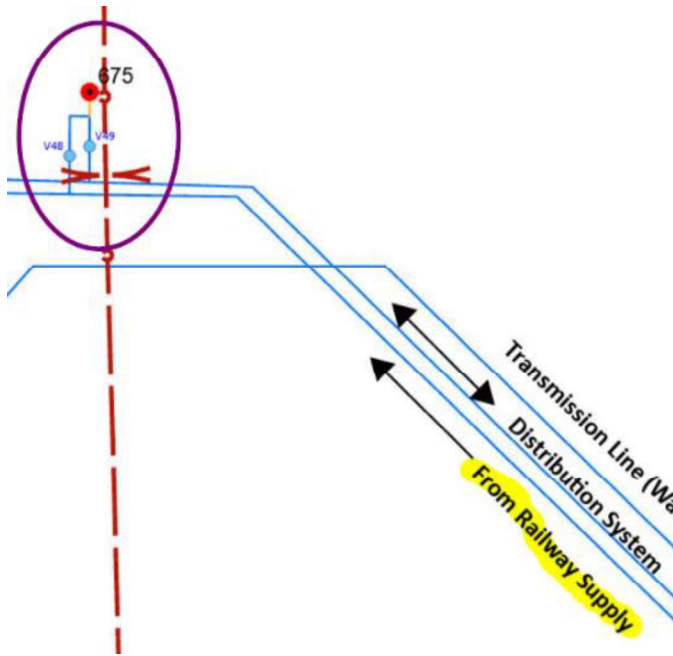
WSP also conducted a preliminary review of the piping schematic provided by the City (2023b) for the Water Complex and identified the possibility of cross connections between treated water lines and lines conveying unchlorinated water or water that may not have had sufficient chlorine contact time. An example of this is shown below (snip from the lower right side of the schematic provided by the City and presented in APPENDIX D).

Opening of Valves V48 and V49 (blue circles) at the same time could potentially allow untreated water from the Railway Wells to enter the distribution system. It is possible that the schematic simplified the actual piping arrangement or does not show all cross connection control features. However, issues such as the one identified in this section should be investigated and, if it is determined that a cross connection indeed exists, mitigated.

- A detailed assessment of the piping arrangement at the Water Complex should be undertaken to confirm site conditions and assess potential cross connections. If issues are identified, a cross connection control plan should be developed and implemented to mitigate the issues identified. The infrastructure drawings should then be updated to reflect the changes.
