**Table A-1: Results of Hazard Screening and Groundwater at Risk of Containing Pathogens (GARP) Assessment**  
**Railway Well Field, City of Parksville, BC**

**APPENDIX B**

**Site Photos**

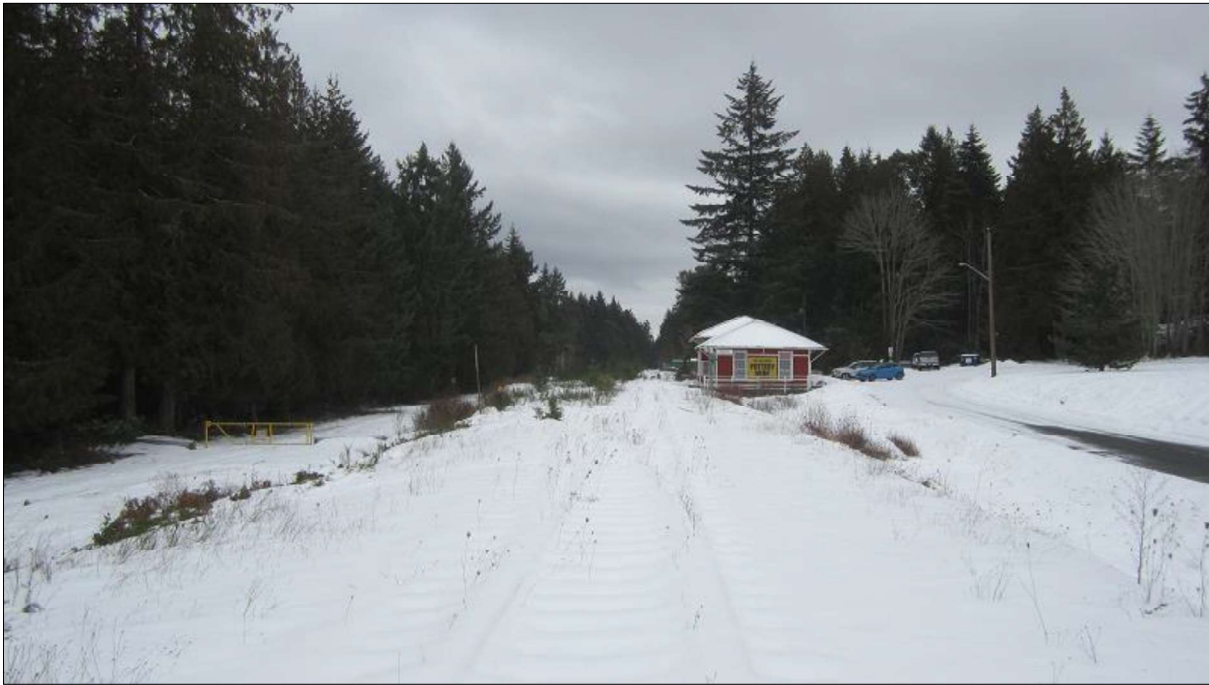
**Photo B-1:** Photo of the Railway Well Field taken on 27 February 2023, looking east. The Arrowsmith Potter's Guild store is visible in the centre of the photo and the Railway Wells are located along the vegetated areas past the yellow gates to the left (Railway #1, #2, #3 and #4) and right (Railway #5, #6 and #7).

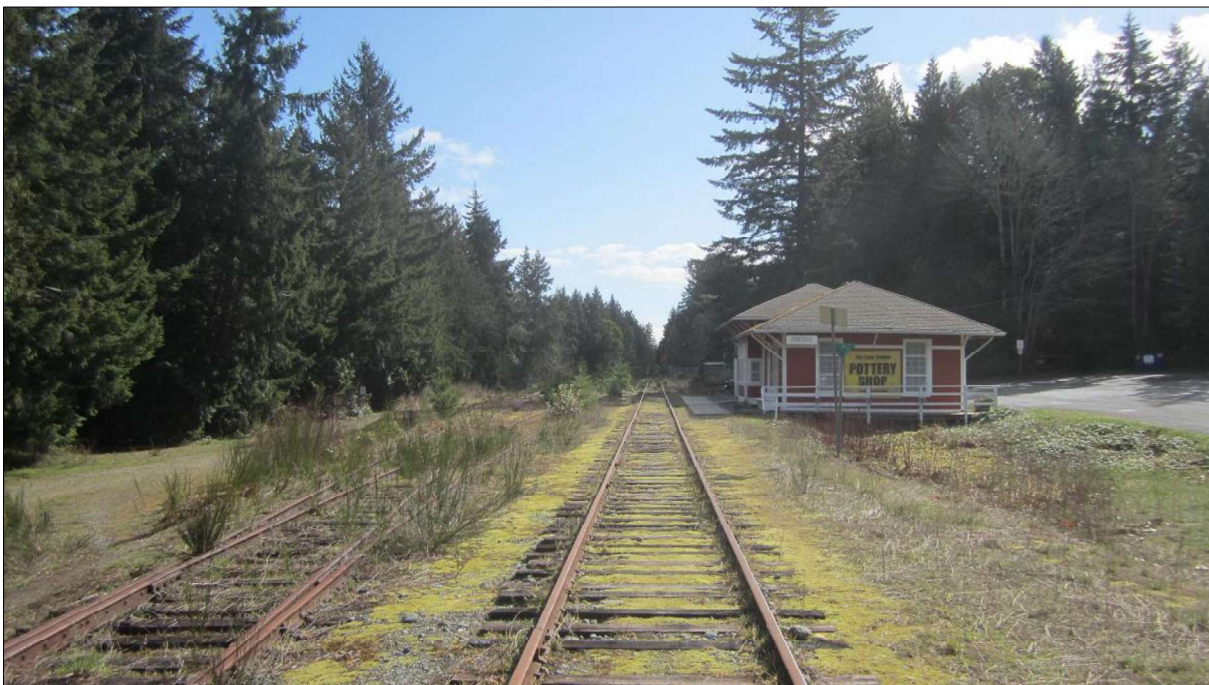
**Photo B-2:** Photo of the Railway Well Field taken on 8 April 2023, looking east.

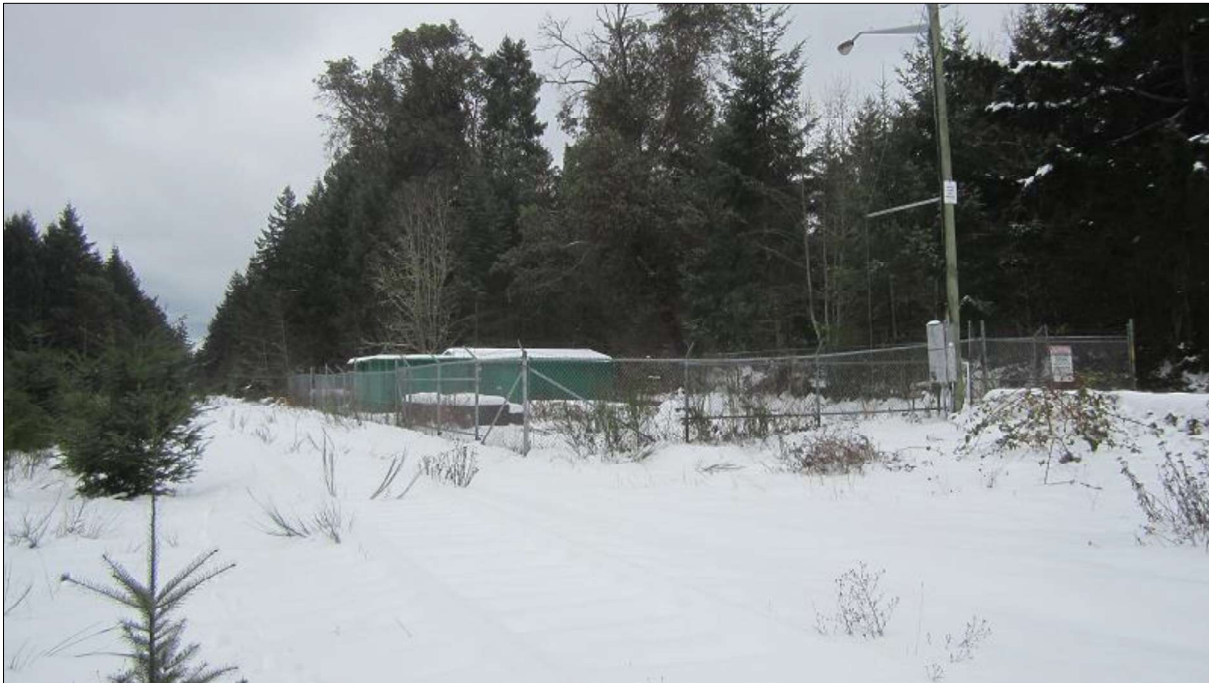
**Photo B-3:** View of the fenced compound that is located in the central portion of the Railway Well Field. The City advised that the compound is used by the E&N Railway for storage; no subsurface infrastructure or utilities were identified.

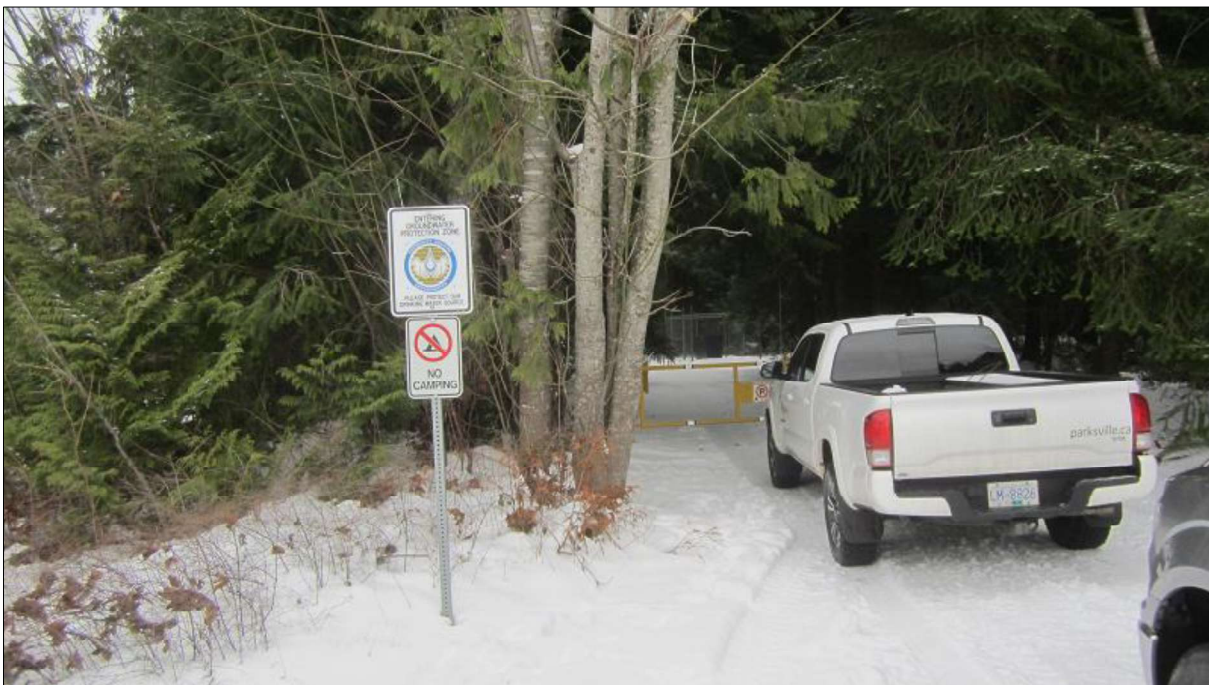
**Photo B-4:** View looking east towards the south Railway Wells, with Railway #7 visible in the background. Vehicular access is controlled with the locked gate.

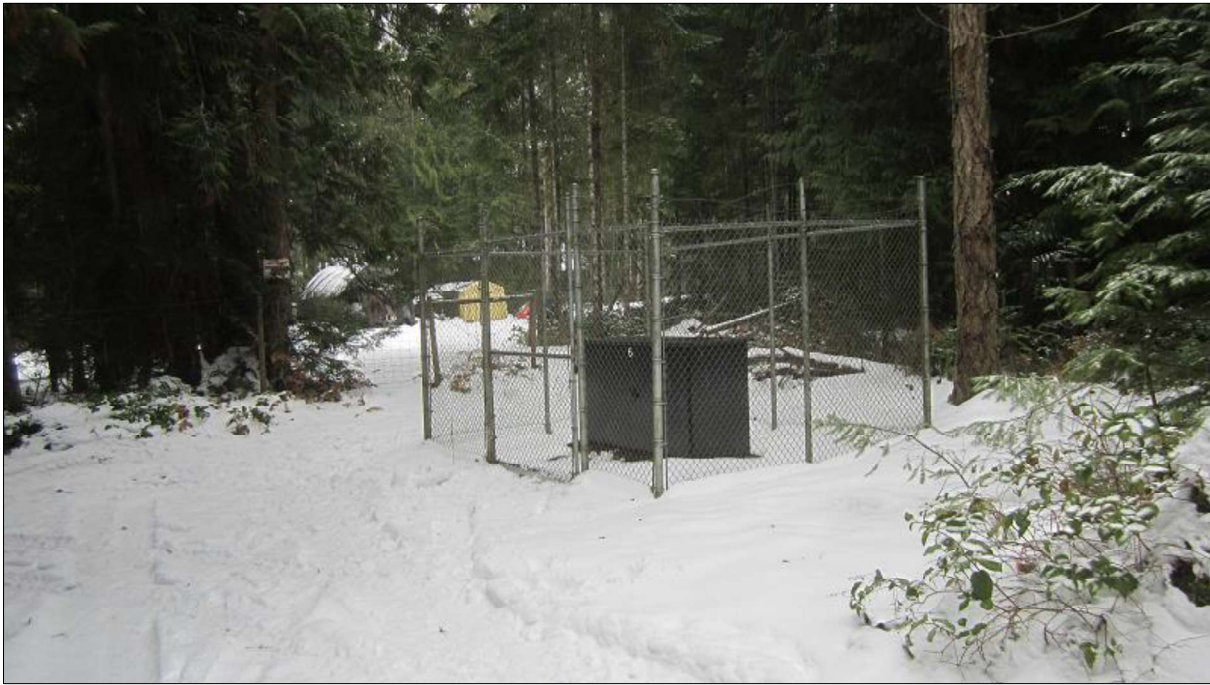
B4	Viruses	Y	Railway #6 is located less than 40 m (i.e., < 300 m) of private residential properties along Wildgreen Way (south of well) and the 200-day time-of-travel zone for Railway #6 extends into the area of the residential properties to the south of the well (Figure 3). The individual septic systems that service these private residences may represent a potential source of enteric viral contamination to the aquifer. The surficial deposits at Railway #6 were described by the driller as comprising sandy, gravelly silt, sand and gravel to a depth of 2.7 m bgs, underlain by compact to dense sandy silt to a depth of 4.4 m bgs. Although these deposits, and an unsaturated thickness of approximately 8.8 m, are inferred to provide some protection to groundwater quality, there is uncertainty regarding the thickness, composition (i.e., confining properties) and extent of the deposits throughout the area. Other wells that are identified on the WELLS database as being present in the vicinity of the Railway Well Field could provide a preferential pathway for migration of contaminants to the aquifer if they were not closed properly.

**Photo B-5:** View of Railway #6 on 27 February 2023. Each well at the Railway Well Field is located in a locked, fenced compound and protected with a locked, steel kiosk. Residential property is visible in the background.

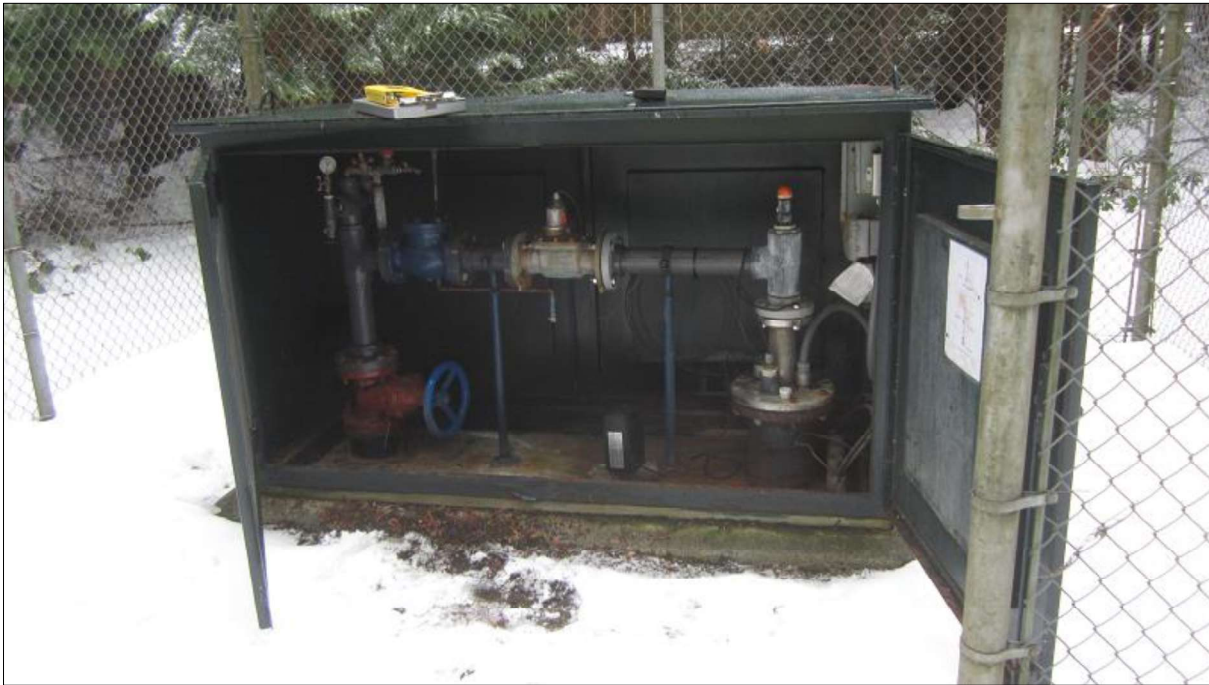
C3 Floodproofing of Wells	N	Railway #7 is located in a locked kiosk that prevents unauthorized access and provides protection from flood water. The concrete slab floor of the kiosk is approximately 0.08 m (3-inch) above surrounding grade and the floor inside the kiosk is graded to direct surface water away from the well and into a floor drain that is located 048 m (19-inch) from the well casing. The drain is reported on detailed drawings to discharge to daylight, at a location inferred to be behind the concrete slab. Railway #7 is therefore interpreted to meet the floodproofing requirements outlined in Part 7, Section 63 of the GWPR <sup>5</sup> and Section 16 of the DWPA <sup>4</sup> .
	C4 Wellhead Protection	Y	The engineering drawing for Railway #7 (APPENDIX E) indicates that casing stick-up from the top of the well cap to the floor of the kiosk is 0.17 m; however, during the site visit the stick-up from the estimated top of well casing (i.e., the top of flange) to the floor was measured to be 0.30 m (11.75-inch), thereby meeting the minimum required in the GWPR <sup>5</sup> . The well's location inside the secured kiosk is interpreted to provide protection to Railway #7 and water drains away from the wellhead towards a drain in the kiosk floor. Therefore, the wellhead conditions for Railway #7 are interpreted to satisfy the requirements outlined in Part 3, Division 5 and Part 7 of the GWPR <sup>5</sup> and prevent surface water and foreign matter from entering the well.

**Photo B-7:** View of Railway #7. The metal kiosk, which is typically locked, is secured to a concrete slab that is completed above surrounding ground surface and is graded away from the kiosk walls.

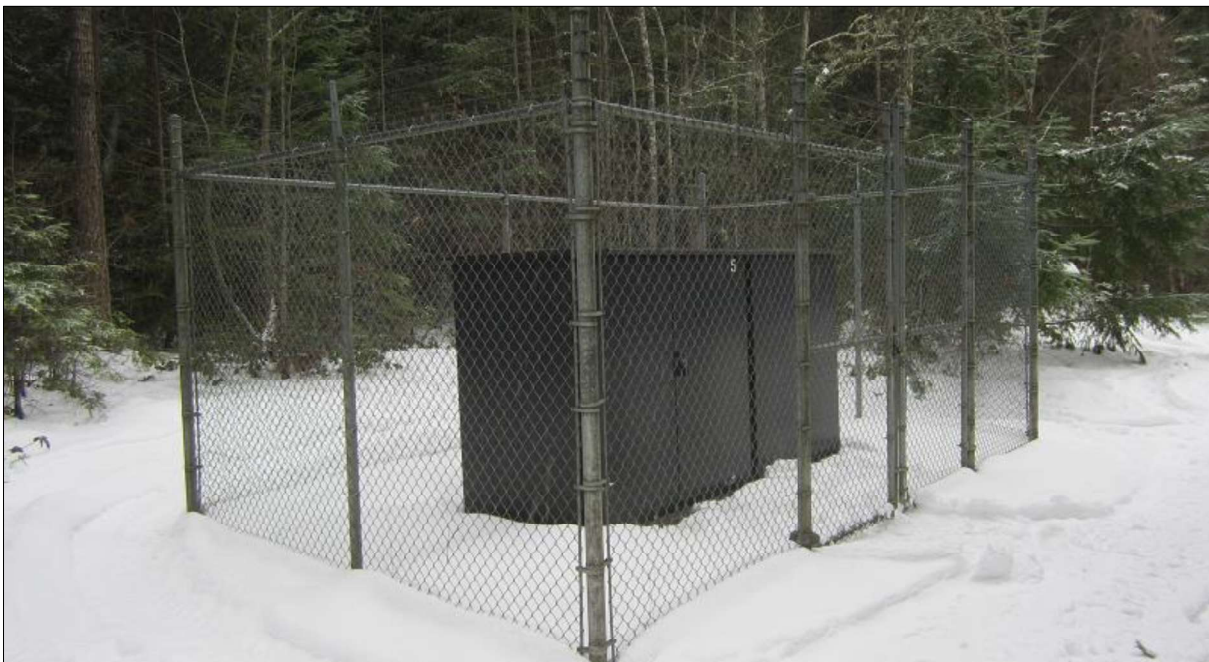
**Photo B-8:** View of the fenced compound and metal kiosk at Railway #5; the relatively larger kiosk includes an additional chamber that contains electrical controls for operation of the three Railway wells south of rail line (i.e., Railway #5, #6 and #7).

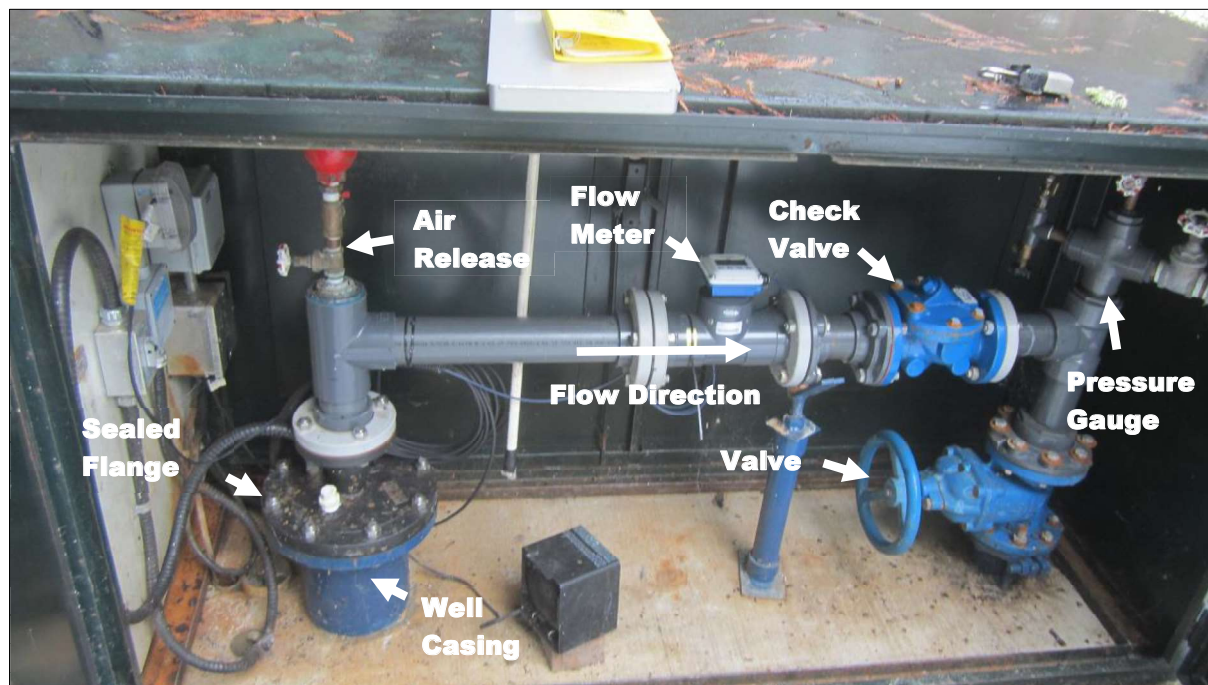
**Photo B-9:** View inside kiosk at Railway #4 with main components at the wellhead labelled. The concrete floor is graded to direct water away from the well casing to a drain (behind space heater that is visible to the right of the well casing).

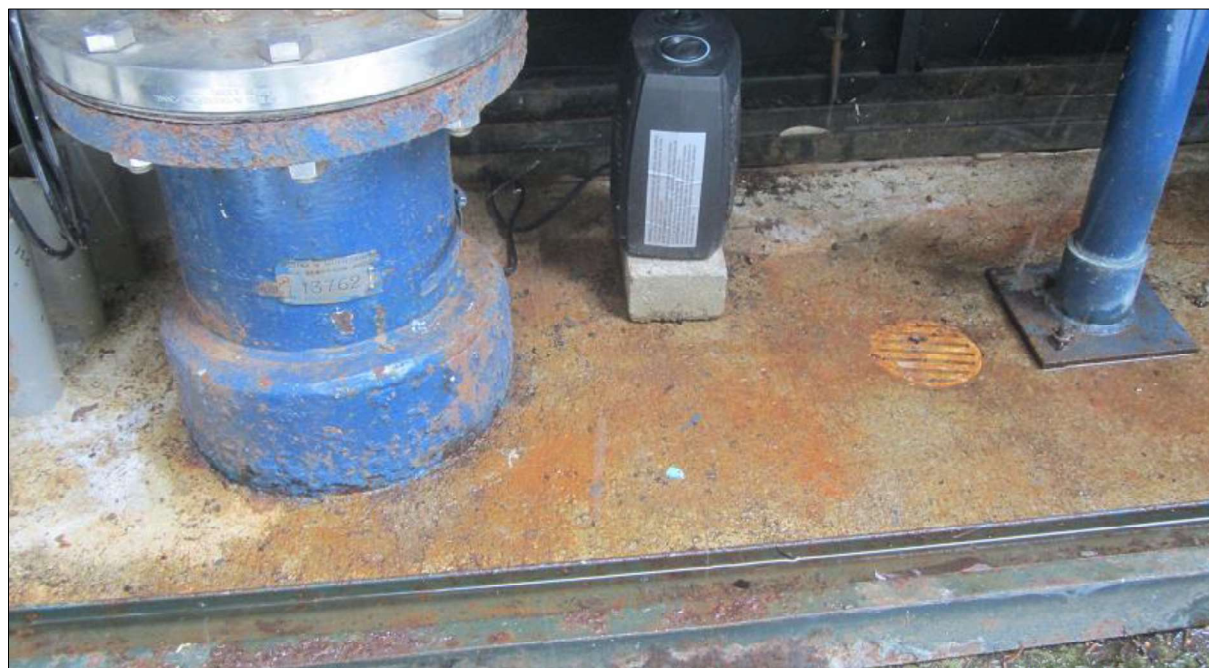
**Photo B-10:** View of the kiosk floor at Railway #6 that is graded towards a drain that is inferred to discharge to shallow ground; detailed design drawings documenting the drain were not available for review.

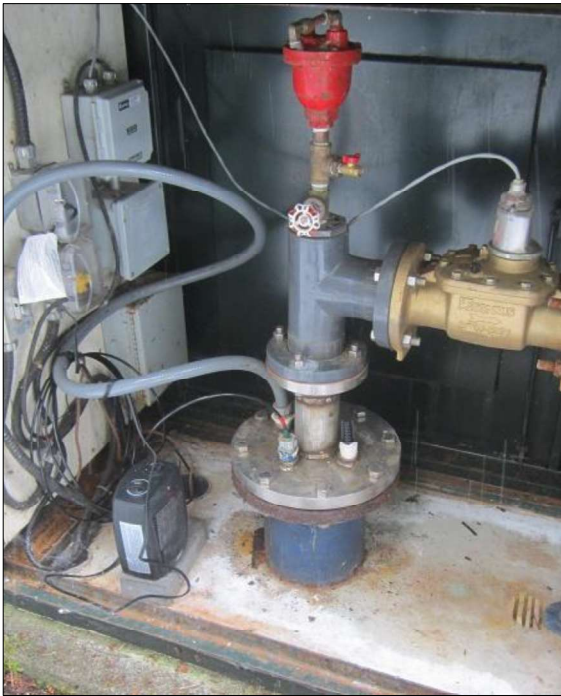
**Photo B-11:** View of stainless steel flange that has been installed at Railway #2.

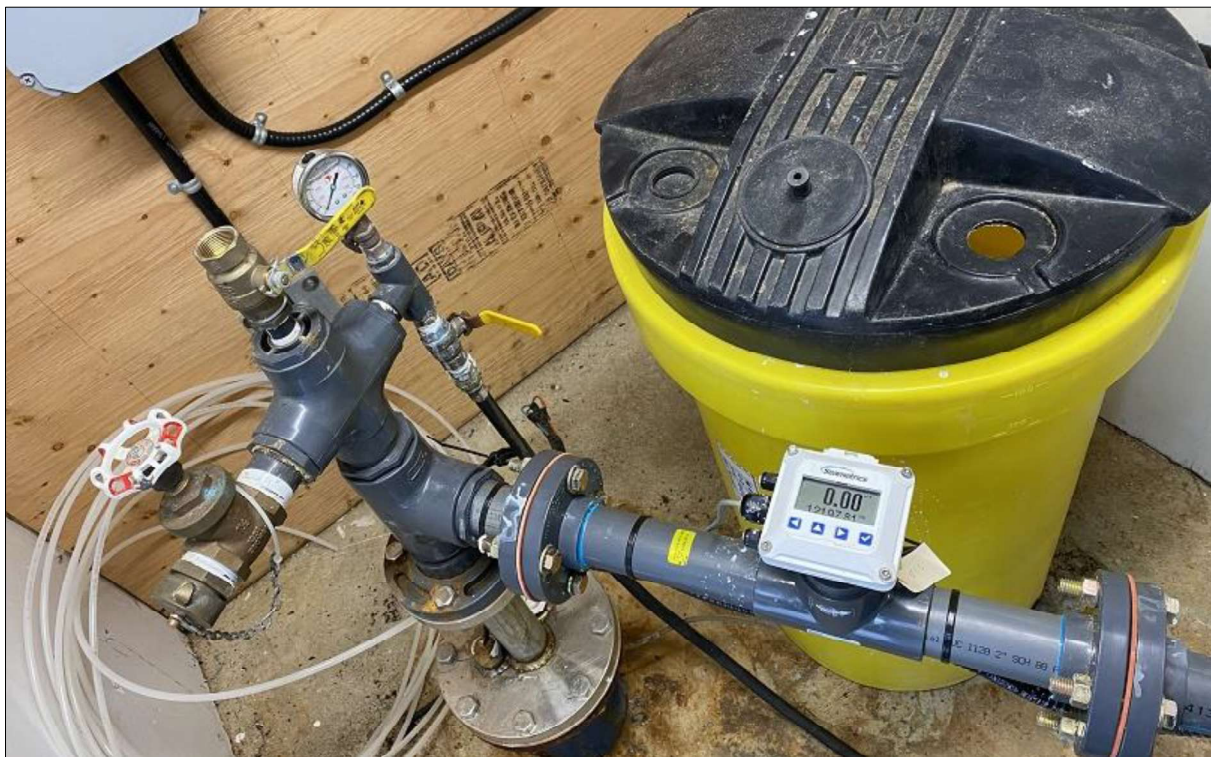
**Photo B-12:** View of wellhead at Springwood Well #1, located at the Springwood Water Complex, where groundwater from the well is chlorinated.

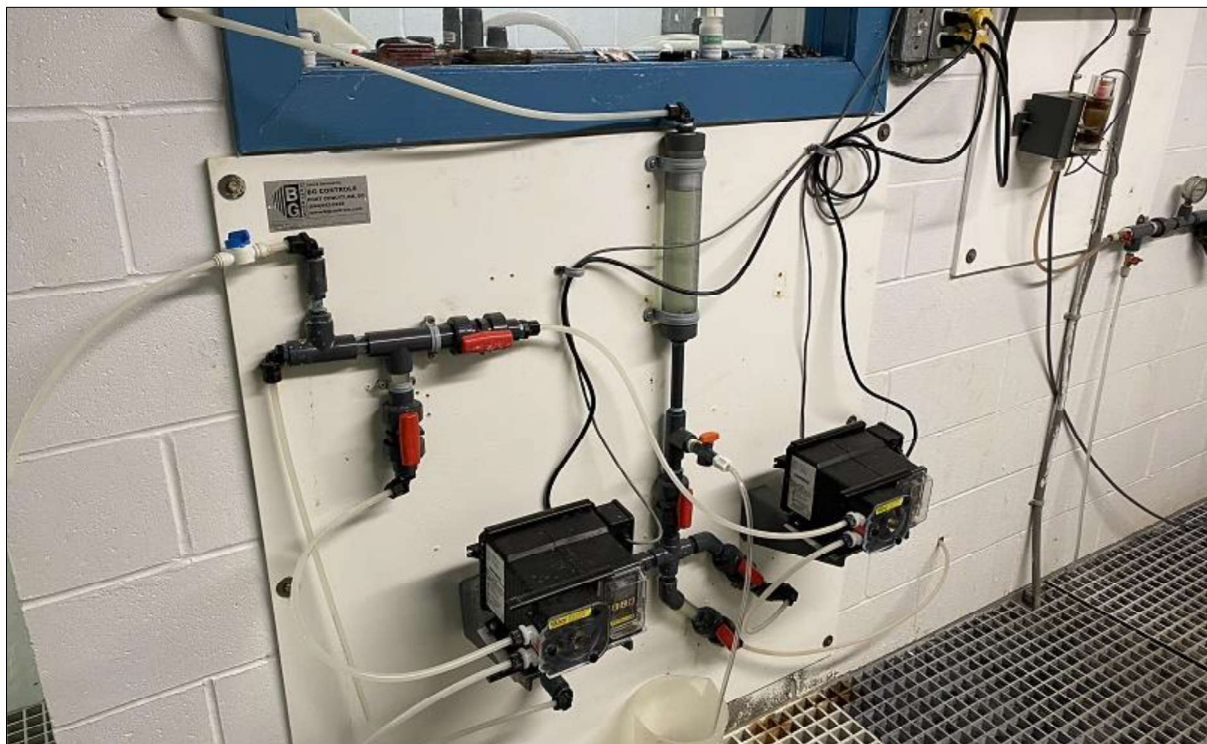
**Photo B-13:** View of chlorination equipment that is used to treat water at the pumphouse prior to being transferred to Reservoir No. 4.

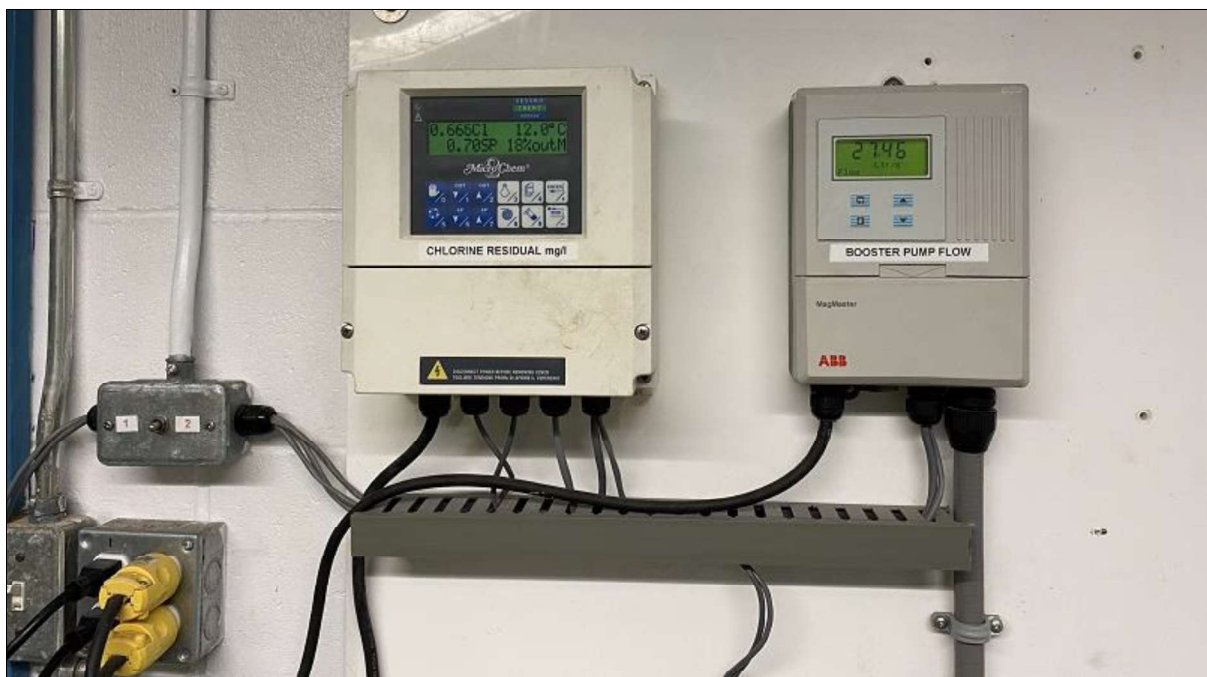
**Photo B-14:** View of chlorine analyser at pumphouse to monitor residual chlorine in water prior to being transferred to Reservoir No. 4.
