AWS/ERWS Operations January Updates

Update #1 February 2023

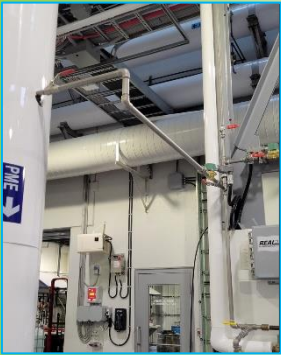
New Piping for UVT Analyzer

- New piping and sampling points were installed for the ultraviolet (UV) analyzer to eliminate air in the line that causes intermittent spikes and faulty alarms.

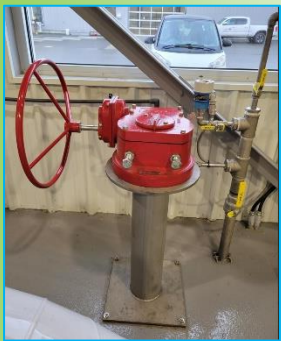
Valve Seating and Blower Anchoring Work by Contractor

- Contractor returned to site to exercise and seat the main isolation butterfly valve and secure the blower units to the concrete base, under warranty.
