2021

# ANNUAL WATER REPORT

City of Parksville  
Operations

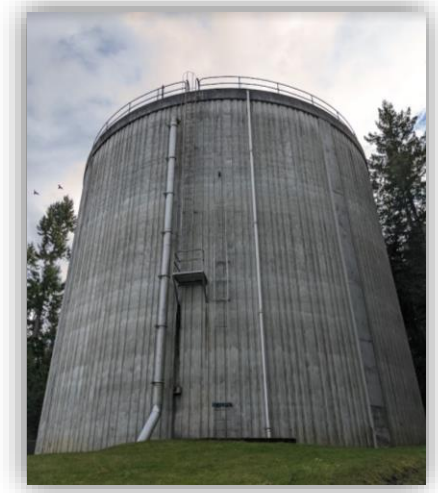
Reservoir #4

A summary of the reservoir storage capacity and status is provided in the following table.

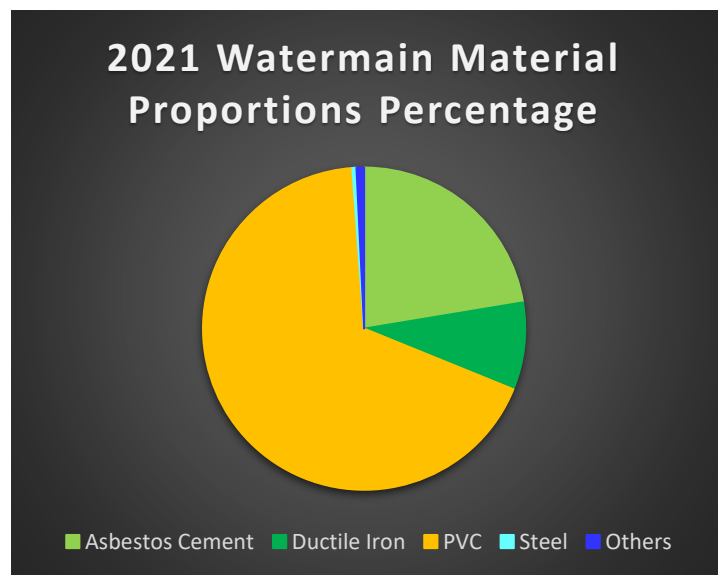
### 2021 Watermain Material Proportions

Material Type	Distance (km)	Percentage
Asbestos Cement	23.45	22.39 %
Ductile Iron	9.16	8.75 %
PVC	70.9	67.69 %
Steel	0.43	0.41 %
Others	0.8	0.76 %
<b>Total</b>	104.74 km

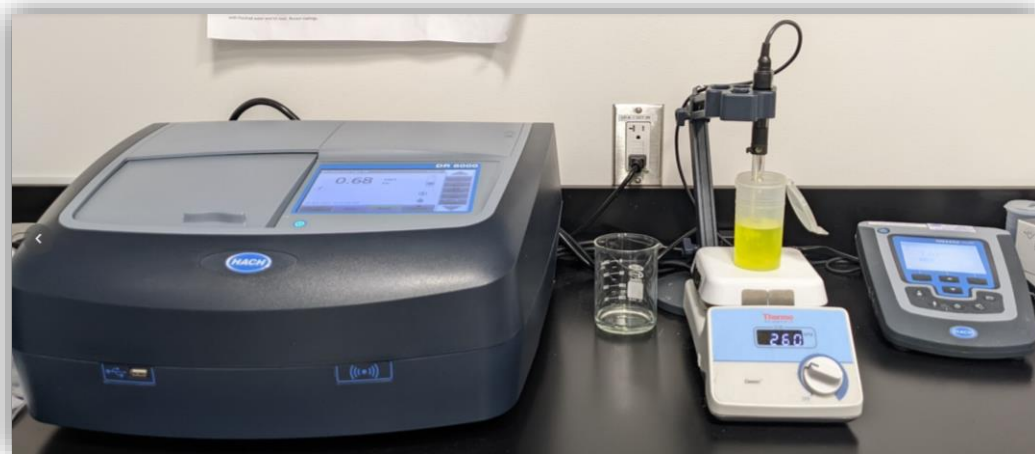
Testing and sampling are conducted daily in-house at the water treatment plant lab to meet regulatory requirements. Raw water is tested for temperature, turbidity, colour, pH, and UVT. Treated water is tested for free chlorine, turbidity, colour, pH, and UVT.

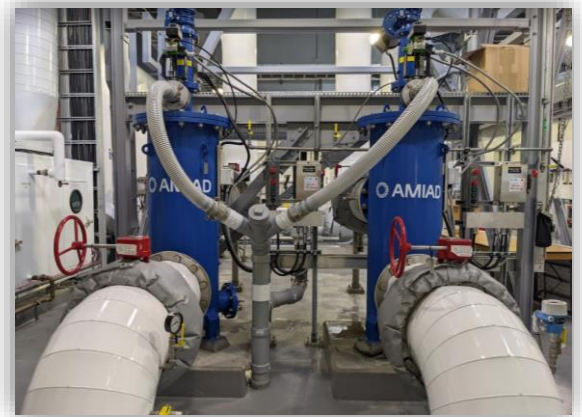
### Strainers at the Water Treatment Plant

- Monitor and ensure coagulant dosing is carrying out accordingly. Flush and clean the line when not in use
- Monitor strainer's differential pressure and check for leaks. Conduct service and maintenance as needed to improve system performance

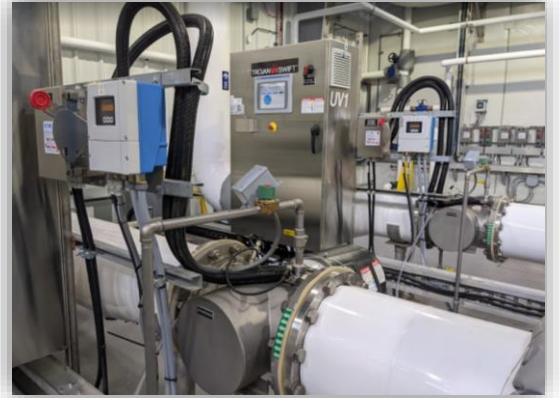
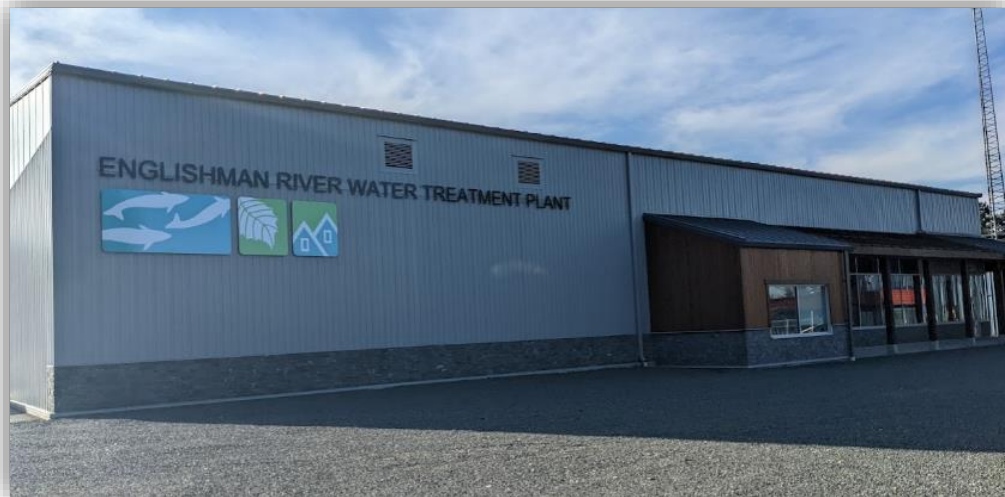
### UV Units at the Water Treatment Plant

- Monitor the ultraviolet transmittance trend ensuring it meets log removal. Service the instrument as necessary to improve performance
- Service the ultraviolet units twice a year
- Service chlorine analyzer

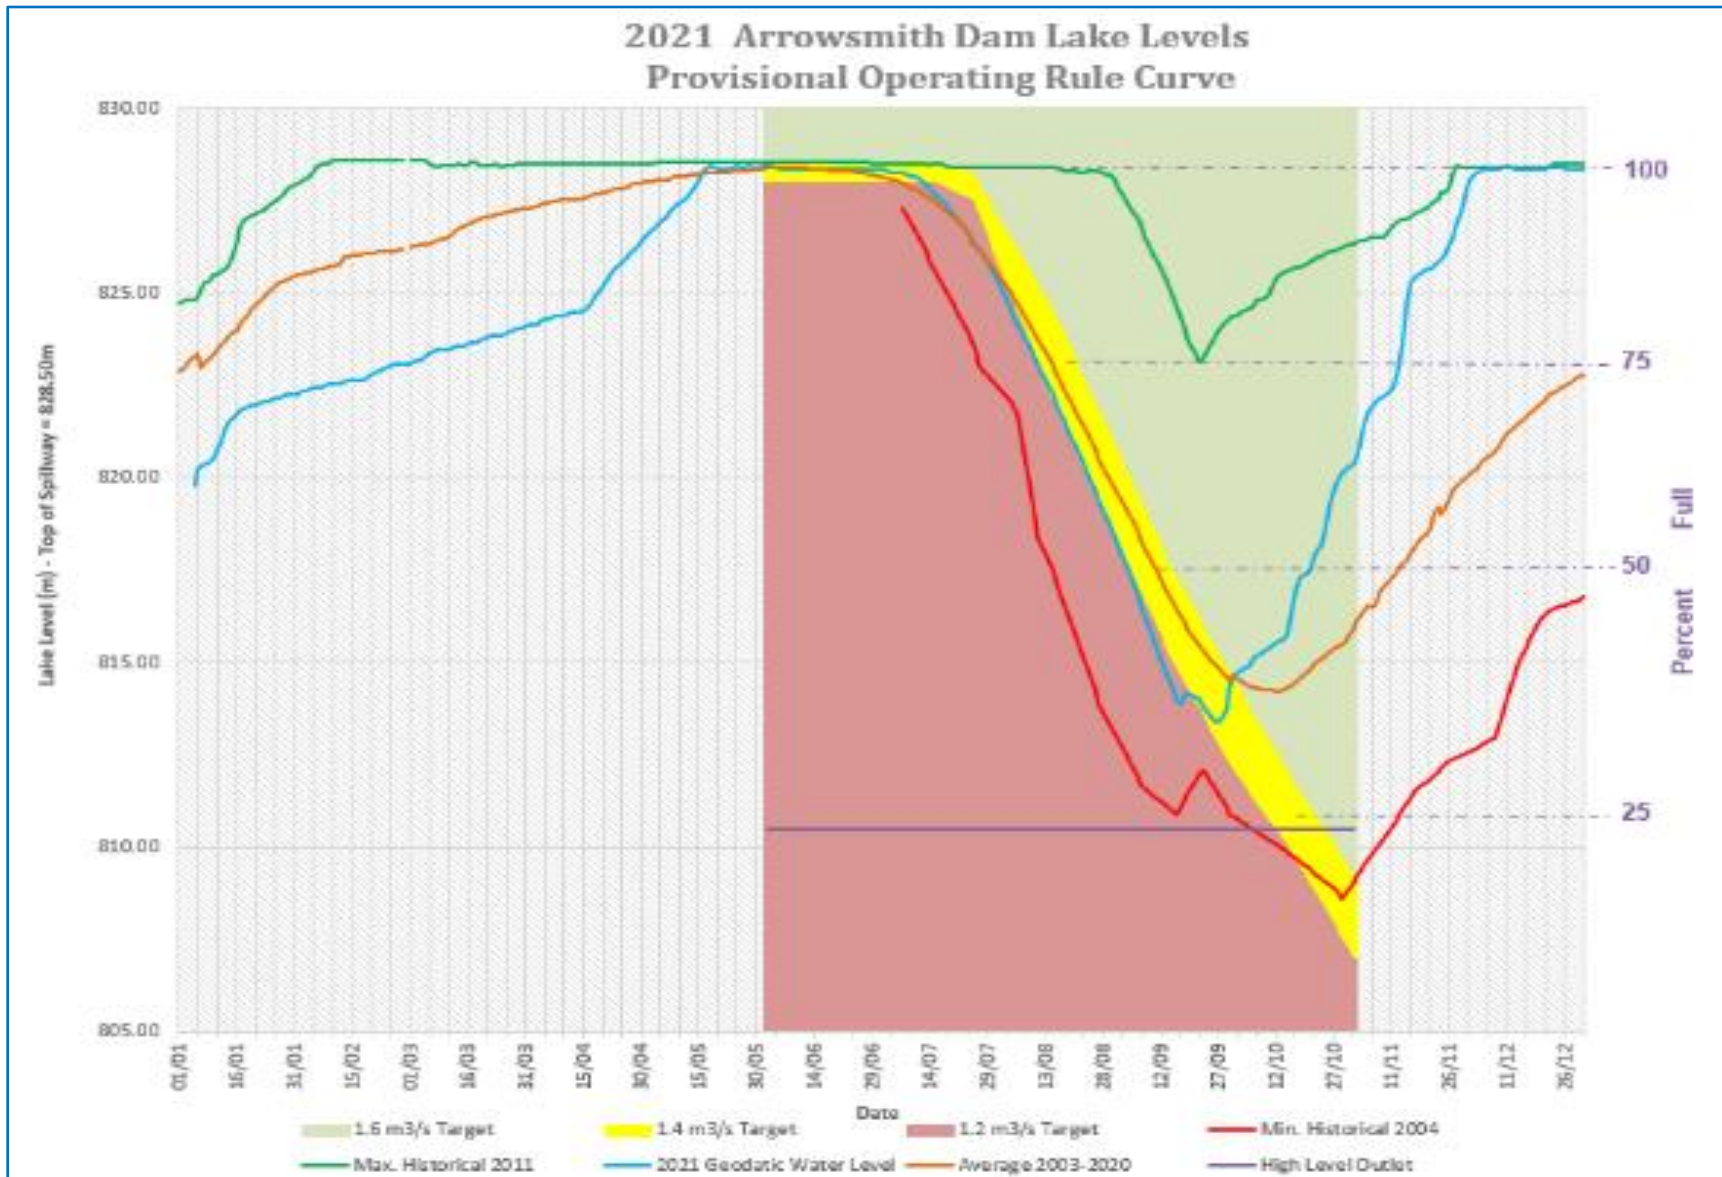
## Appendix B - Dam Lake Levels

**Appendix B** shows the Arrowsmith Dam Operating Curve. The Ministry of Environment, Fisheries and the Arrowsmith Water Service (AWS) developed an operating rule curve to conserve reservoir storage water for critical fisheries rearing periods. A minimum flow is released into the river based on this curve between June and October.

In 2021, temperatures and weather patterns surpassed normal operating conditions. The reservoir level declined earlier than expected due to the extreme heat waves in June. Water was released into the river starting on June 24, 2021, and extended to September 29, 2021. Water conservation was implemented to reserve, prolong, and balance the reservoir volume for July to September while maintaining the river level at 1.3 m<sup>3</sup>/s to 1.6 m<sup>3</sup>/s per the Provincial Operating Permit. October and November heavy rainfalls replenished the reservoir a month earlier than anticipated. Reservoir lower-level outlets and pipes were fully opened during these times to minimize negative impact from the back-to-back storms.
