City of
Parksville

ANNUAL WATER REPORT

Executive Summary

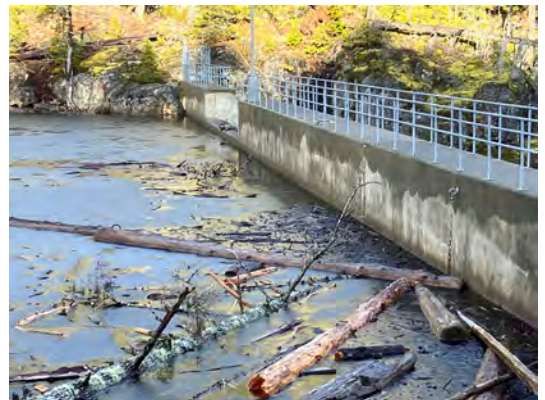
Debris accumulated over the winter.

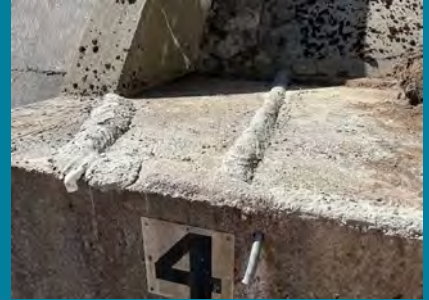
New Foundation Drain,
August.

Woody debris were collected and piled for fall burning. Weir drains were cleaned, and a new foundation drain was added to Block A to separate two zones.

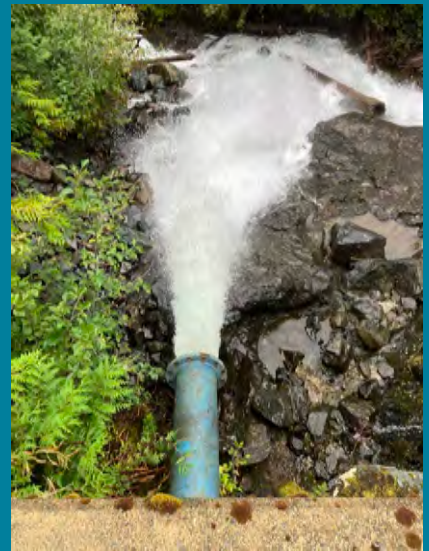
Dam Release from Siphon,
September.

The remainder of the woody debris was collected and piled for fall burning. Valve positions were verified to ensure the correct volume is displayed on SCADA. The orifice plate was removed from the siphon line to increase flow, and a crack on the upstream side of block A was assessed and filled.

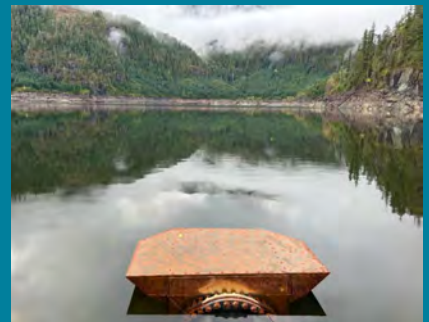
High Level Intake, October.

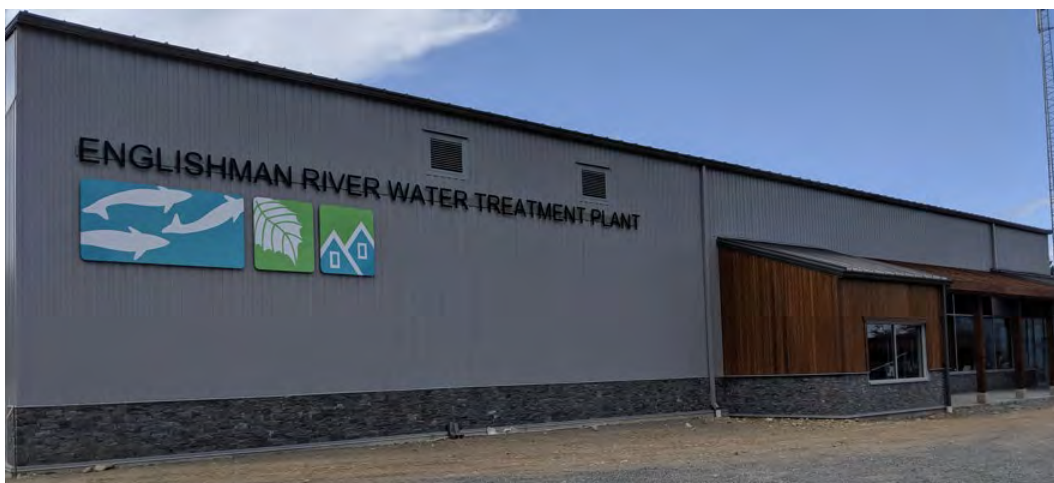
The water treatment plant currently has capacity to treat up to 16 megaliters per day (ML/d), through fine strainers, primary and secondary ultrafiltration (UF) membranes, ultraviolet (UV) disinfection and chlorination.

Englishman River Water Treatment Plant.

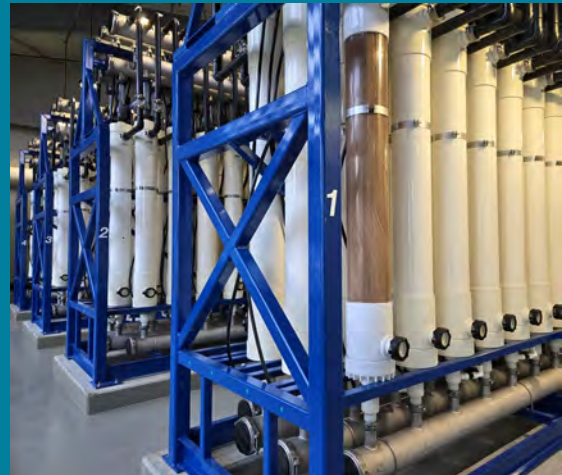
Ultrafiltration Membrane Trains.

The water from the strainers flow to the UF membrane trains. The UF membranes act as a physical barrier to suspended matter which include contaminants such as bacteria, viruses and parasites. Once enough contaminants accumulate on the feed side of the membrane, a cleaning process occurs to bring the membrane back to a good working pressure. This cleaning process is done with periodic backwashes and chemically enhanced clean cycles.

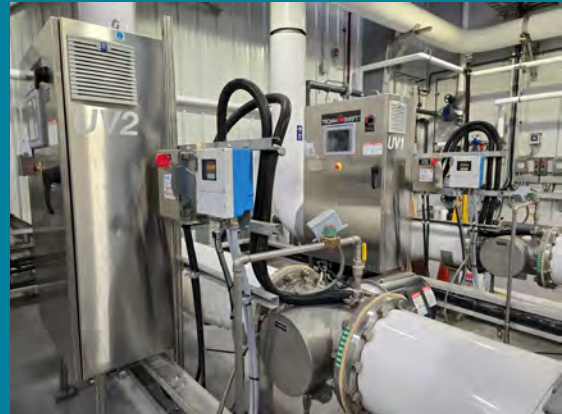
Ultraviolet Reactors.

Both ultraviolet (UV) and chlorination are used in the disinfection process. The water from the membrane trains flow to one of the UV reactors, which inactivates *Cryptosporidium*, *Giardia*, and viruses by altering the DNA or RNA of pathogens destroying their ability to reproduce. The UV disinfected water then flows to the contact tank, where it is dosed with sodium hypochlorite as a secondary disinfection, and CO₂ for pH adjustment.

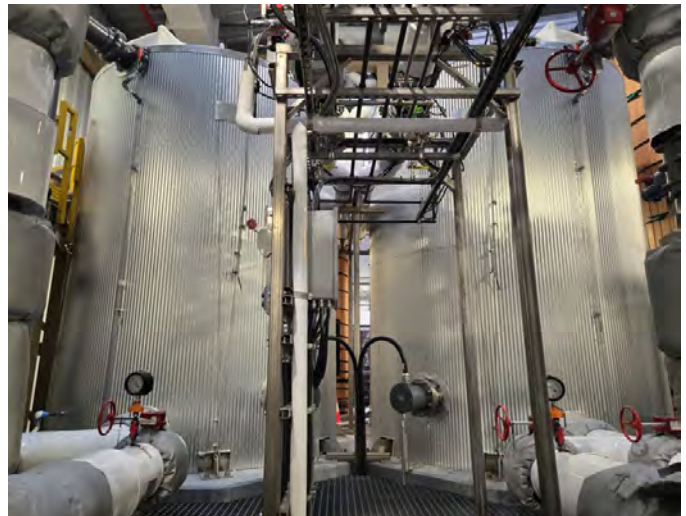
WTP Chemical Room CIP tanks.

Staff focused on the UF cleaning system and optimization for the month of April, this included updates to interface with improved operation and increased trending and tracking of cleans, and improvement of controls to schedule cleans more effectively based off the information in the trends and tracking. Lab work now include in-house calculations of the Langelier Saturation Index (LSI) to gather more detailed information to guide the corrosion control program.

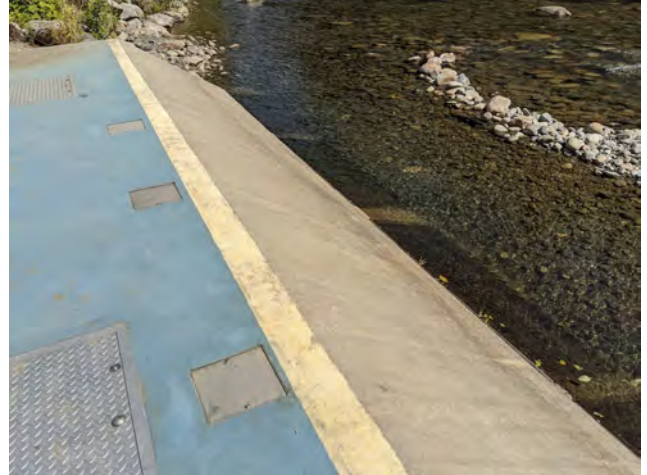
Rive intake: Location of daily checks for fish impingement.

Operators identified valves in need of adjustment or repair. Daily checks for fish impingement were completed for the 5-year fish monitoring program, along with weekly check of data logger casing, data download and review for turbidity and temperature. Weekly data reviews allowed for prompt calibration of the turbidity probe when needed.

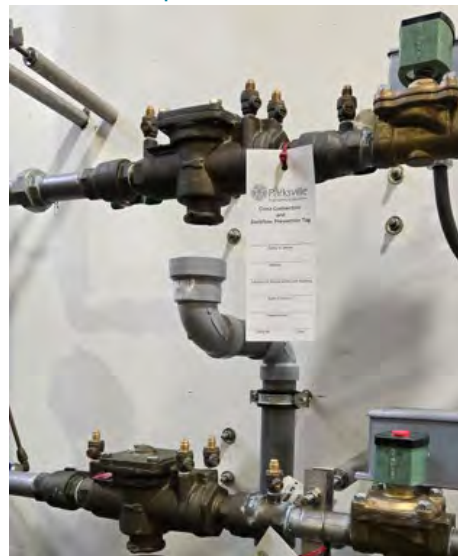
WTP Chemical Room backflow preventers.

Backup generator was load tested by a contractor. Backflow assemblies were tested at the intake building and at the water treatment plant by City staff.

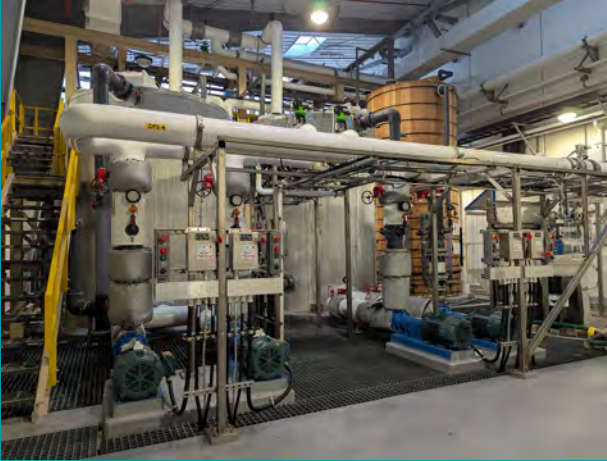
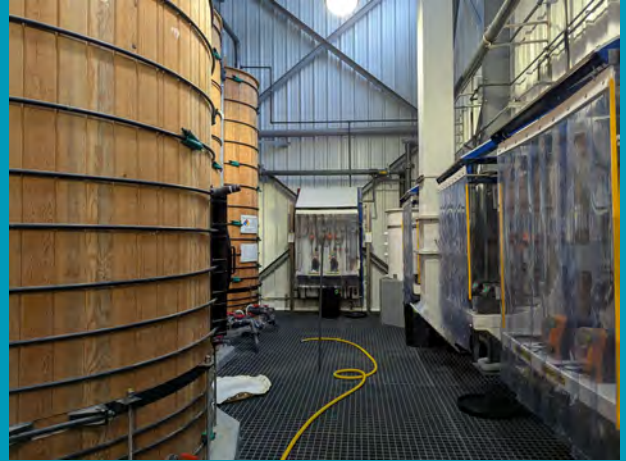
Water Treatment Plant Chemical Room.

All North Engineering collaborated with operations and conducted a detailed safety audit of the chemical room. This project resulted in recommendations regarding chemical storage, tank replacement, as well as many other safety issues related to the chemical room.

This audit took place due to two tank failures that have occurred since the plant was commissioned in 2020. Additionally, operators identified potential safety concerns that were also investigated.

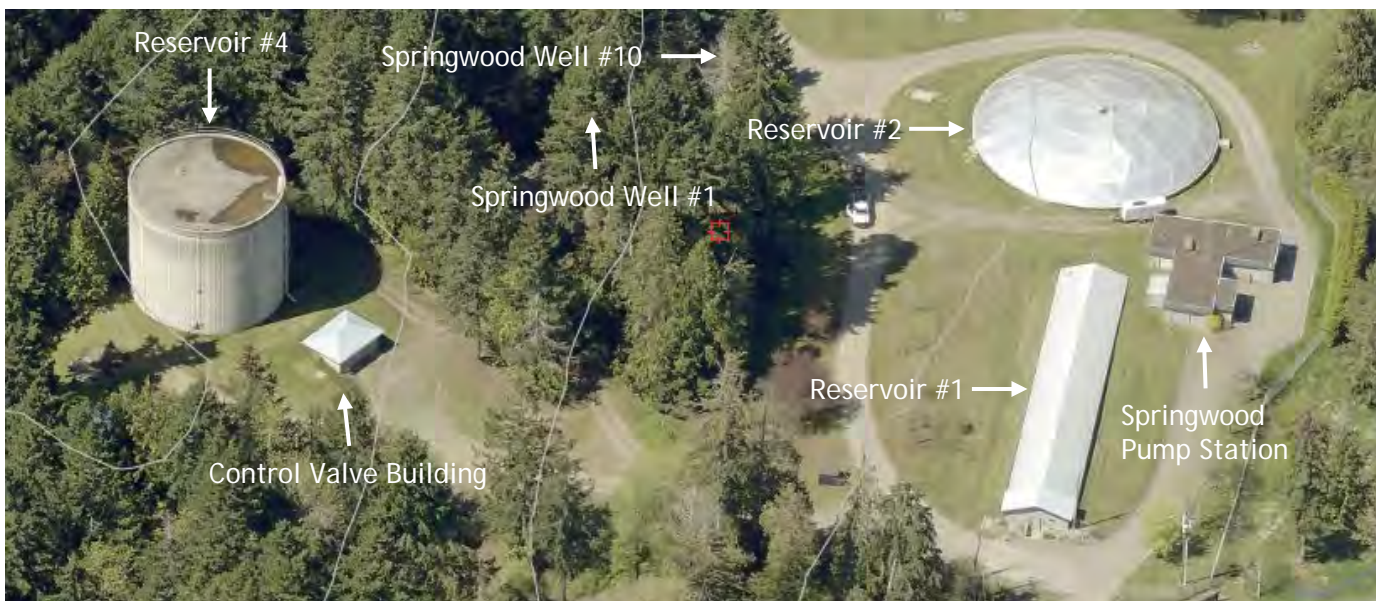
Some chlorination happens at Springwood Well #1, to ensure disinfection takes place at reservoirs #1 and #2. At reservoir #4, well water gets mixed with treated water from the WTP, and it is then distributed through the distribution system.

Springwood Water Complex.

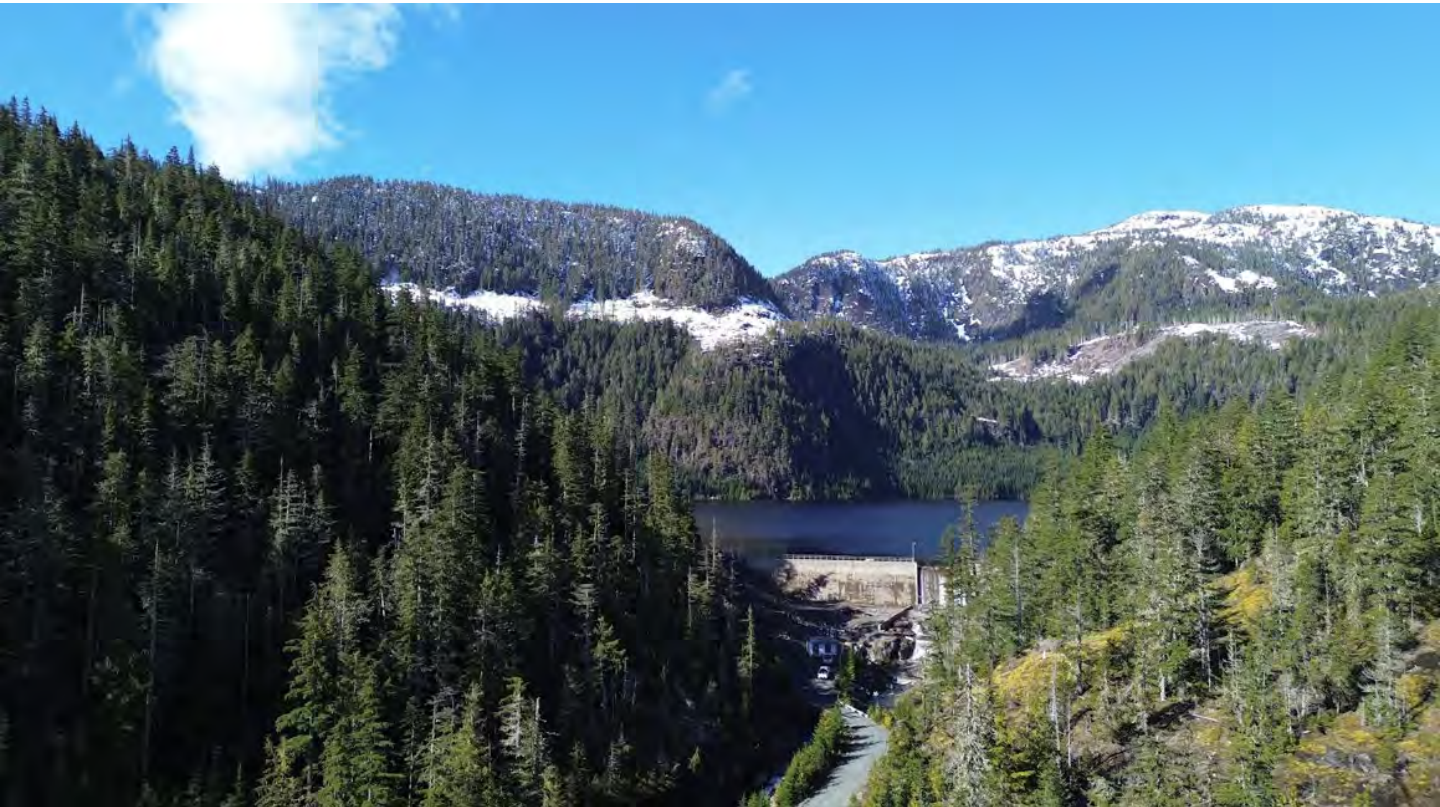
[Arrowsmith Dam.](#)

The City of Parksville, the Regional District of Nanaimo, and the Town of Qualicum Beach are partners in the Arrowsmith Water Service (AWS). The concrete gravity dam, commissioned in 2000, is located at Arrowsmith Lake roughly 20 km SW of Parksville. The dam has a capacity of 9,000,000 m³ and is operated and maintained by the City of Parksville utilities staff. Water is released to the Englishman River through a low-level (600mmø) and high-level outlet (900mmø). Flow and lake levels are monitored regularly by staff through the SCADA system.

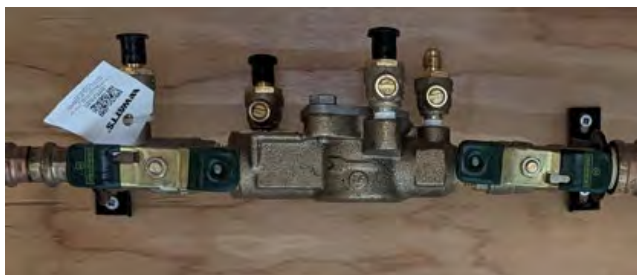
Double check valve assembly.
