2013 ANNUAL WATER REPORT

1.0	INTRODUCTION
2.0	PARKSVILLE WATER SYSTEM
3.0	DISTRIBUTION SYSTEM
4.0	SCADA
5.0	WATER SAMPLING AND TESTING10
6.0	WATER QUALITY COMPLAINTS
7.0	ENGLISHMAN RIVER WATER SERVICE JOINT VENTURE AGREEMENT
8.0	ROUTINE MAINTENANCE PROGRAM
9.0	2013 IMPROVEMENTS
10.0	2013 CAPITAL PROJECTS
11.0	2014 CAPITAL PROJECTS & IMPROVEMENTS
12.0	CROSS CONNECTION
13.0	EMERGENCY RESPONSE PLAN15
APPE	NDIX A - WELL LOCATION MAP
APPE	NDIX B - ARROWSMITH DAM LAKE LEVELS 2013
APPE	NDIX C - MAP OF PRESSURE ZONES
APPE	NDIX D - 2013 BACTERIOLOGICAL TEST RESULTS
APPE	NDIX E - FULL SPECTRUM ANALYSIS
APPE	NDIX F - WATER SYSTEM OPERATING CONDITIONS

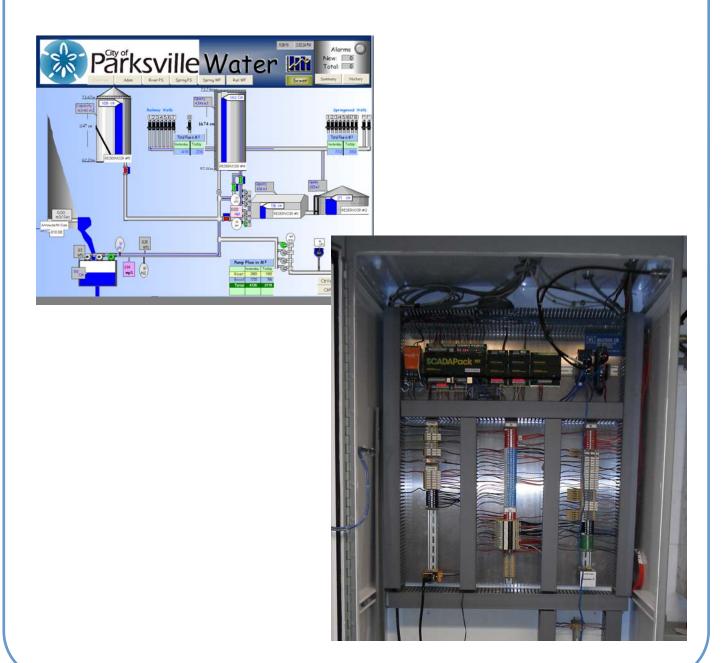
The water system and sewer pump stations are controlled by a computerized control system called SCADA. This system allows the Operators to monitor reservoir levels, the on/off status and flows of pumps, and monitor chlorine residuals. The operator can change set points and monitor the system remotely. Alarms are automatically called out to City staff that monitor the system 24 hours a day, 7 days a week.
