## **APPENDIX D. DESIGN CRITERIA**

Provided separately for Parkville Community Park Stormwater Management Master Plan.

**Project Name** | Parksville Community Park Stormwater Management Master Plan      **Date** | April 2021  
**To / Contact info** | Michael Lonsdale (MLonsdale@parksville.ca)  
**Cc / Contact info** | Ayla Defoor (ADefoor@parksville.ca)  
**From / Contact info** | Kerri Robinson, P.Eng. (krobinson@eorinc.com)  
**Regarding** | Characterization & Design Criteria

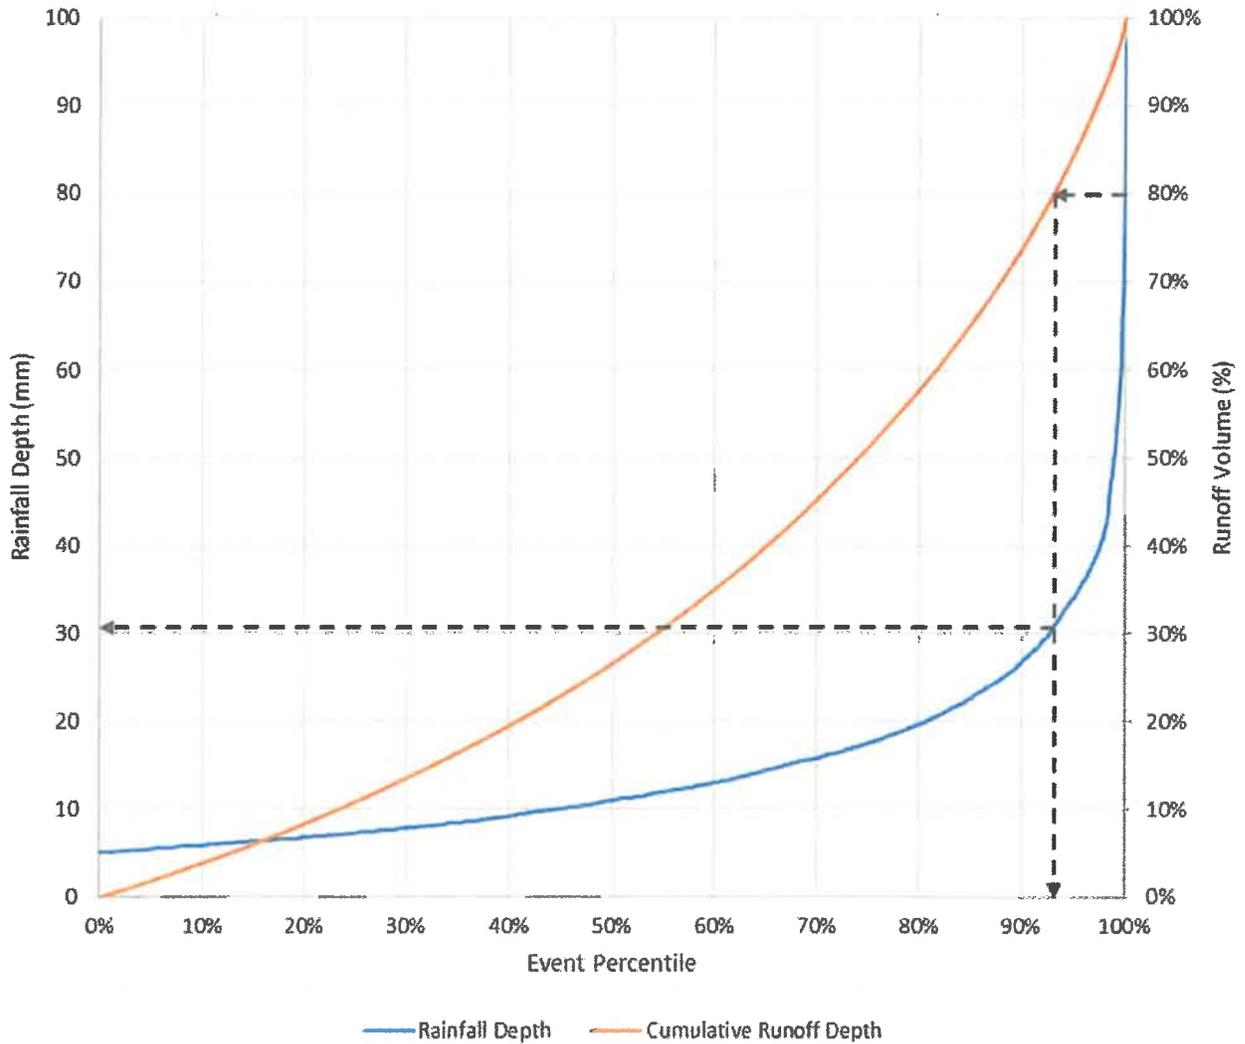
Figure 2. Rainfall Frequency Analysis, Nanaimo Airport (1947-2020)

improved upon by a more detailed analysis that separates individual events without truncating them every 24 hours.

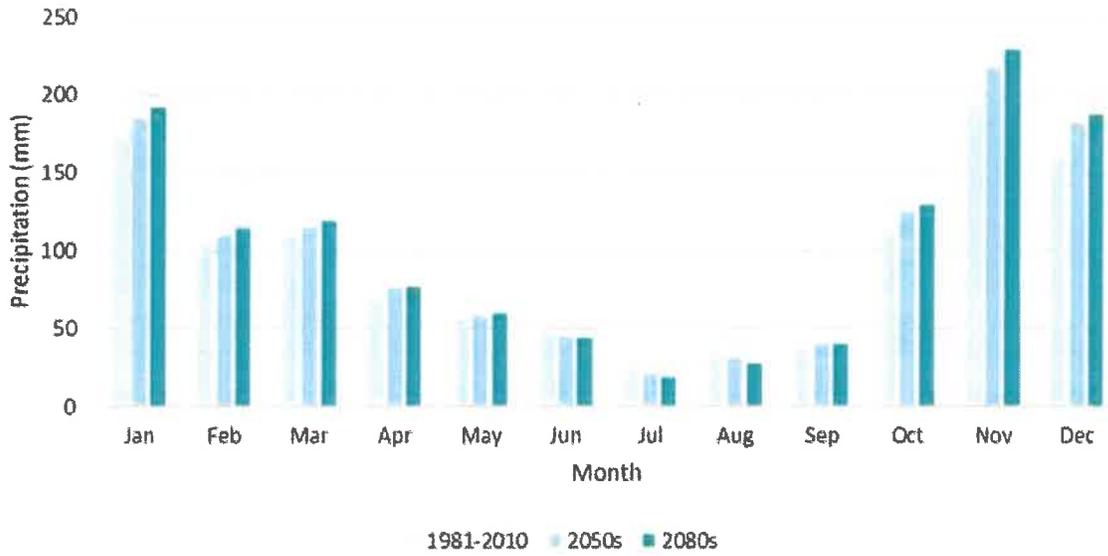
Figure 4. Monthly Precipitation in Coombs, BC (Adapted from Dillon Consulting, 2020)

As part of the SWMMMP for the Park, Dillon Consulting developed projected monthly water balances based on the Environment Canada weather station in Coombs, BC for mid- and late-century timeframes, representing the 2050s and 2080s, under the “worst case” RCP 8.5 (Intergovernmental Panel on Climate Change, 2013). Overall, the projections indicate that the wettest winter months will become wetter (up to 18% by 2080s in the winter) and driest months will become even drier (up to a 22% decrease in the summer), as shown in Figure 4. Potential evaporation is estimated based on average temperature and is anticipated to increase in every month, as shown in Figure 5. The difference between precipitation and potential evaporation is an indicator of the local water balance conditions. As shown in Figure 6, the water surpluses in the cooler months (October to April) and deficits in warmer months (May to September) are expected to increase. Cooler months may have surpluses up to approximately 175 mm, while warmer months can have a deficit of approximately 75 mm historically. Historic precipitation records indicate an increasing trend in summer dry periods from 20 days in 1984 to 24 days by 2009, which may continue into future summer periods since smaller rainfall events are expected to occur less frequently. Additional details are provided in Appendix B and in the separate MS Excel Spreadsheets.

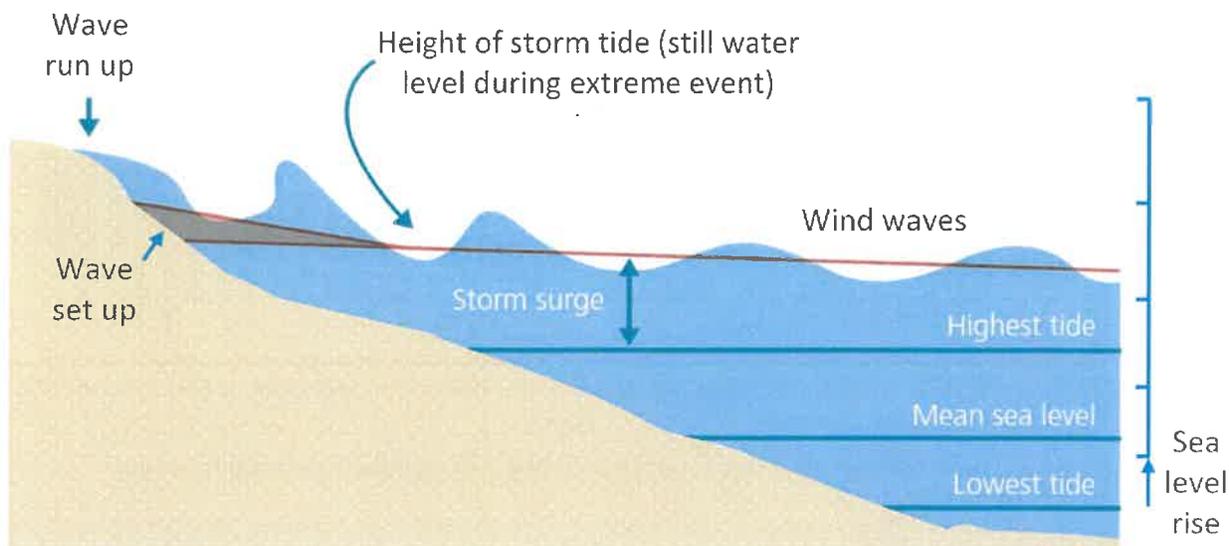
Figure 7. Impacts of Tides, Storm Surge and Wave Processes on Sea Level (Department of Sustainability and Environment, 2012)

Extreme sea levels are often a result of high tides coinciding with storm surges. Storm surges are the temporary increases in sea levels caused by storms and their associated severe winds and decrease in atmospheric pressure. The 'storm tide level' is the combination of the astronomical tide level and storm surge, as shown in Figure 7, and is the effective 'still water level' during an extreme event. Wave effects are in addition to the storm tide level. Each of these contributing factors will be elevated in the future due to sea level rise (SLR). Coastal inundation from storm surges can be exacerbated when heavy rain associated with the storms also cause riverine flooding in estuaries and inland flooding in low-lying areas (Department of Sustainability and Environment, 2012).

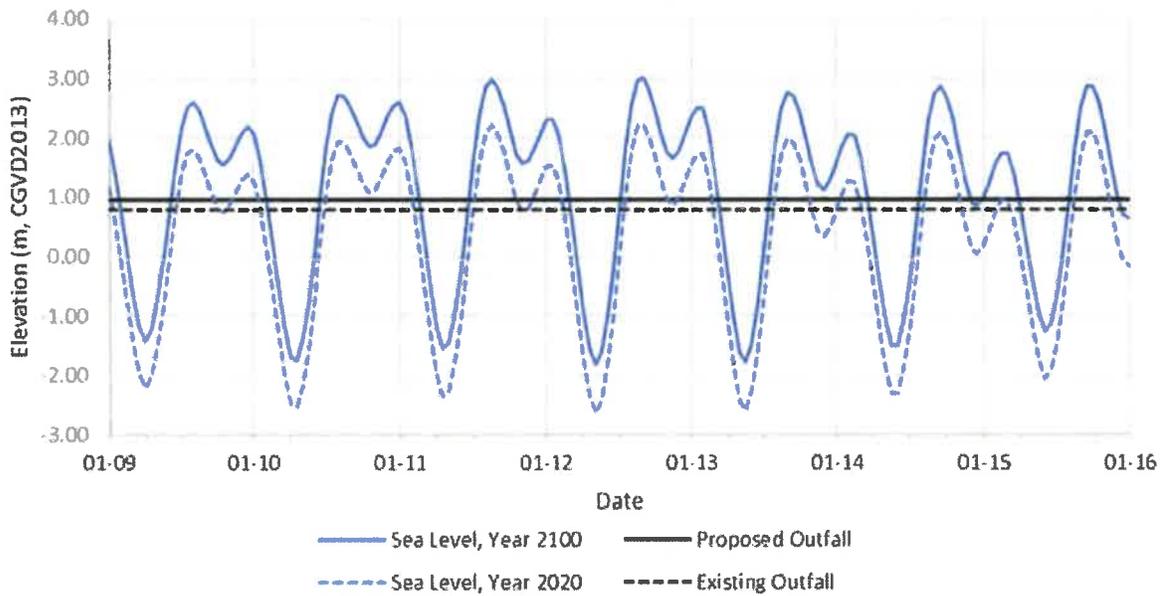
Figure 9. Existing and Future Sea Level Relative to Storm Sewer Outfall (Adapted from Northwest Hydraulics Consultants, 2020b)

As part of the SWMMP, Northwest Hydraulics Consultants (NHC) conducted a study to assess sea level under existing and future climate conditions, considering the effects of global SLR on tides and storm surge, as well as wave effects. Future, late-century projections were estimated based on applicable guidelines from the BC Ministry of Environment (BC MOE, 2018) and include considerable uncertainty. The study summarized tide levels at the Park as outlined in Table 10. NHC also developed a time series of sea water levels from September 2019 to April 2020 based on measured levels at Point Atkinson transformed to the project site. The time series includes the measured astronomical tide as well as residuals from storm surge and wind/wave set-up (Northwest Hydraulics Consultants, 2020b). An excerpt of the time series is shown in Figure 8. Figure 9 illustrates the time series shifted to account for regional SLR by year 2100 (+0.79 m) relative to the Park’s existing storm sewer outfall and a new outfall which was recently installed, but not connected, as part of shoreline improvements. Sea levels will back up into the Park’s stormwater management system through the outfall and will submerge parts of the contributing system under extreme sea levels. This effect will occur with increasing frequency and duration under future climate conditions due to SLR, even when the system is connected to the new outfall.

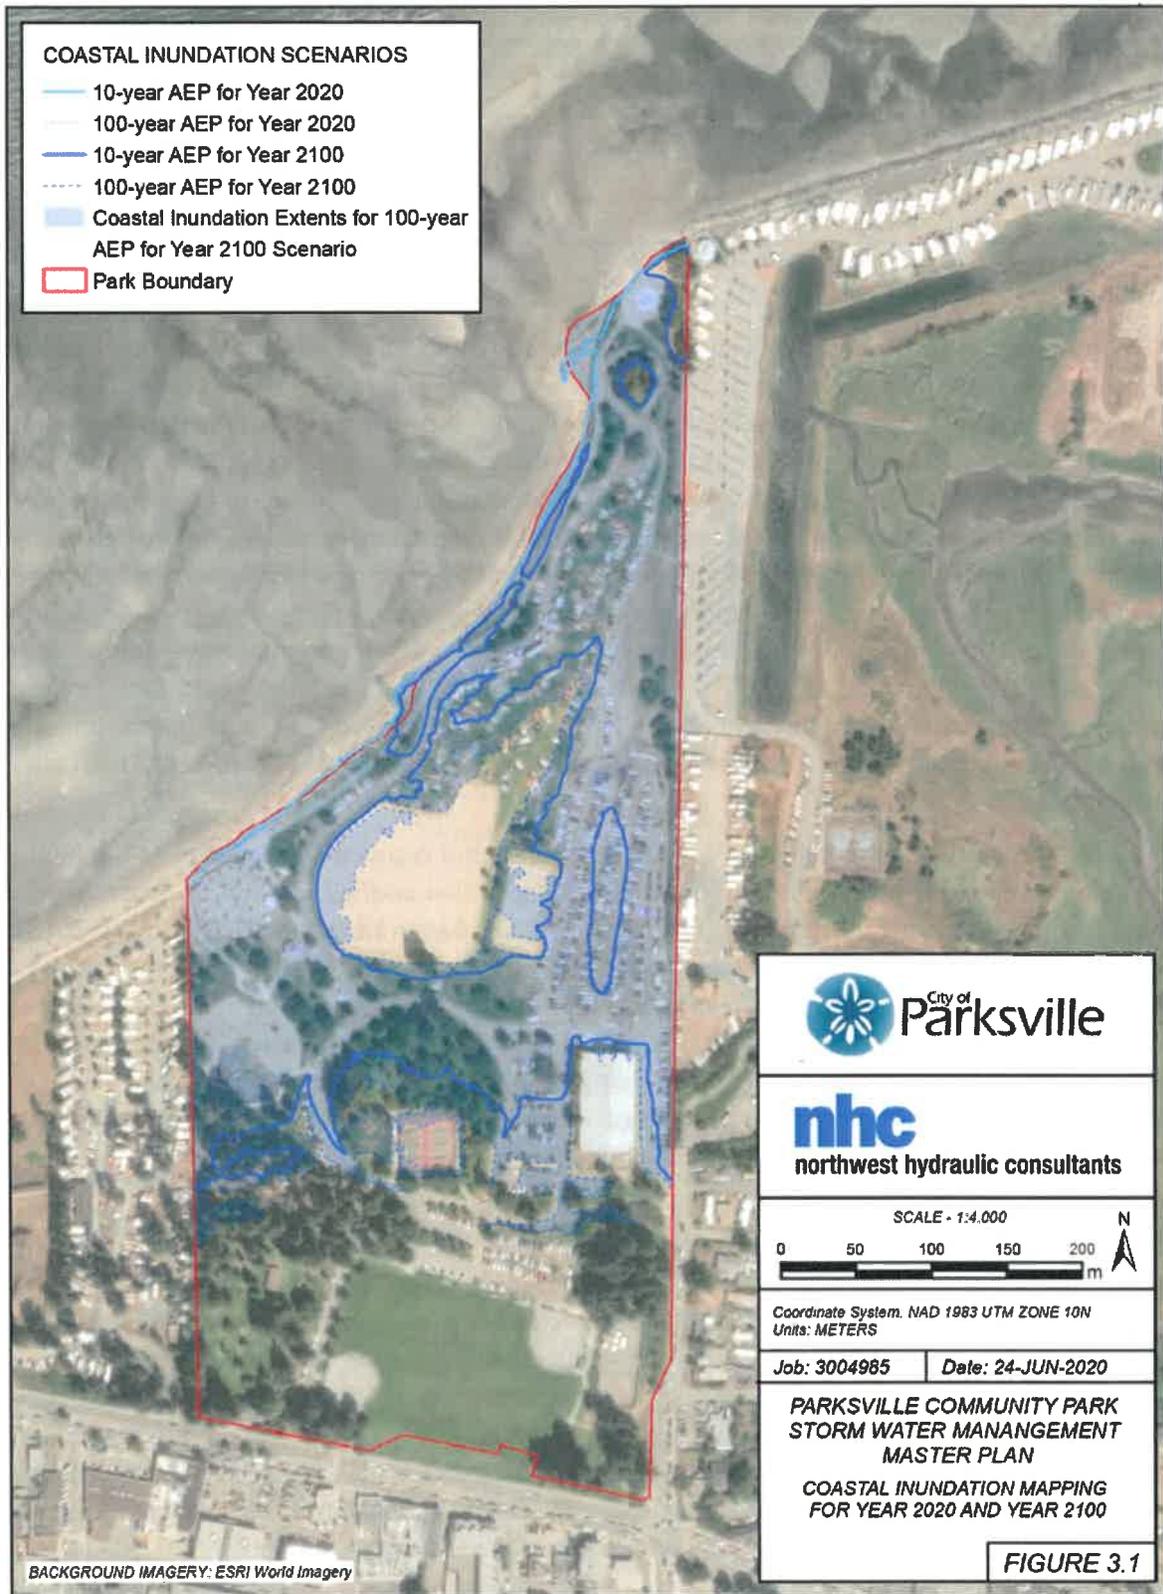
Figure 10. Coastal Inundation Mapping for Year 2020 and Year 2100 (Northwest Hydraulics Consultants, 2020a)

NHC found that present day wave effects will be limited to the beach except for some overtopping and isolated ponding that will occur at the peak of a storm event, lasting two to three hours, at locations where the Park pathway has minimal freeboard (i.e. the western half of the Park shoreline, primarily to the southwest of the rock groyne where the beach crest elevation drops to approximately 3.1 m CGVD2013). Wave overtopping rates are dependent on the elevation of the beach crest, which may change based on the City’s SLR adaptation strategy, and so the study developed this relationship for consideration in future planning. In Year 2100, wave heights within the inundated park area will likely be approximately 0.3 m, however additional analysis is required to assess the potential effects of wave breaking. The study considered potential wave runup under existing and future climate, with the latter assessment considering a scenario with future raised shoreline elevations. If the shoreline is not raised, then waves will break on the shoreline and impacts will be dependent on other factors needing further consideration (Northwest Hydraulics Consultants, 2020a).

Overall, the study utilized the 200-year design event levels and regional SLR to estimate the future Natural Boundary at an elevation of 4.2 m. NHC recommended adding 0.6 m of freeboard to the Natural Boundary to define the future Flood Construction Level at an elevation of 4.8 m (CGVD 2013), as shown in Figure 11 and in accordance with the probabilistic method illustrated in Figure 12 (Northwest Hydraulics Consultants, 2020a). The Flood Construction Level cited in the City’s Official Community Plan is 4.1 m (City of Parksville, 2013). The Flood Construction Level indicates the elevations above which habitable spaces in buildings should be constructed and also can be used to establish the target elevation for shoreline berms. Details of the study method and findings are provided in Appendix C.

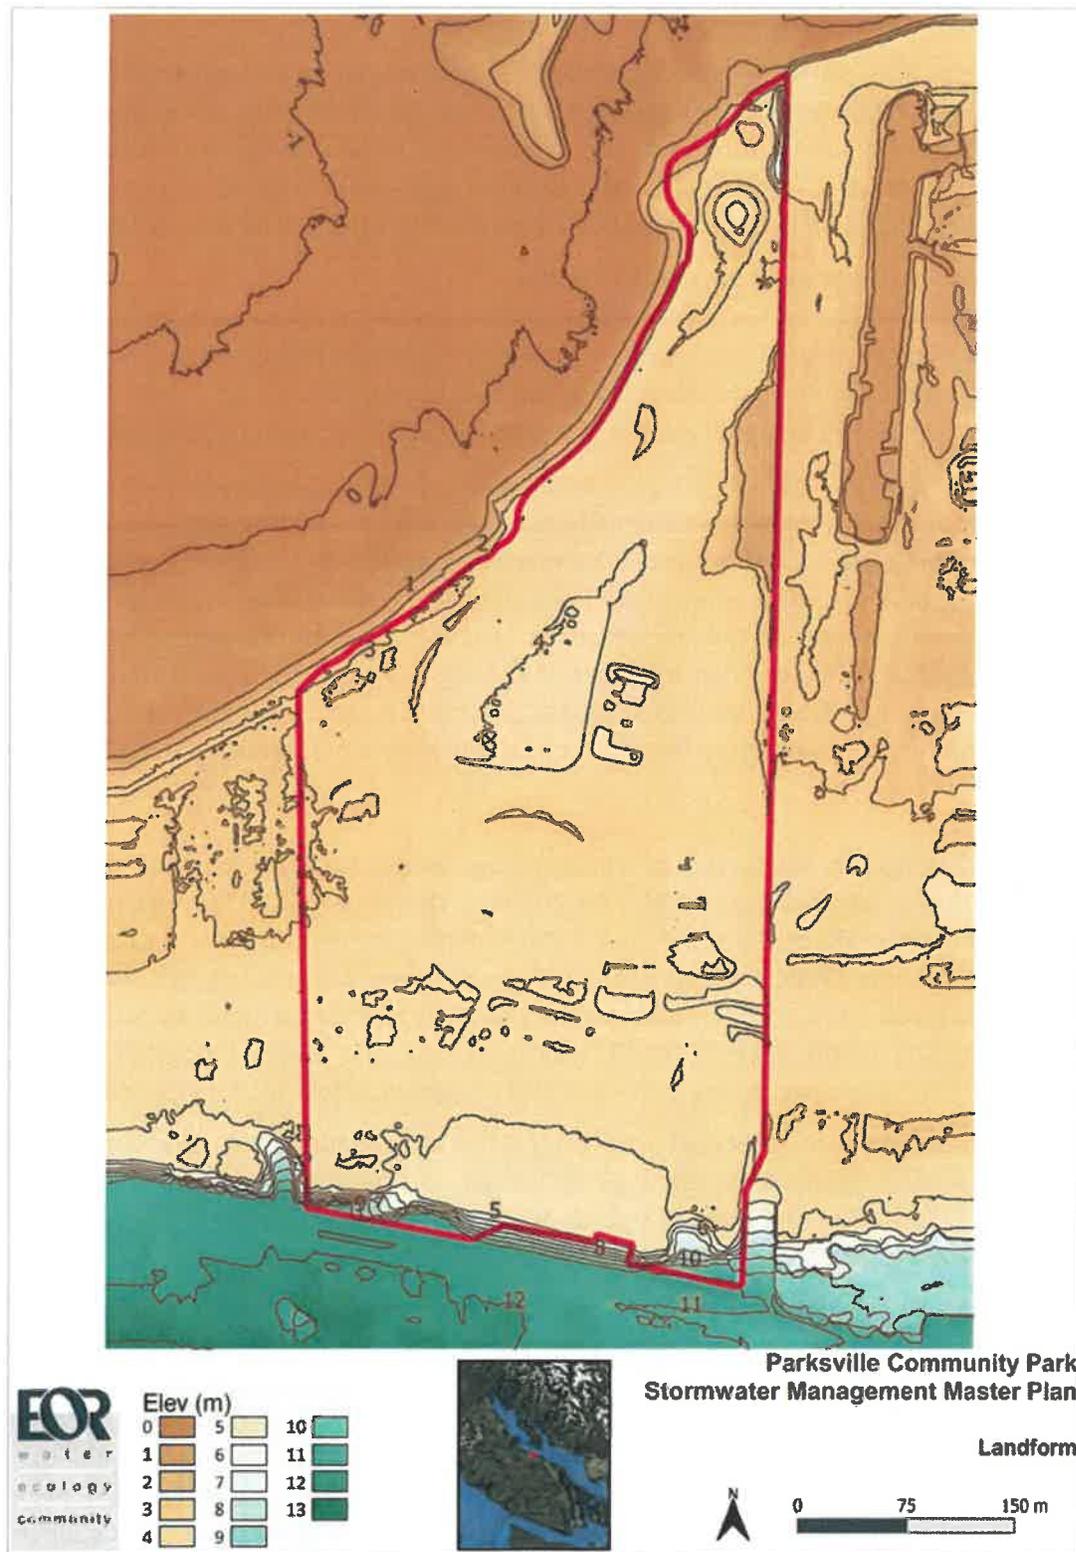
Figure 14. Topography

Elevations throughout most of the Park range from sea level to approximately 5 m above sea level, with a steep slope on the southern boundary rising to 11 m above sea level. The topography of the Park is mapped in Figure 14 using light detection and ranging (LiDAR) provided by Regional District of Nanaimo. Additional topographic survey was conducted of the Park by JE Anderson in January and February 2020. Sims Associates Land Surveying Ltd. surveyed the right-of-way adjacent to the Park on Corfield Drive and Highway 19A in May 2020.

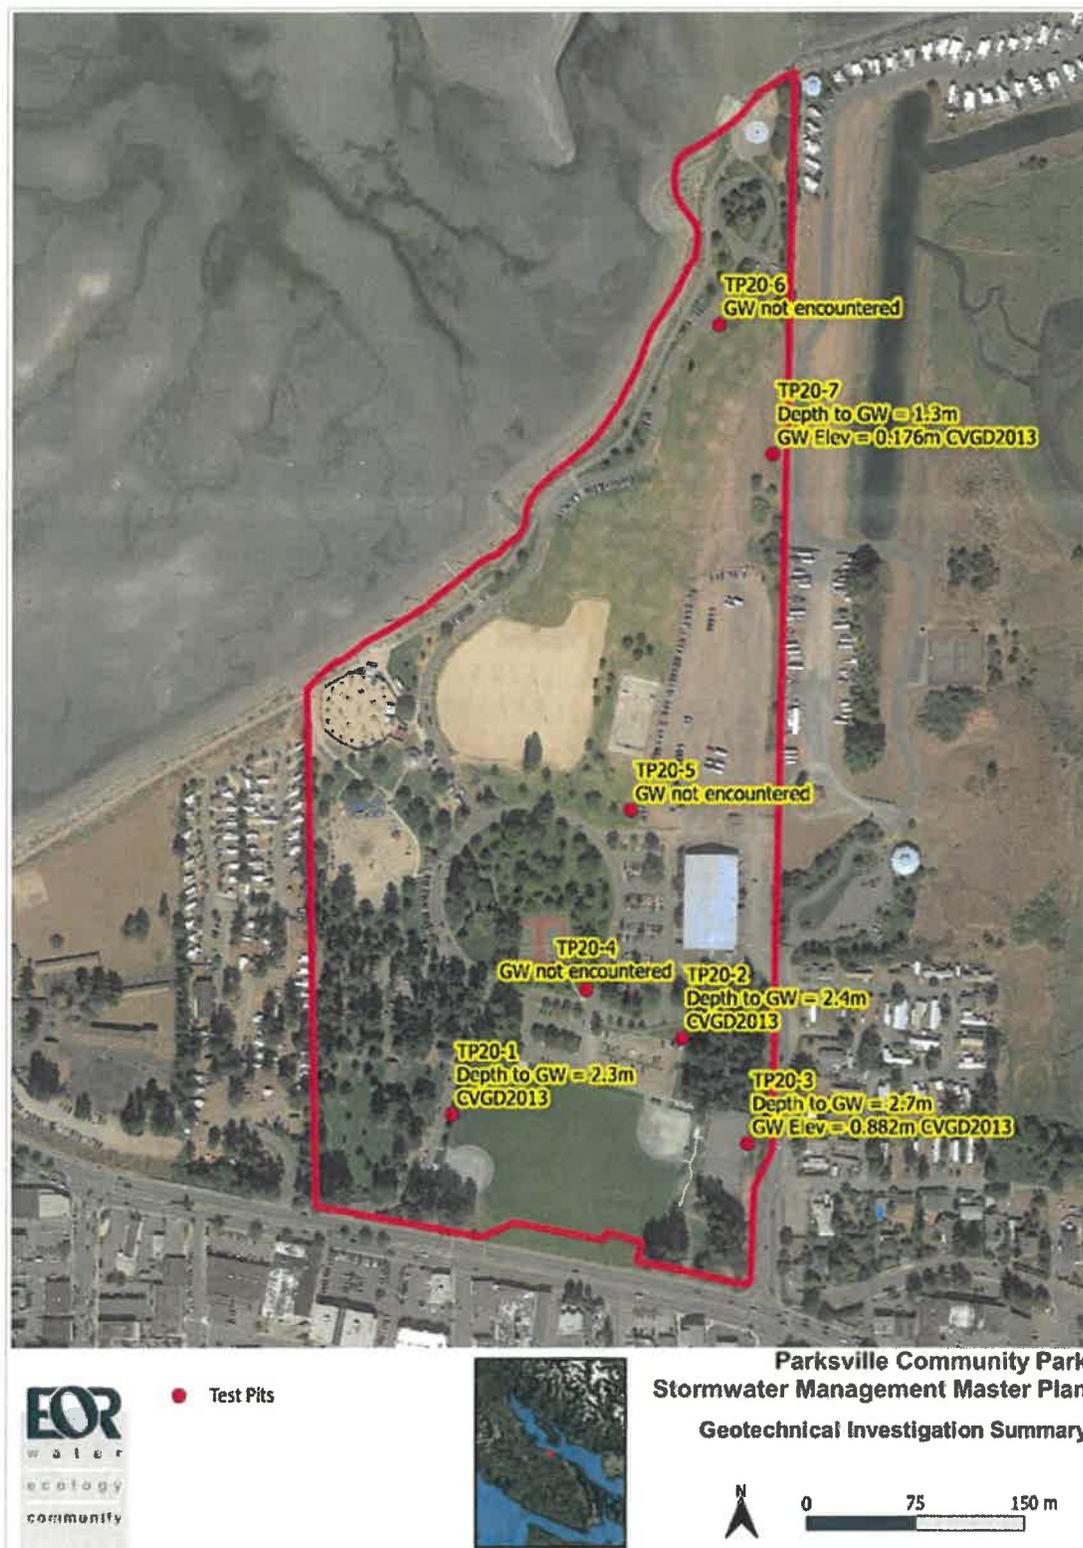
Figure 15. Summary of Geotechnical Results

The geotechnical investigation conducted by Thurber Engineering Ltd. characterized depth to groundwater at the time of the investigation (May 14, 2020). As shown in Figure 15, no groundwater was encountered at three of the test pits (TP20-4, TP20-5, TP20-6). Depth to groundwater in the three southernmost test pits (TP20-1, TP20-2, TP20-3) ranged from 2.3 to 2.7 m. The shallowest groundwater was observed 1.3 m below ground in the dry basin located northeast of the curling rink on the eastern boundary of the Park (TP20-7), which was also the lowest topographic point investigated. Additional information on the geotechnical investigation is provided in Appendix D.

Grain size analysis of selected samples were used to refine soil classifications. The grain size analysis confirmed that the confining layer at most test pit locations is poorly graded sand (SP), which has a design infiltration rate of 20.3 mm/hr (Appendix E) and should be confirmed by in-situ infiltration testing during detailed design of stormwater practices. The exception to this finding is the the organic silt encountered at TP20-3 to a depth of 2.3 m, indicating low potential for infiltration at this location. Infiltration capacity will also be affected by groundwater elevations, which are discussed in the next section. Additional information on the geotechnical investigation is provided in Appendix D.

Groundwater elevations below the Park are expected to fluctuate seasonally due to relationship to sea level and precipitation, and may potentially be influenced by irrigation of the Park as well. TP20-1 is located west of the baseball fields, which are drained by a daintile system although their influence on groundwater is unknown. In addition, sea level rise associated with climate change may cause increased groundwater elevations. The extent of these influences at the Park is uncertain due to a lack of monitoring data, however the relatively shallow groundwater elevations observed at some locations in May 2020, especially in the dry pond, indicate vulnerability to groundwater flooding or shallow groundwater impeding infiltration capacity.

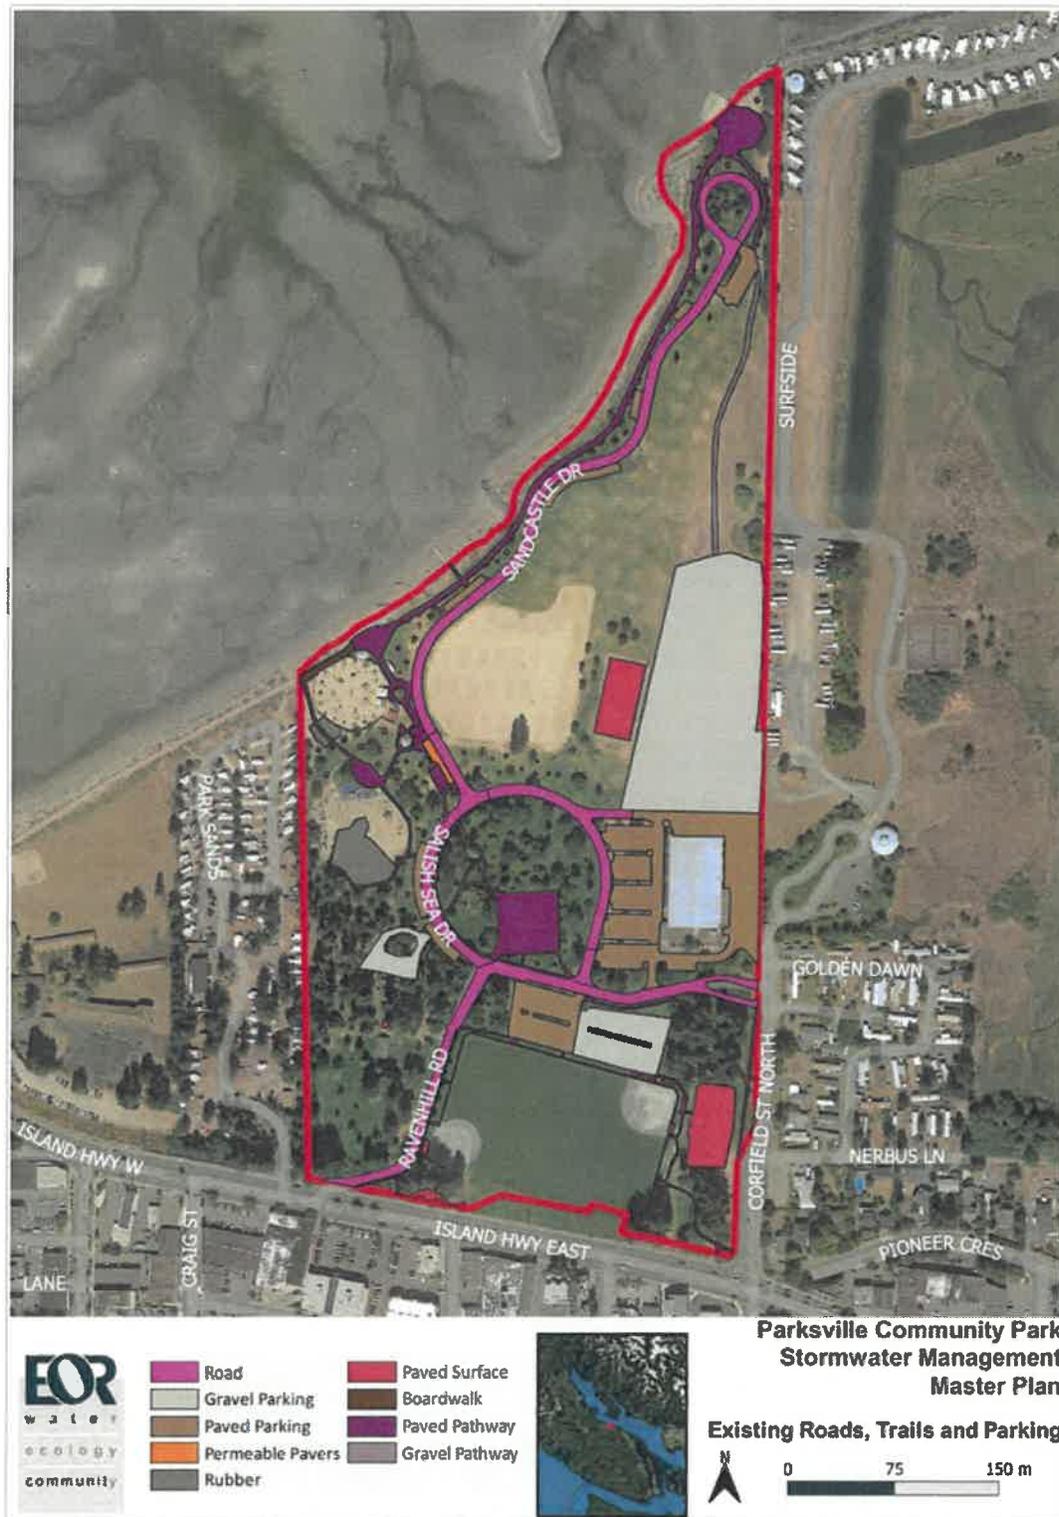
Figure 20. Existing Road and Trail Infrastructure in Park

The existing road, parking and trail infrastructure in the Park is illustrated in Figure 20. The three roads in the Park are Sandcastle Drive, Salish Sea Drive and Ravenhill Road. The three main parking lots in the Park are the paved and gravel lot by the sports field, the paved lot west of the curling rink, and the large gravel overflow lot north of the curling rink. Additional parking is provided in smaller, roadside parking along Sandcastle Drive. City staff noted some historic issues with accelerated asphalt deterioration in areas with frequent nuisance flooding issues, as well as east of the curling club. The City installed a section of permeable pavers in one of the roadside parking areas in 2015, which is functioning well so far. There are several limitations for pedestrians in the Park based on gaps between sidewalk and trail networks. The City sweeps the streets in the Park every two weeks.

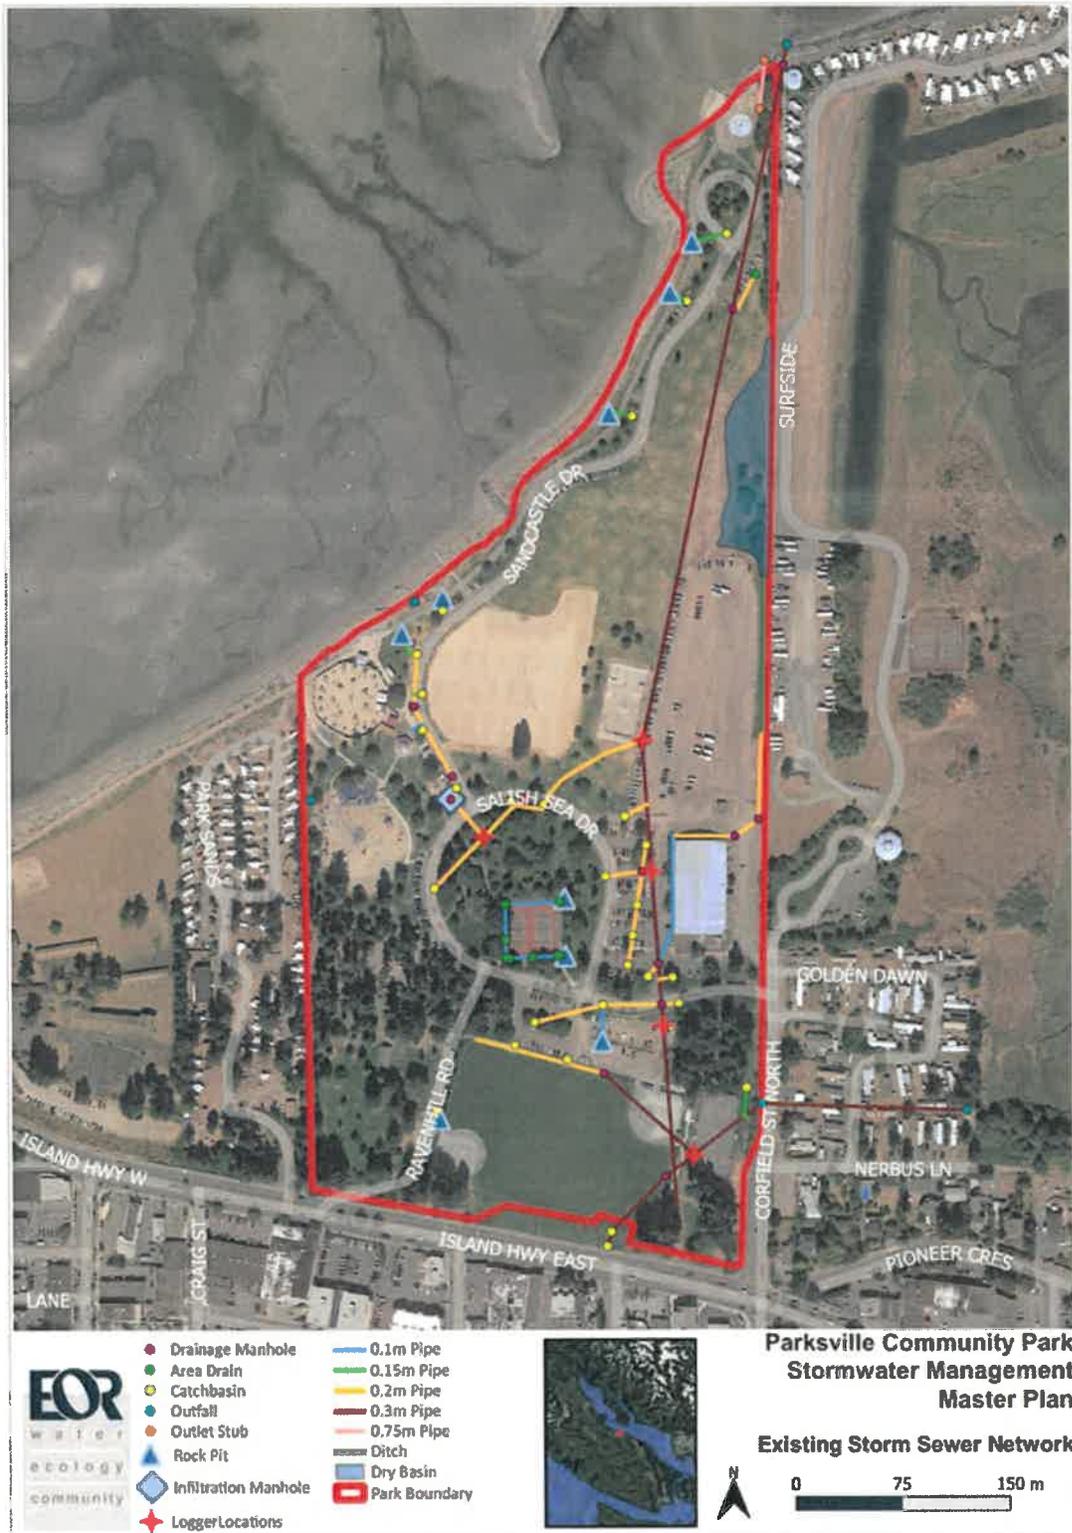
Figure 23. Existing Stormwater Management System

The existing stormwater management system in the Park uses retention and conveyance strategies to manage stormwater runoff. Runoff from approximately half of the Park is retained by subsurface infiltration facilities (e.g. rock pits), a dry pond and landlocked topography. Runoff from another third of the Park drains to the storm sewer networks and ultimately to downstream outfalls. One of these areas is at the southeast corner of the Park, where the storm sewer network drains to an outfall to the Englishman River Estuary located northeast of the residential area east of Corfield Street North and north of Nerbus Lane. The second outfall is to Parksville Bay and is located at the northeast corner of the Park at Arbutus Point. Most of the remaining area of the Park also drains to the Parksville Bay storm sewer network, however a sag in the storm sewer network northwest of Salish Sea Drive prevents most drainage from reaching the Parksville Bay outfall, leaving the area partially isolated where runoff is retained at an infiltration manhole. Throughout the Park, the existing roads and parking lots direct runoff to the storm sewer network via curb and gutter systems. An inventory of the stormwater management infrastructure in the Park is summarized in Table 12 and illustrated in Figure 23. The major catchments throughout the Park are illustrated in Figure 22. As shown in Figure 23, an outfall stub with larger capacity than the existing storm sewer was installed at Arbutus Point during shoreline stabilization improvements designed by NHC and built in 2017 (Northwest Hydraulics Consultants Ltd., 2017). The basic design parameters of the pipe (e.g. location and diameter) were selected by the City and the outfall invert elevation was set to the level of the beach at the base of the slope, approximately 0.15 m above the existing outfall. The City has noted that the existing outfall periodically clogs with sediment and debris, however it is unknown to what extent the new outfall will mitigate this issue.

Type	Quantity	Intended Purpose
Storm Sewer	2.1 km	
Manholes	14	
Inlets (e.g. Catchbasins)	37	Convey runoff away from roads and structures
Outfalls	2	
Ditches	108 m	
Infiltration Manhole	1	Infiltrate runoff where system has insufficient outlet capacity
Soakaway Pits (e.g. Rock Pits)	9	Infiltrate runoff in isolated areas of the Park
Dry Pond	1	Infiltration
Drain tile	Unknown	Drain baseball fields

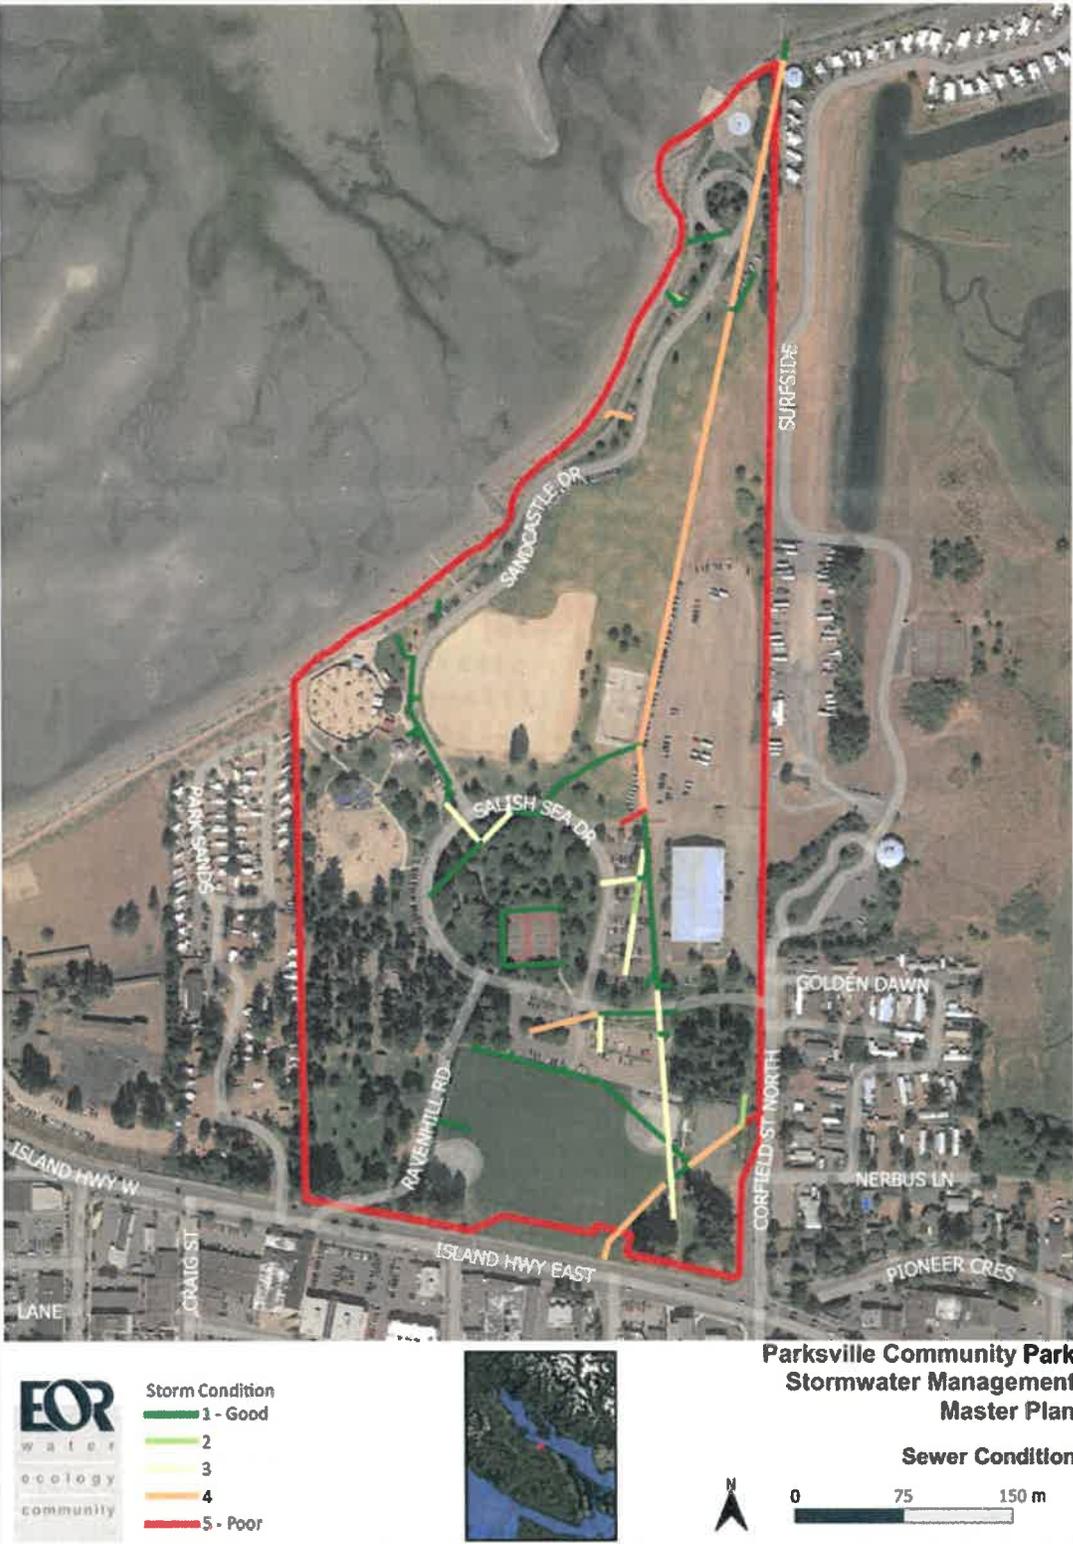
Figure 24. Estimated Sewer Condition

The age of the stormwater management infrastructure is uncertain; however sewer conditions were considered based on CCTV inspections by Pipe-Eye Video Inspections. Sewer condition codes were assigned by Pipe-Eye Video Inspections based on findings observed on the CCTV videos. Sewer condition codes are from the North American Association of Pipeline Inspectors Sewer Condition Codes Index (NAAPI, 2003) which uses the Water Research Centre (WRc) sewer conditions classifications (WRc, 1993). The codes assigned from the CCTV inspection, combined with the video records, were used to estimate a condition ranking for each pipe length using the ranking defined in (WRc, 1993). This ranking is not weighted by risk of failure, nor are any financial implications associated with it. Approximately 1084 m (51 %) of the storm sewer network is asbestos cement. The estimated condition ranking is shown in Figure 24. Hardcopy reports and video files were provided to the City of Parksville Engineering Department.

Condition Rank	Implication	Definition	Rehabilitation Priority
0-1	Excellent Condition	No defects were detected	None
2	Good Condition	Deficiencies have insignificant influence to tightness, hydraulic/static pressure of pipe (wide joints, badly torched intakes, minor deformation of plastic pipe, minor erosions, etc.)	Long Term
3	Fair Condition	Constructional deficiencies diminishing static/hydraulic/tightness (open joints, untorched intakes, minor drainage obstructions, cracks, protruding laterals, minor wall damage, individual root penetrations, corroded pipe walls, etc.)	Medium Term
4	Poor Condition	Constructional damages with nonsufficient static safety, hydraulic or tightness (pipe bursts, pipe deformations, noticeable in/exfiltration, cavities in pipe wall, severe protruding laterals, severe root penetrations, severe corrosion of pipe wall, etc.)	Short Term
5	Failed or Failure Imminent	Pipe is already or soon will be impermeable (collapsed, deeply rooted/obstructed, pipe loses water or poses danger of backwater in basements, etc.)	Urgent

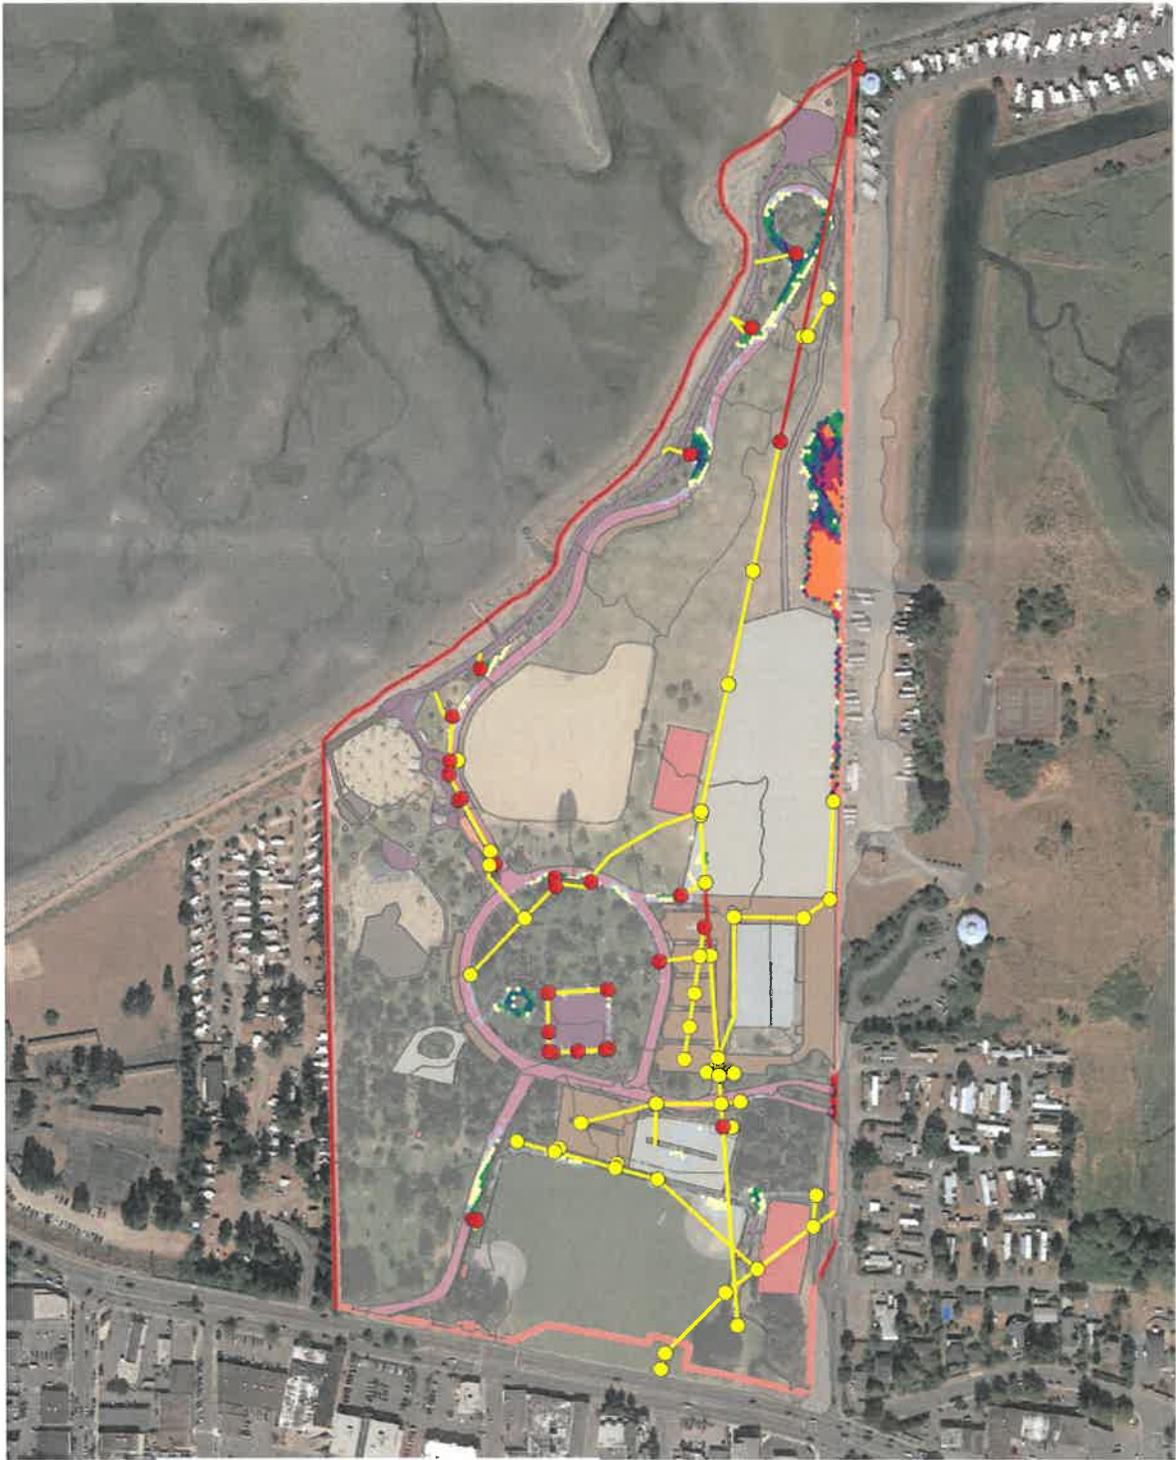
**Figure 27: Existing Conditions  
 Model Results 10-yr 24 Hour  
 SCS Type 1A Rainfall Event**

- Critical design events (Figure 27 and Figure 28):
  - Minor System (10-year return period): 24-hour SCS Type 1A Pacific Coast
  - Major System (100-year return period): 24-hour SCS Type 1A Pacific Coast
- Existing conditions deficiencies:

- Late summer short duration, high intensity events exceed the inlet and pipe capacity of the system.
- Observed surface flooding and water levels in storm sewer system on January 29, 2020 were used to validate the model. Infiltration facilities areas within the Park, shown in Figure 29, have many uncertainties associated with them including volume, depth, inlet capacity and infiltration rate. Estimates for these parameters were made for the infiltration sites in the model to best represent observed conditions on January 29, 2020.

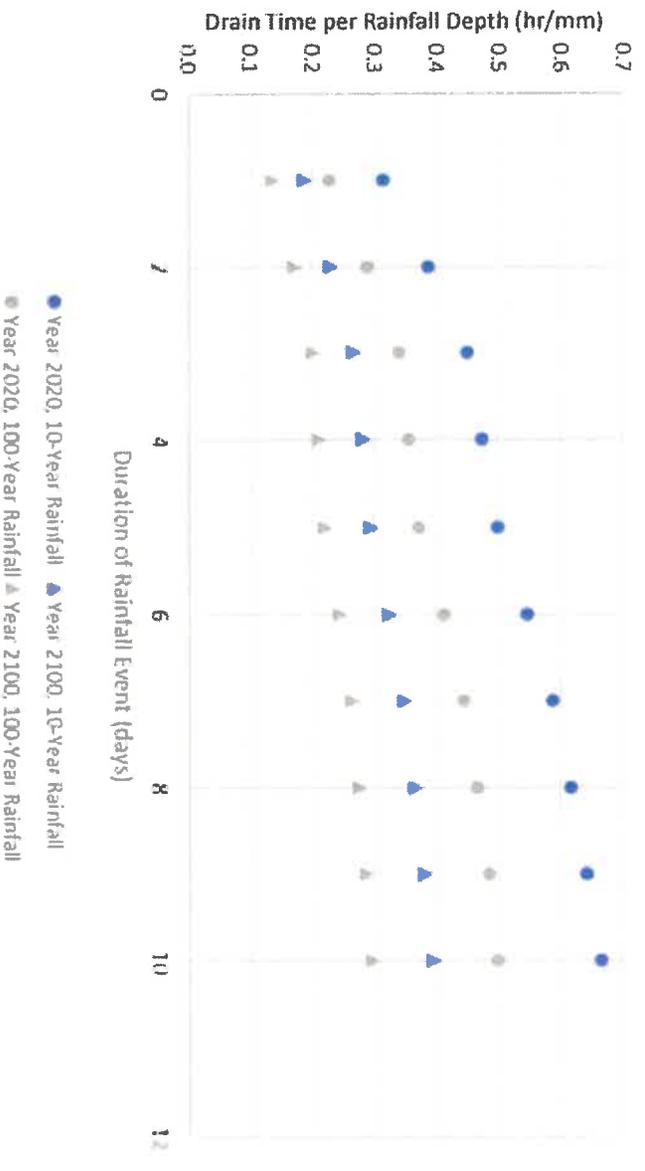
Figure 31. System Drain time Relative to Rainfall Depth for 1-Day and Multi-Day Events

- The above deficiencies are exacerbated by multi-day rainfall events since parts of the system cannot drain within 24 hours of an initial rainfall event.

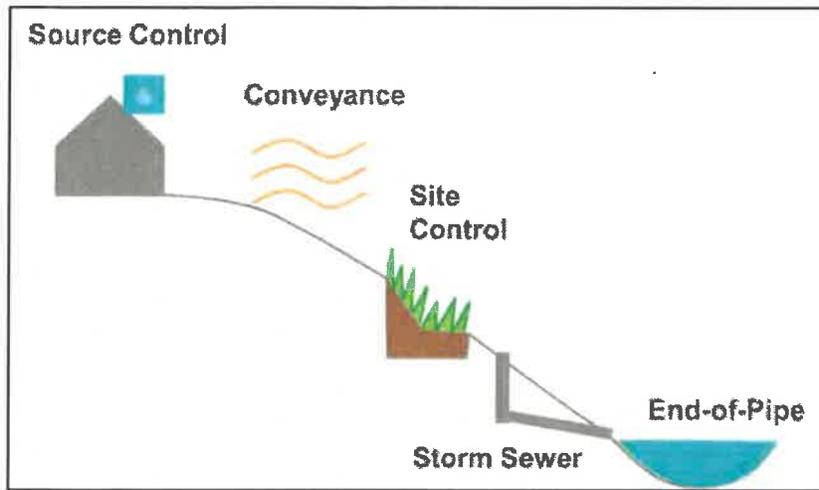
Figure 32. Treatment Train Components

The treatment train approach to stormwater management is recommended for future upgrades. The approach uses multiple practices to manage the quantity and quality of stormwater runoff as it travels across the landscape from its point of origin to the downstream waterbody. A simple schematic of a treatment train is provided in Figure 32. Treatment trains often include pollution prevention, which are described in the next section. Practices are selected to minimize the amount of stormwater runoff generated on site and maximize control of pollutants while complying with constraints such as limited space, physical conditions and regulatory requirements. Source, conveyance, and site controls include Better Site Design (BSD) techniques, Low Impact Development (LID) and Green Infrastructure (GI) strategies that work with nature to manage stormwater as close to its source as possible (see Figure 38). In general, these practices are favoured over end-of-pipe facilities because they reduce stormwater volumes and pollutant loading, which often results in lower stormwater management costs (less hard infrastructure, smaller end of pipe practices, less expensive operation and maintenance). They mimic natural processes to infiltrate, filter, evaporate, and transpire stormwater. Where source, conveyance, and site controls are insufficient or infeasible, traditional conveyance (e.g. storm sewers, ditches, culverts) and end-of-pipe facilities (e.g. ponds) can be used as part of the treatment train approach. End-of pipe facilities focus on centralized detention of stormwater, which involves storing and then slowly releasing stormwater while settling suspended sediment and associated pollutants to the bottom of facilities. Detention is one approach to mitigating flood risk and improving resiliency to large rain events. Examples of conventional stormwater management facilities include wet ponds, dry ponds, constructed wetlands, detention chambers, and hydrodynamic separators (e.g. oil-grit separators). Additional processes can be included in end-of-pipe facilities to enhance their benefits, such as percolation trenches or rock pits to cool discharge from the ponds.
