## **APPENDIX D. DESIGN CRITERIA**

Provided separately for Parkville Community Park Stormwater Management Master Plan.

**Project Name** | Parksville Community Park Stormwater Management Master Plan      **Date** | April 2021  
**To / Contact info** | Michael Lonsdale (MLonsdale@parksville.ca)  
**Cc / Contact info** | Ayla Defoor (ADefoor@parksville.ca)  
**From / Contact info** | Kerri Robinson, P.Eng. (krobinson@eorinc.com)  
**Regarding** | Characterization & Design Criteria

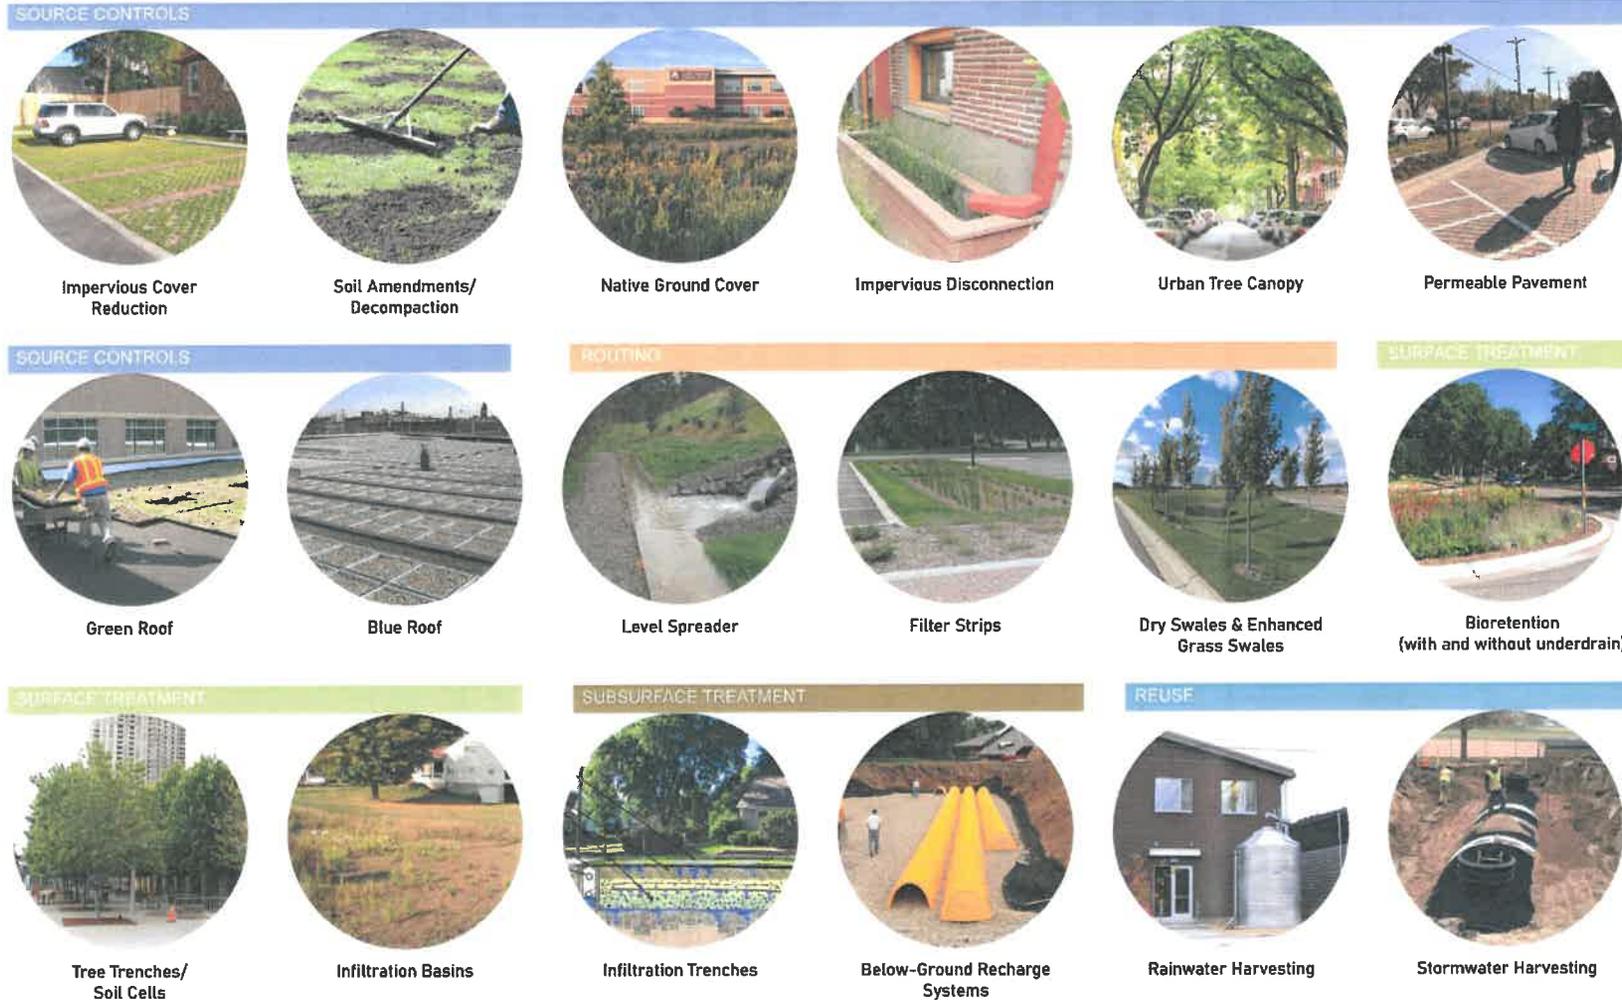
Figure 33. Runoff Volume Control Practices

The stormwater management plan for Parksville incorporates numerous end-of-pipe practices such as wet and dry detention ponds, below ground chambers, rooftop storage, oil/water separators and a catchbasin flow restrictor. To supplement this existing network of practices, the city should consider using Green Infrastructure to provide the source control, conveyance and site control prior to relying on the end-of-pipe facilities. These best management practices (BMPs) should be used to retrofit the system and cost-effectively manage runoff volumes, as illustrated in Figure 33. The benefits, suitability and constraints of these practices are outlined in Table 15 to Table 17. Within the Community Park, the main constraint to consider in terms of runoff volume control is the potential risk of shallow groundwater limiting infiltration capacity at several locations. In addition, there is one location east of the lacrosse court where infiltration will be limited by organic silt soils. Table 18 summarizes feasibility-level screening of runoff volume control practices based on typical considerations within the Park.

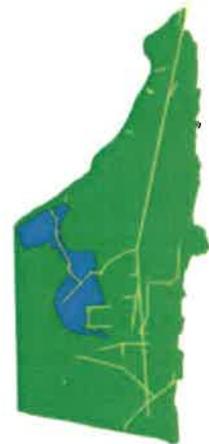
- The catchment ultimately drains to the sea outfall but a sag in the storm sewer prevents small rainfall events from draining to the trunk sewer and outfall
- Isolated events are retained by an infiltration manhole
- This area is vulnerable to minor ponding from waves breaking along the shoreline and very vulnerable to late-century coastal inundation / associated impacts as it is located at the low point in the Park's shoreline pathway
- The design and storage capacity of the infiltration manhole is unknown, but the system was not intended to drain inland flooding from coastal inundation
- A small area of roadside parking consists of permeable pavers installed in 2015
- A small increase in impervious cover is anticipated in this catchment based on future trail and amenity improvements

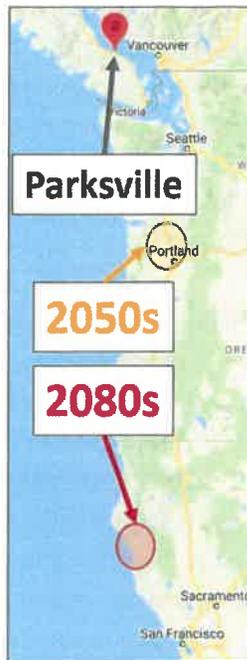
Climate analogue regions were identified based on projected changes in annual average precipitation and temperature, suggesting the best fit regions are the Portland, Oregon and portion of Northern California near the Mendocino National Forest, for the 2050s and 2080s, respectively (Figure 1). Selection of climate analogue locations for Parksville proved to be a challenge compared to other locations in the central and eastern portions of Canada and the United States. Challenges stem from the geography of the Vancouver Island location, as it is unique along the Pacific Northwest coastal region of North America. Central valleys running parallel to the Pacific Coast are analogous to the Strait of Georgia, but are not equivalent. This dynamic is why regions, rather than specific locations were selected for analogue comparison, and these factors are why we do not anticipate correlation to be as close between climate projections and analogue locations as has been demonstrated for other locations in central and eastern North America.

**Figure 1 - Analogue regions selected for design rainfall data comparison for Parksville's future climate, based on projections for 2050s and 2080s under RCP8.5.**

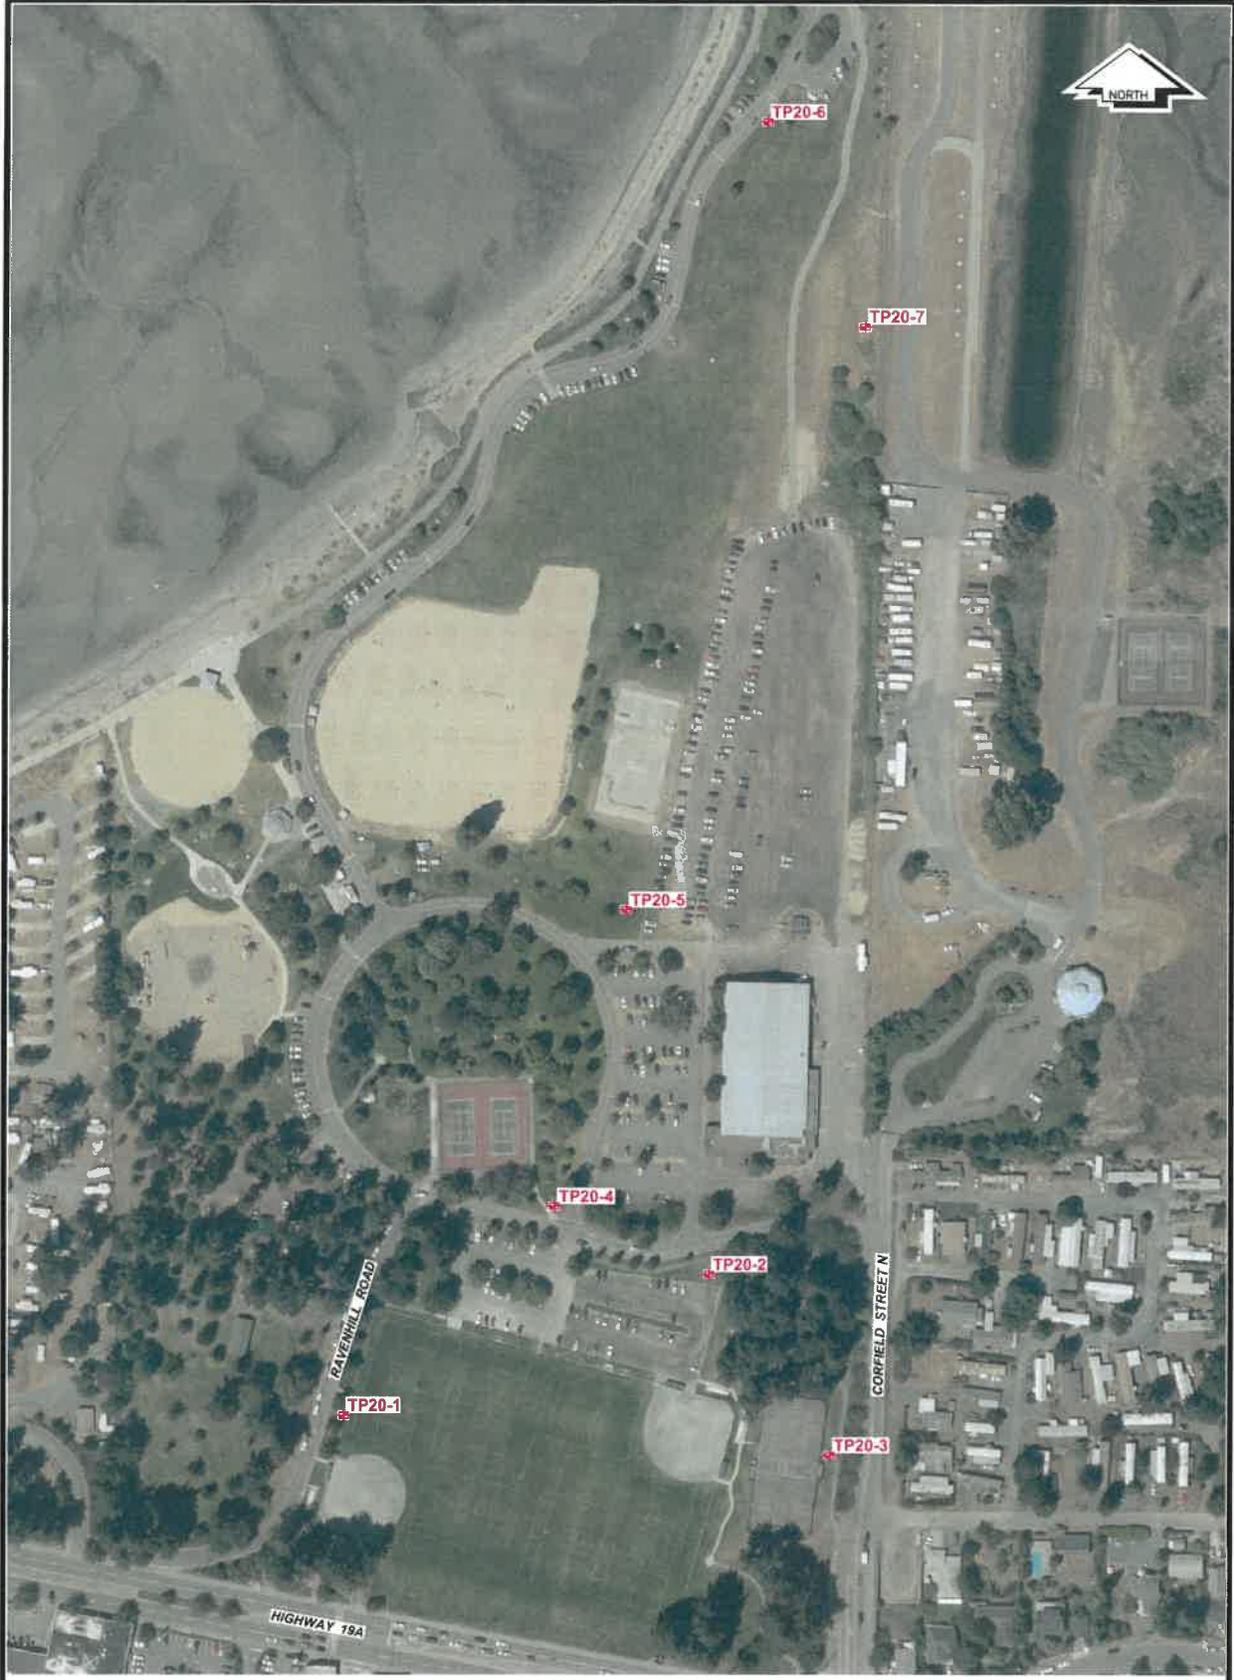
LOG OF TEST PIT (NO EST.) R. RRS\_26367\_PARKSVILLE\_2020 TEST PIT LOGS.GPJ THURBER BC.GDT 10/7/20-THURBER VICTORIA FEBRUARY 2012 REVERSE.GLB

- 1. Test Pits were located by hand-held GPS unit; locations are approximate only.
- 2. 2018 aerial imagery from the Regional District of Nanaimo.

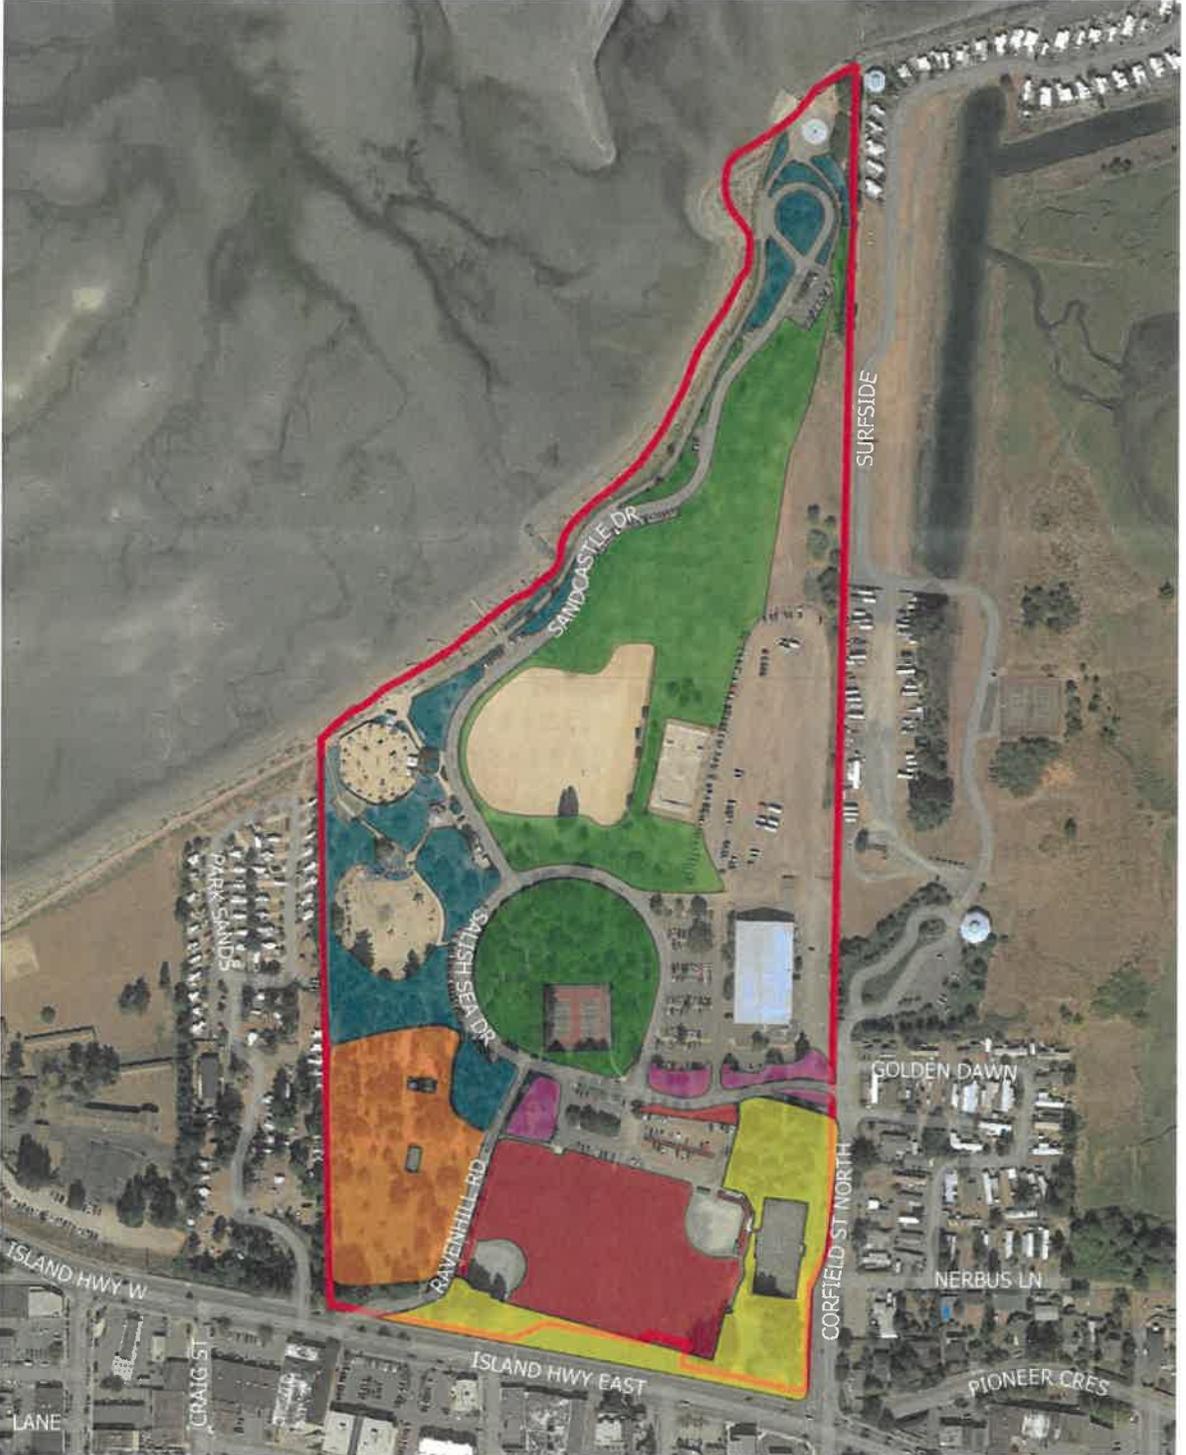
**APPENDIX G1 - Parkville Community Park Irrigation Zone Map**

- Irrigation Zones**
- Battery
  - Unit 400
  - Unit 500
  - Unit 550
  - Unit 600
  - Unit 700
