City of
Parksville
Engineering & Operations Department

**STATE OF MUNICIPAL
INFRASTRUCTURE**

ANNUAL REVIEW

December 2008

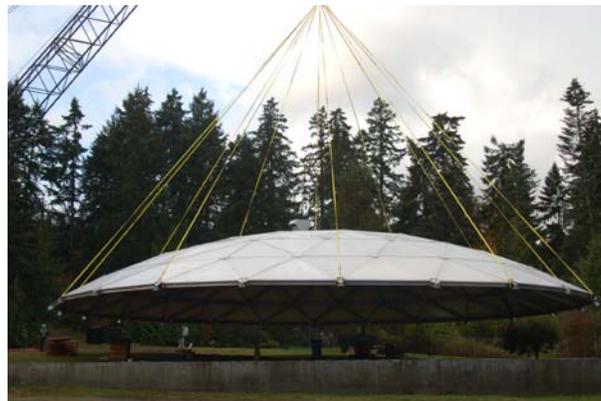
New Geodesic Dome Roof (2008) — Springwood Reservoir No. 2
