WSP Project No: 221-03915-00

Subject: Reconnaissance Assessment Memo of the Parksville Wetlands, Parksville, BC

PROJECT:
Parksville Wetlands Trail

TITLE:
Reconnaissance Assessment

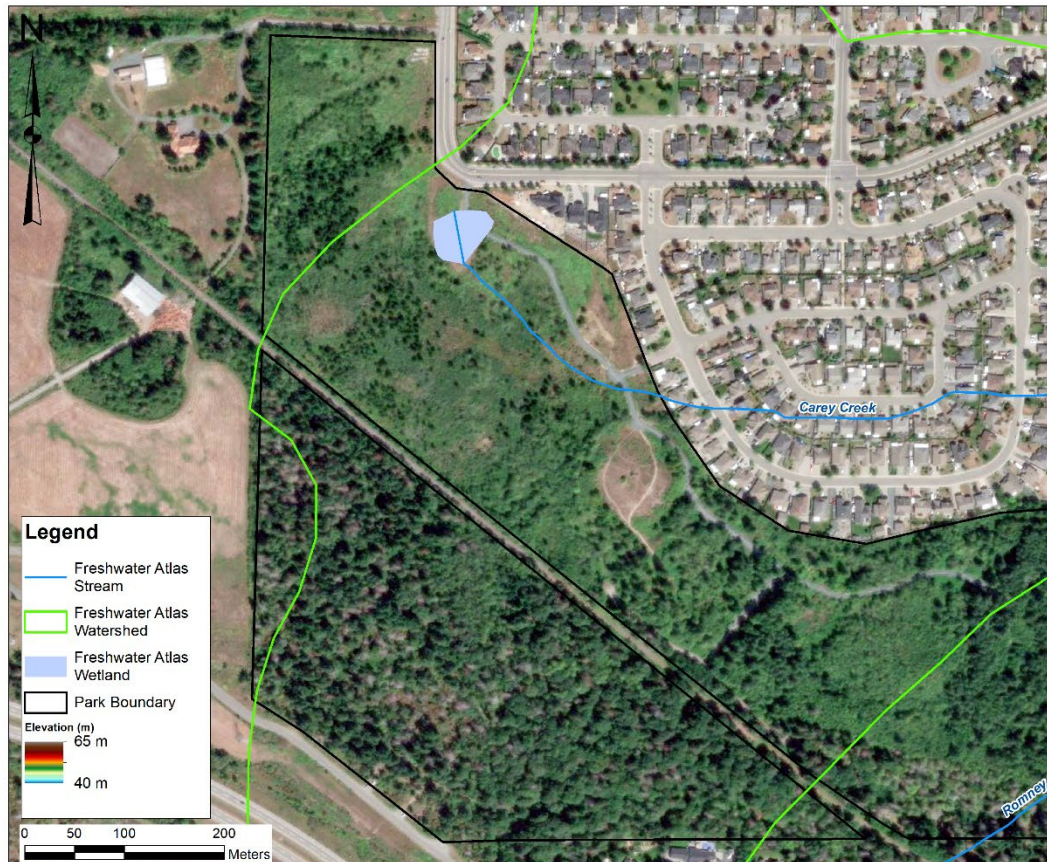
Figure 2: Parksville Wetlands, Baseline Data from BC Freshwater Atlas

The desktop review revealed that the provincial and municipal web mapping databases do not accurately represent the current location of wetlands and creek features at, or adjacent to, the Project. The desktop data review indicated that the majority of the Parksville Wetlands north of the Railway Tracks are located within the Carey Creek watershed. Only the southeast portion of the park drains towards Romney Creek. The average elevation within the Parksville Wetlands limits is approximately 50 masl. The overall drainage direction within the entire Parksville Wetlands is northeast (Figure 2).

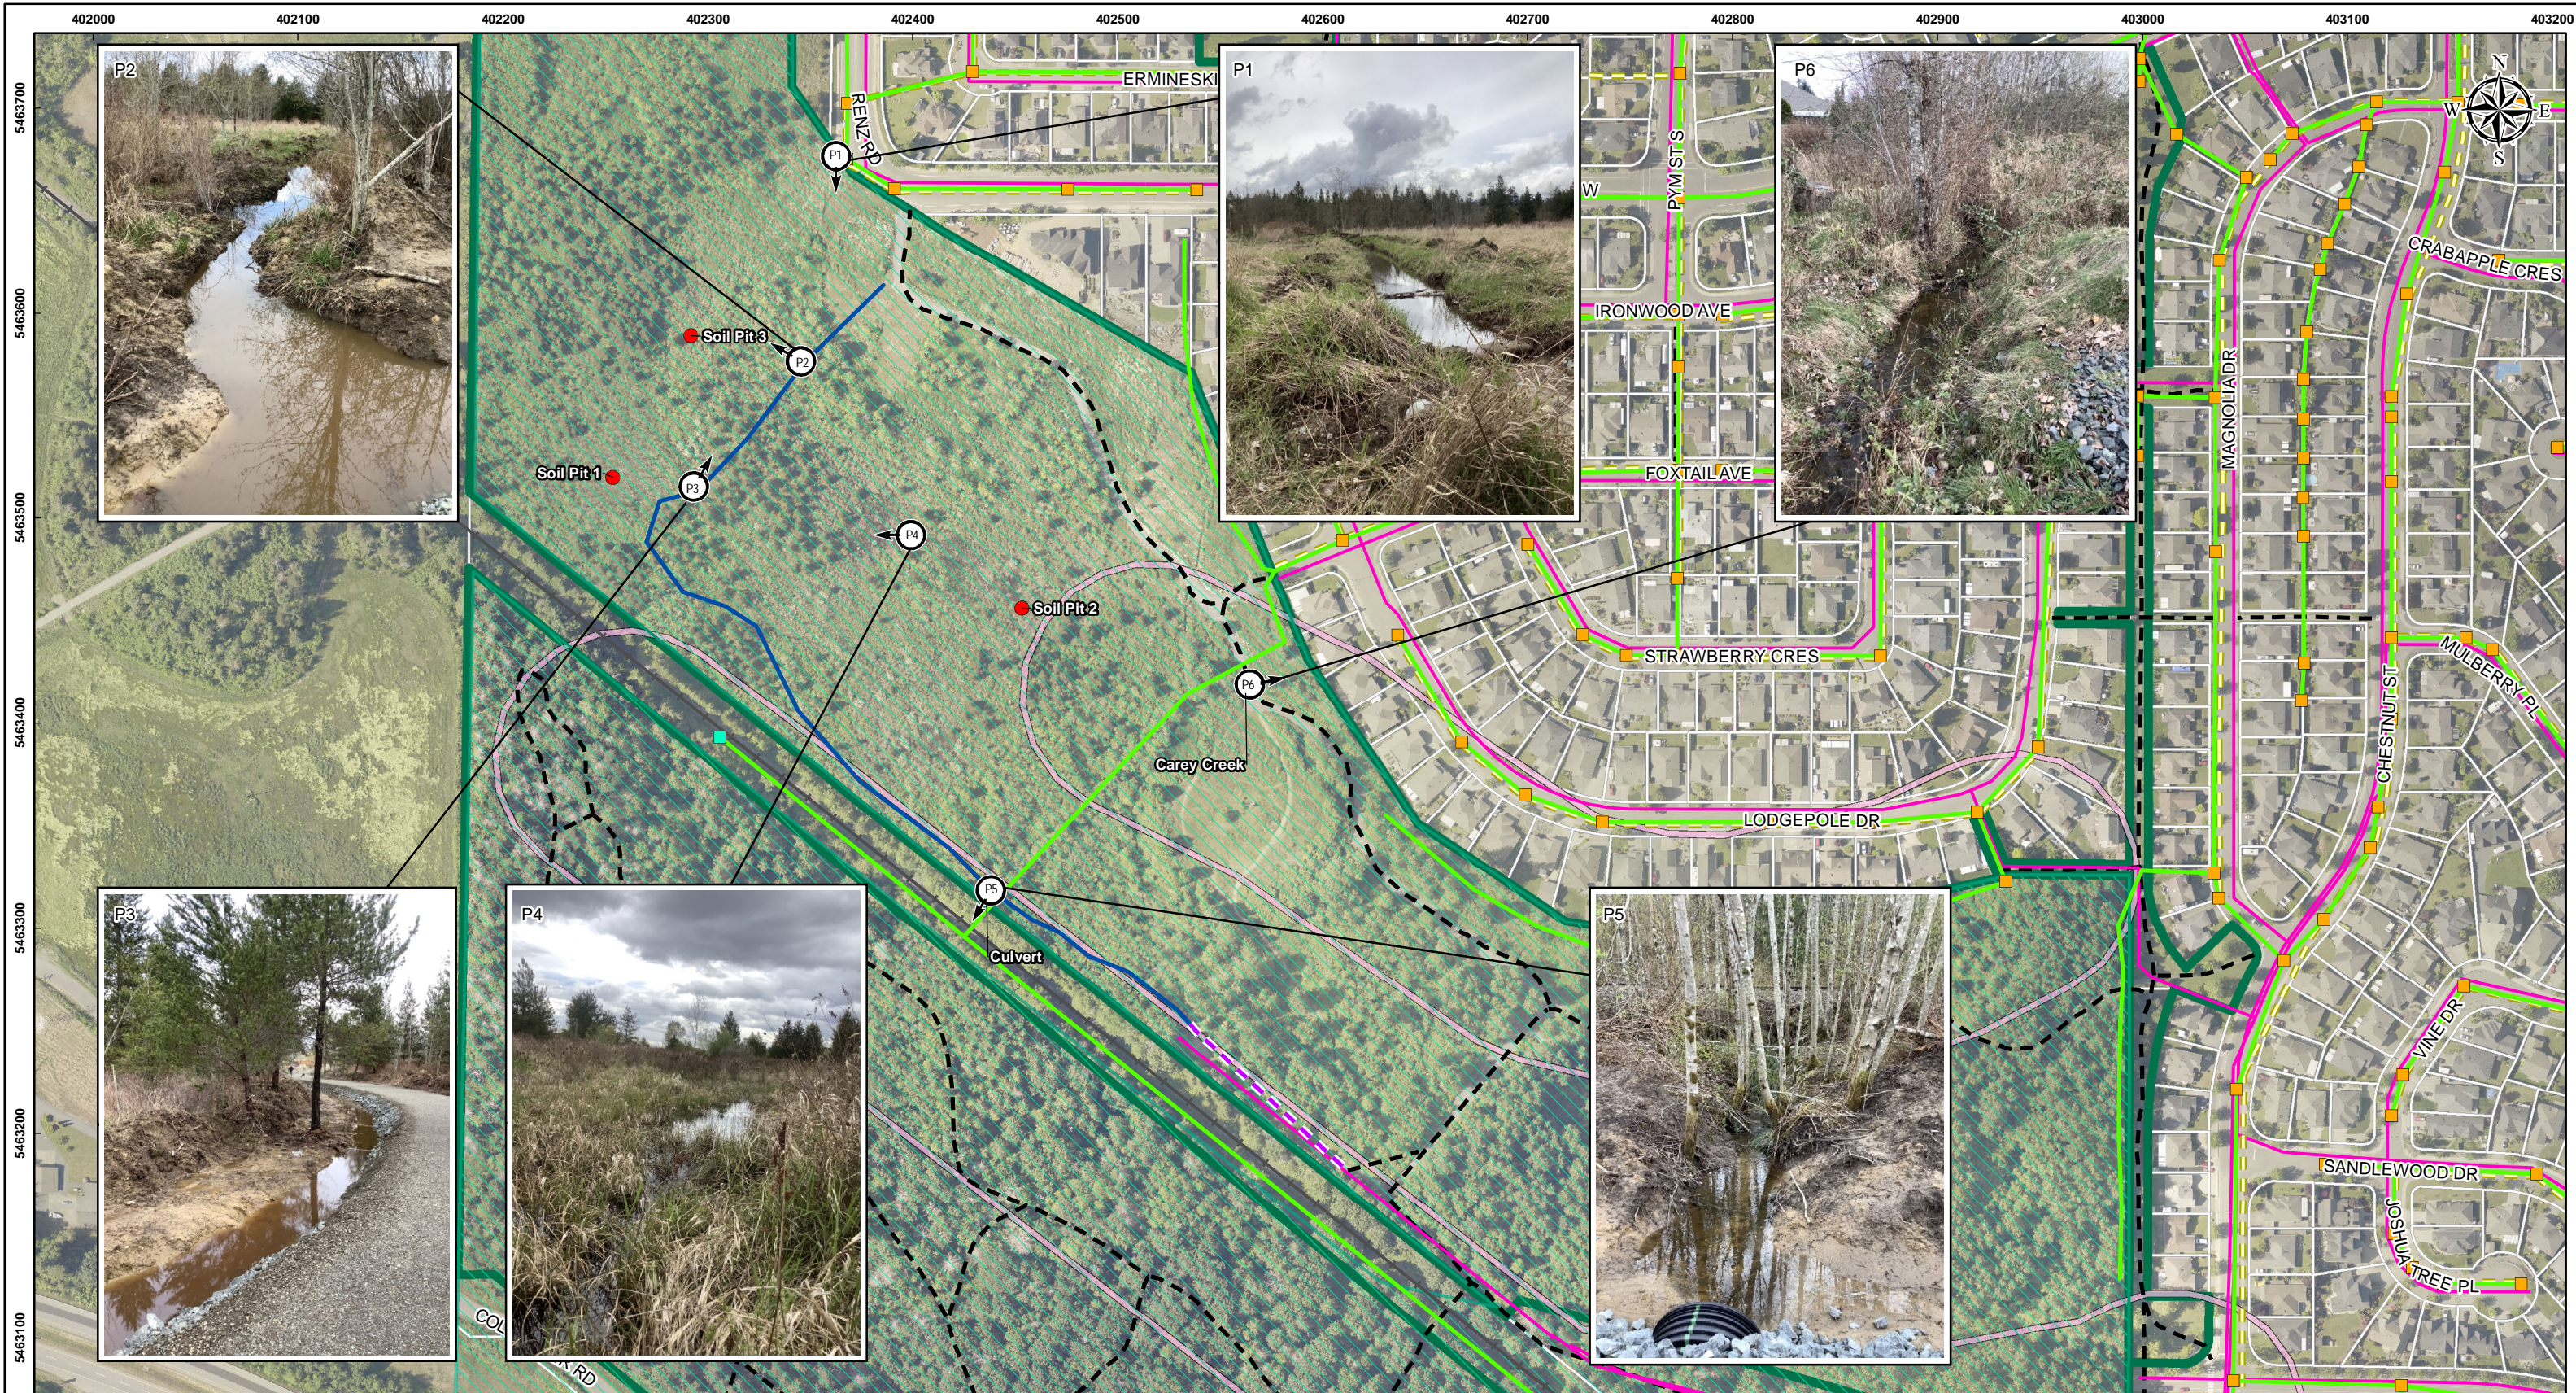
Figure 1

An existing outlet channel of approximately 75 m, connects the wetland area to a City storm drain at the northwest edge of the park, at the Hirst Ave. West and Renz Road intersection. This outlet channel was present before the Project occurred. The channel was cleared of organic materials around the same time as the new trail construction. At the time of the site visit the channel conveyed flows from the wetland area into the storm drain. It appears that the upstream end of the channel is connected to the side ditch of the new trail (Figure 1).

During the second site visit, biologists conducted preliminary wetland classification at three locations (Figure 1, Attachment1). The resulting classifications indicated that the wetlands are similar in extent to those identified using Lidar (Figure 3) but are also potentially present in a disturbed site adjacent to the trailhead near Hirst Avenue West and Renz Road (Figure 1). Based on preliminary findings it appears that the wetlands present on site are a mosaic of both swamp and marsh. A Sitka Sedge – Hemlock - Parsley marsh (Wm50) a Blue-listed ecological community, was identified at Soil Pit No. 2 and occurs adjacent to the Pink Spirea – Sitka Sedge swamp (Ws50) a non-listed ecological community.

The Wm50 marsh ecological community commonly occurs on the south coast along slow-moving shallow water bodies and prefers permanently flooded conditions (McKenzie and Banner, 2004). This wetland tolerates changes in hydrology and disturbance. The Ws50 swamp is also common at low elevations of the Georgia Depression and experiences prolonged saturation and early season flooding. The species diversity is low, and sedges dominate the understory. Soil Pits No. 1 and 3 are both located in previously disturbed areas and were both classified as Ws50 (Figure 1, Attachment 1).
