Arrowsmith Water Service and Englishman River Water Service Monthly Update - October 2025

Englishman River Water Service

Arrowsmith Water Service

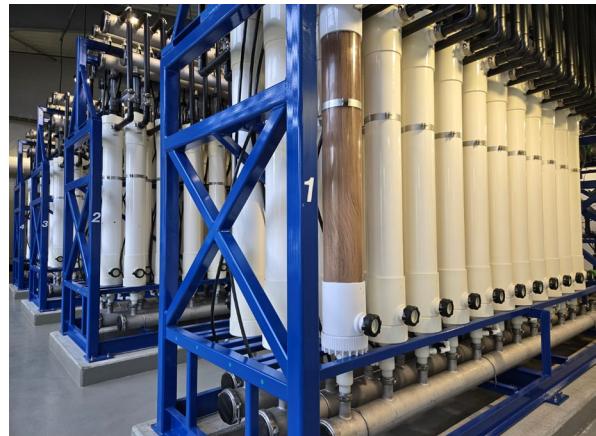
Ultrafiltration Membranes at the water treatment plant

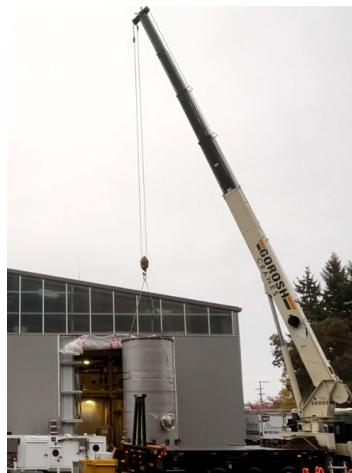
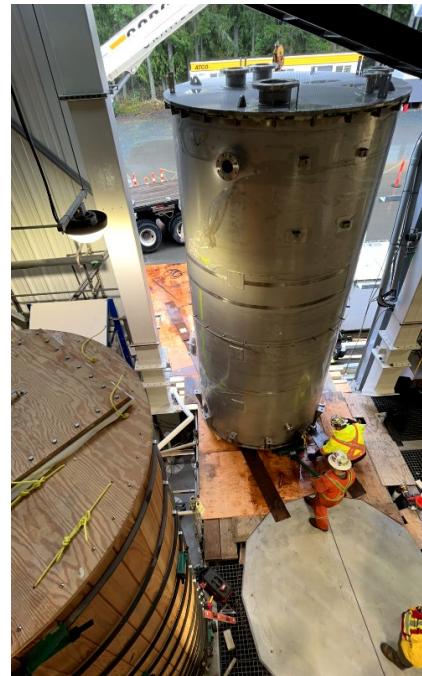
New Sodium Hydroxide tank being unloaded and moved onto its pedestal.

- During key stages of the chemical tank replacement project, October 20 onward, the plant operated on reduced hours and limited days.
- By the end of October, a section of the chemical room outer wall was removed, and two chemical skids were temporarily relocated. The new sodium hydroxide tank was placed onto its pedestal.
- A service technician was on site for the bi-annual service and inspection of the UV system.
- The heating system was serviced mid-October.

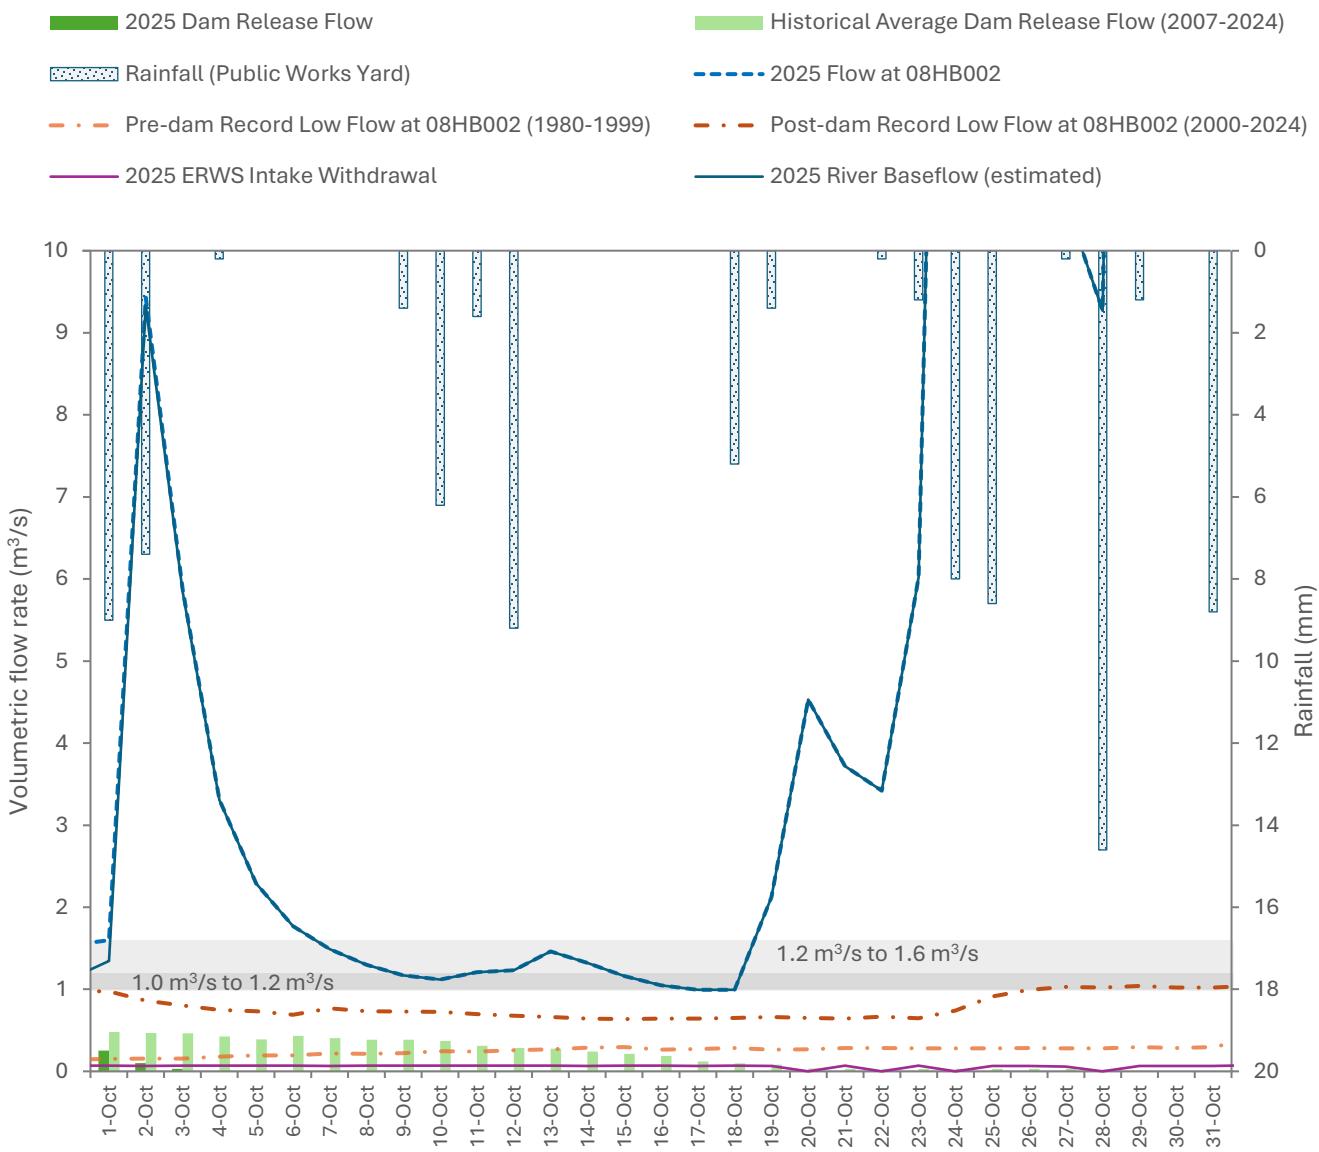
Figure 3. Volumetric flow rates and rainfall.

- Weekly dam inspections are ongoing.
- Wood piles were burned.
- The dam flow release valves were shut down on October 4 due to observed increase in flow at the WSC Hydrometric Gauge 08HB002 (see figure 3). This increase in flow was due to rainfall events that took place at the end of September and early October. The valves have been shut off since as rainfall was somewhat frequent during the month of October. This has led to a lake level increase of 3.5m (see figure 2) . The flow release valve system was not winterized to ensure flow could be made available for the whole month of October.
- Water restrictions ended on October 31st.
