Understanding the Parksville Wetlands

PARKSVILLE WETLANDS

BACKGROUND

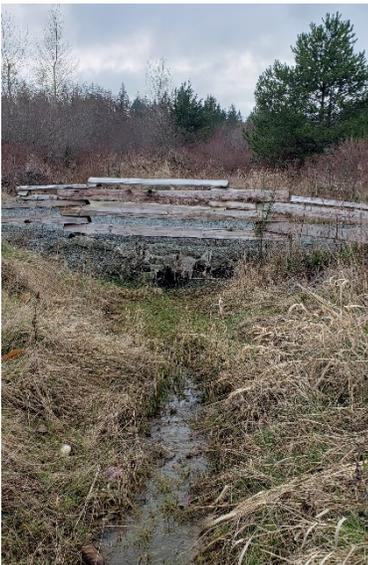
Existing drainage in the wetlands is maintained with drainage entering the park in multiple locations on the Coldwater Roadside. Water flows from the Inland Highway and Errington into drainage courses and culverts that make their way north through the park. Drainage leaves the park in four main areas: the intersection of Despard and Chestnut, along the Maple Glen Linear Park, the end of Foxtail Avenue and the intersection of Hirst and Renz. This drainage system, in place for many decades, pre-exists the park.

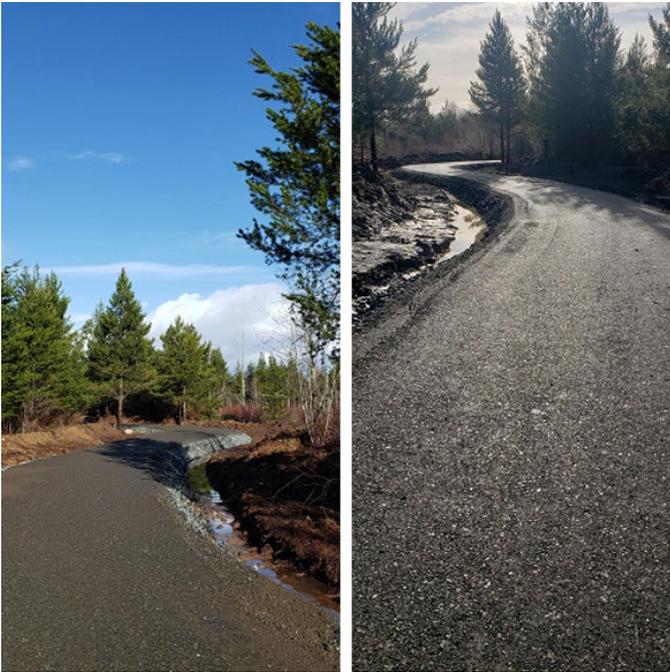
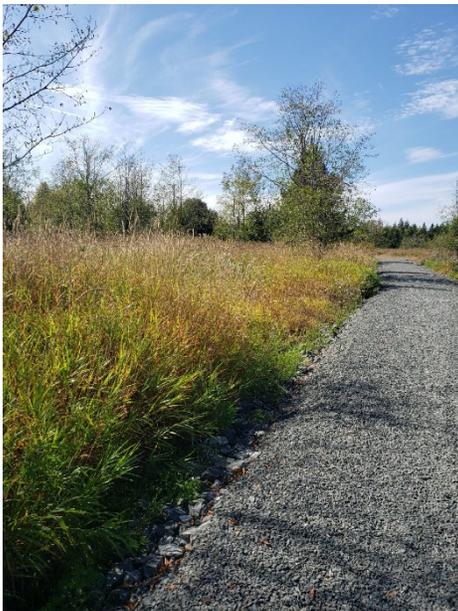
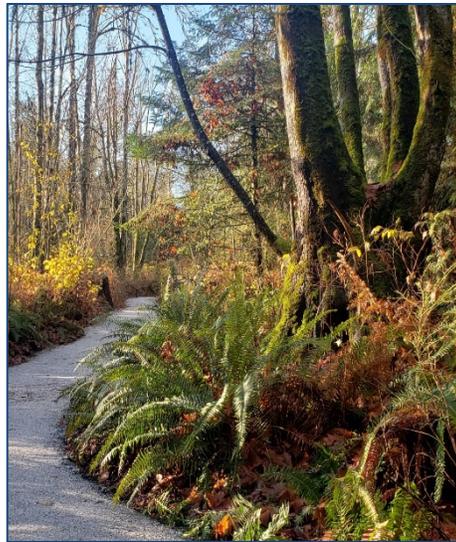
Recently completed trail (left)
Trail work completed 2021 showing limestone cap (right)
Trail work completed in 2019 showing regrowth (bottom left)

Main trails are double track and constructed to an approximate three-metre width with an additional area of about one metre on each side, five metres in total. Lesser trails developed off this double track trail reduce to a two-metre width and are for pedestrian use only. Trail routes are chosen to reduce the impact to urban canopy and sensitive areas. Trails typically stay to higher ground and detour around established conifers where possible.

Consideration is given to maintain the natural flow of water through methods that allow for the equalization of water on either side of the trail. This is achieved through culverts and by using clear rock as the base of the trail. The trail bed is made from rock ranging from eight centimetres to twenty centimetres in size to provide pore spaces beneath the trail for water to seep through; trails are not meant to be a dam. Wood removed from the trail route is piled alongside the trail and covered with the organics excavated from the trail bed in a permaculture method called *hügelkultur*.

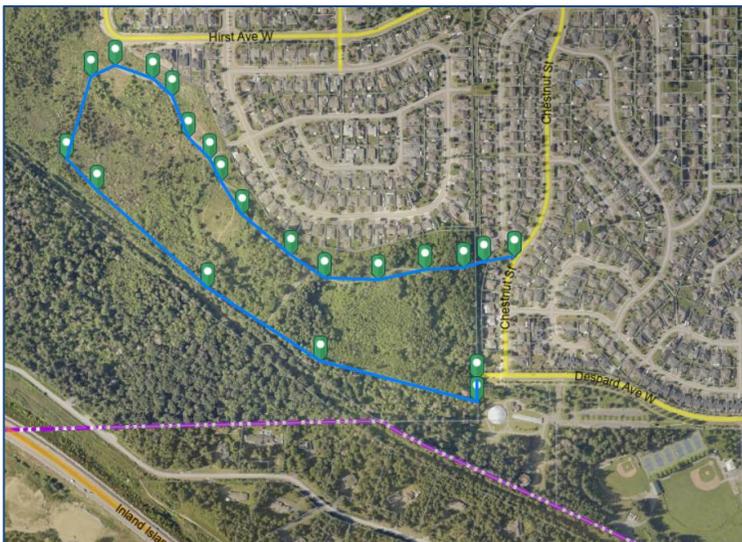
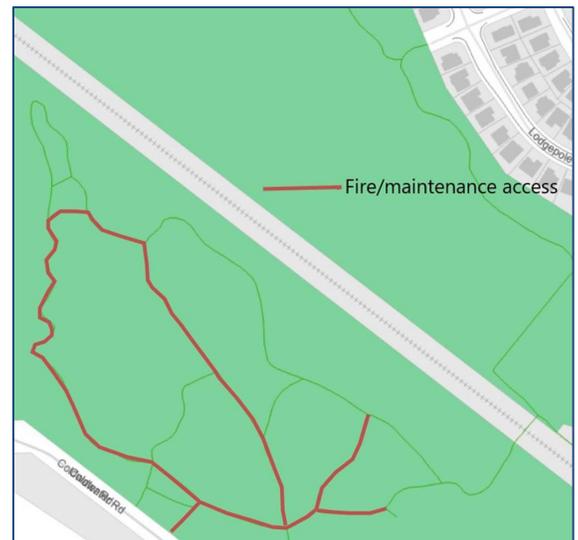
Development of a trail system within the Parksville Wetlands is a priority for the City. Staff are now able to safely access the site to mitigate the hazards from trees and remove dead wood based on our urban forest strategy to manage fire fuel load maximums for the area. Emergency services are now able to enter the area knowing there is a safe egress (*shown in photos below*).

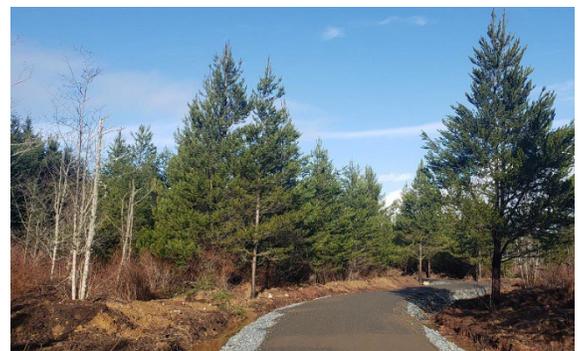
Photos showing trail drainage

Staff consider the natural flow of the water in the park and take steps to ensure that equalization of water on both sides of the trail is maintained. This process is assured by a combination of culverts, shallow trenches and by the profile of the trail bed. The base is comprised of clear rock in various sizes to maintain pore spaces between the rock. Water can make its way through the pore spaces.

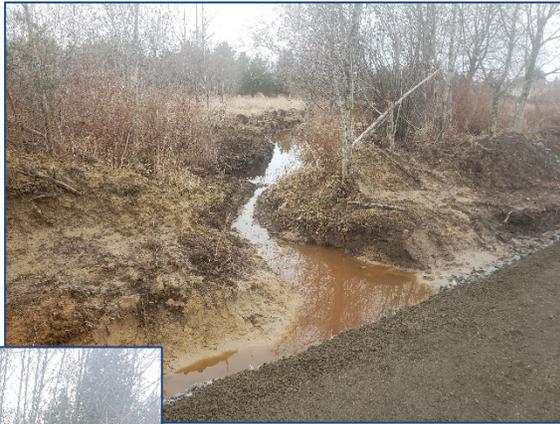
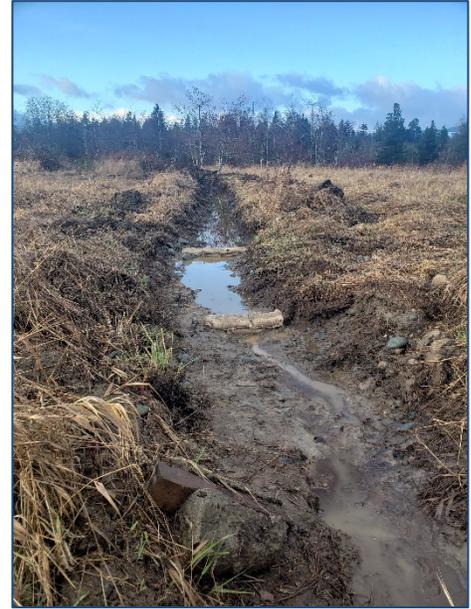
Hirst Avenue drainage (above)

The drainage system that led to the Hirst Avenue and Renz Road catch basin was cleaned of organics, standard practice with ditches and drainage courses throughout the City. Consideration was given to eliminate this drainage course once the trail was built; however, after monitoring, it is was determined this course may still be required. The height of the overflow has been raised which in turn increases the depth of the basin or drainage channel. A deeper channel allows for the retention of more water in the wetlands providing additional percolation time. The raised height will stop the flow of water into the storm basin earlier in the year while still allowing for overflow in times of heavy rain.

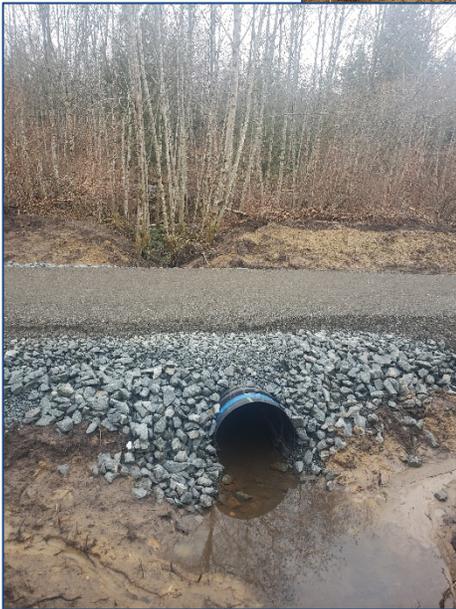
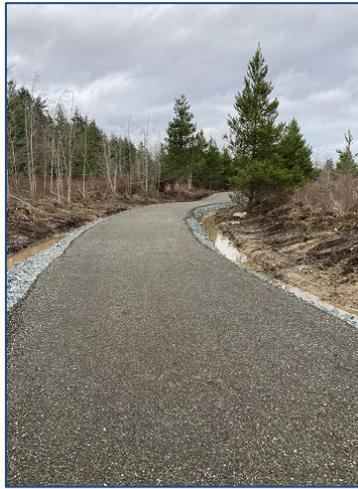
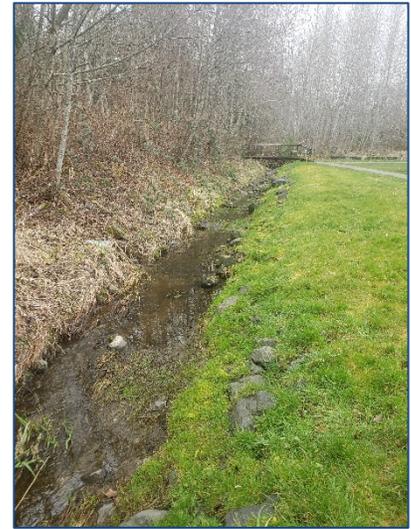
*Foxtail Avenue drainage (left),
Despard Avenue drainage (above)*

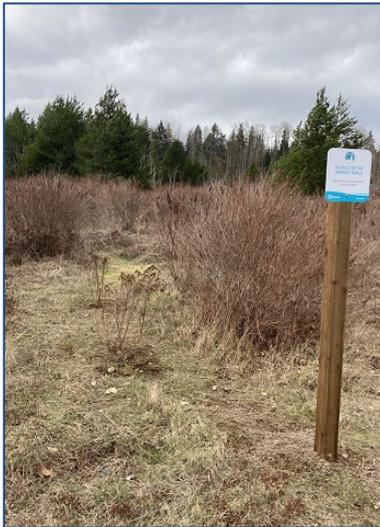
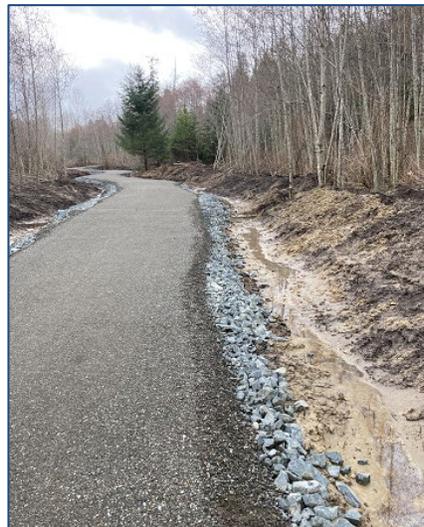
New trail with berms helps to eliminate trampling off trail.

Trail routes are selected to reduce impact to urban canopy and sensitive areas. Organic materials from the chosen trail route were piled to the side of the trail employing a permaculture method used to ease fire concerns and to make for planting of berms along the trail. The berms help manage the water in the wetlands by keeping it in ponding areas while also keeping pedestrians and pets on the trail. A look at the trail built in 2019 connecting Renz Road to Chestnut, demonstrates how quickly the trail re-naturalizes in a few short months and how popular the trails have become.

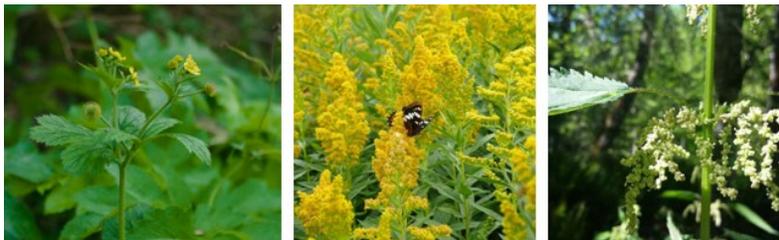
New plant seedings – Large Leaf Avens, Canada Golden Rod and Stinging Nettle

Restoration - work is underway along the trail route with plantings and seeding of native plants. Soon the hügelkultur berms will germinate and help naturalize the trail. Seeds native to the wetlands including Large-leaf Avens, Canada Goldenrod and Stinging Nettle have been planted with other plantings scheduled.
