Englishman River Clay Banks

Englishman River claybanks

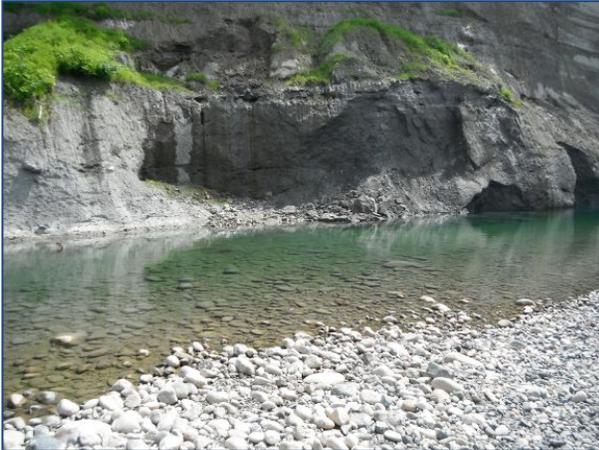
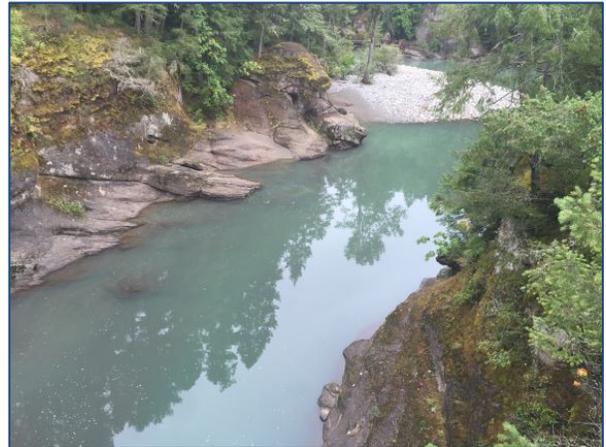
In February, there was significant sloughing of the clay banks (pics attached). Data verified any particles which could be harmful were removed from the water during the treatment process. The clay particles are small and pass through the sand separator and strainers but because they are too large to pass through the fibers of the membrane filtration system, are washed off during the backwash cycle and removed. During a clay bank event, the situation is carefully monitored, and any adjustments are made.

Recently, the City of Parksville has received a few inquiries related to "clay banks" on the Englishman River and if there is reason for concern. This release will provide information about the natural occurring wall of clay behind some properties on Kaye Road in the Rivers Edge subdivision located in the Regional District of Nanaimo. Groundwater flows out of the bank causing pieces of the bank to become unstable and fall into the river; this turns the river grey until the water washes it away.
