## **Arrowsmith Water Service and Englishman River Water Service Monthly Update – August 2026**

This document is intended to provide board members of the Arrowsmith Water Service (AWS) and the Englishman River Water Service (ERWS) with an update on the status of the joint ventures. This document is also publicly accessible through the City of Parksville's website.

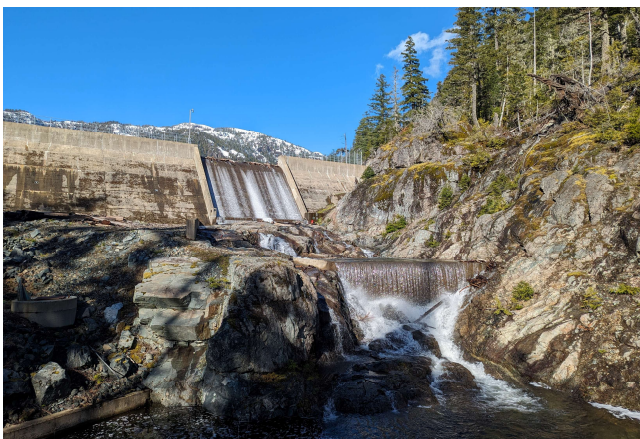
Arrowsmith Water Service (AWS) was established as a joint venture between the Regional District of Nanaimo (RDN), City of Parksville (Parksville), and the Town of Qualicum Beach to develop a regional water supply system. In 1996, AWS applied for a water licence to construct the Arrowsmith Dam. A conditional licence was granted in March 1997, authorizing the Dam to store 9,000,000 m<sup>3</sup> of water for community supply and conservation.

Arrowsmith Dam

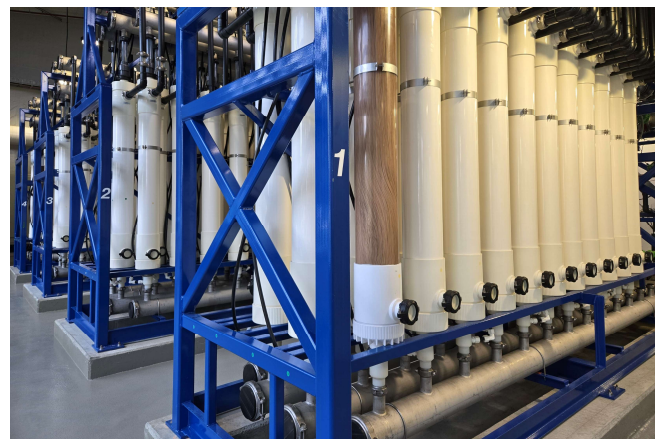
Ultrafiltration Membranes at the water  
treatment plant

Preventive and corrective maintenance activities included repeated cleaning of UF rotameters and turbidity analyzers, finished water turbidity analyzer flushing and cleaning, CL-17 reagent and cell maintenance, pH probe and cell-block cleaning, lab pH probe calibration, lab turbidity and chlorine analyzer verification, sulfuric acid transfer, hydroxide pump tubing replacement, and routine intake screen cleaning. A high-level alarm for reservoir 4 required communication resynchronization.
